**Santa Cruz River, Paseo de las Iglesias
Pima County, Arizona
Draft Feasibility Report**

**APPENDIX F
GEOTECHNICAL**

APPENDIX F
GEOTECHNICAL EVALUATION
FEASIBILITY REPORT
FOR
PASEO DE LAS IGLESIAS, FEASIBILITY STUDY
PIMA COUNTY, ARIZONA

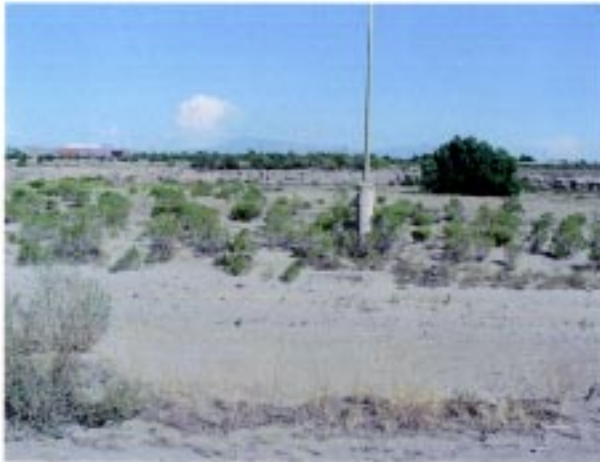
#13: Power pole base in Santa Cruz channel just S. of Drexel

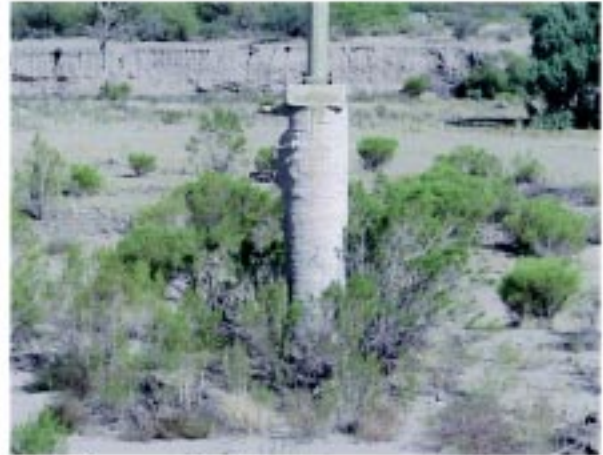
#14: Same pole foundation as previous showing bed degradation

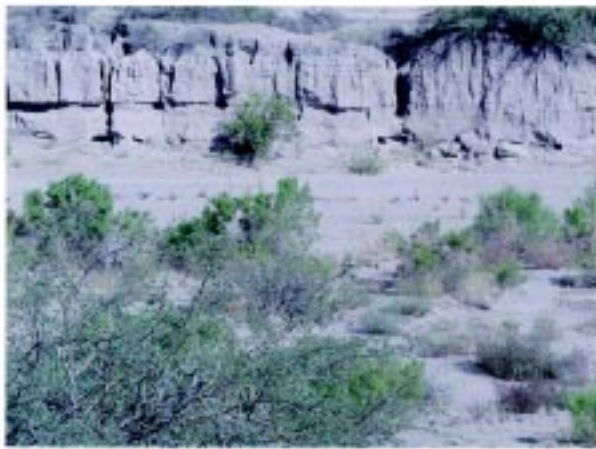
a near vertical inclination at many locations along the reaches of the study (reference photos 14 - 16 and 23-25). The vertical banks, when impacted by the any significant streamflow, are susceptible to being undercut at the bottom and collapsing into the streambed. The undercutting occurs mainly by the water breaking down the weak cementation present in the silty material. The second form of stream bank erosion is piping. As previously noted, the particle size of the slope embankment material is such that it is very susceptible to piping. Either surface or subsurface water flowing over or beneath the banks form large cavities or cave-like structures as the material is removed by piping thru the embankment and out its face.

#15: East bank of Santa Cruz channel just N. of Valencia

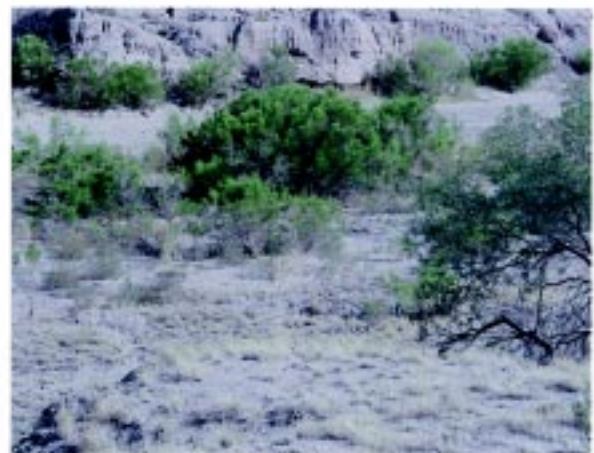
#16: East bank of Santa Cruz channel north of Valencia

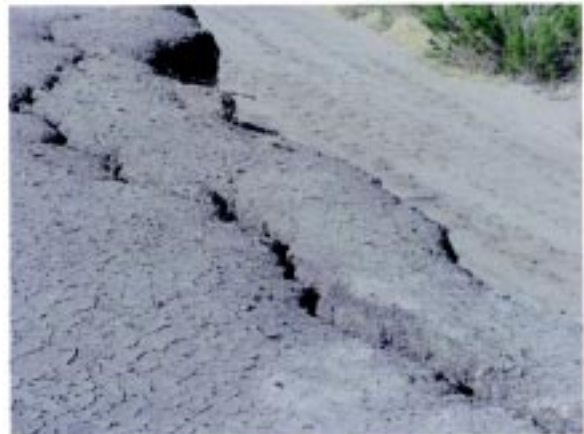
#19: Tension Cracks in W. bank, just S. of Valencia

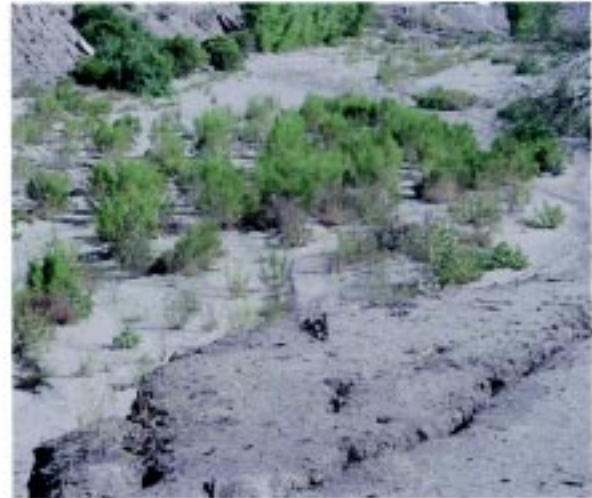
#21: Tension Cracks in W. Bank just S. of Valencia

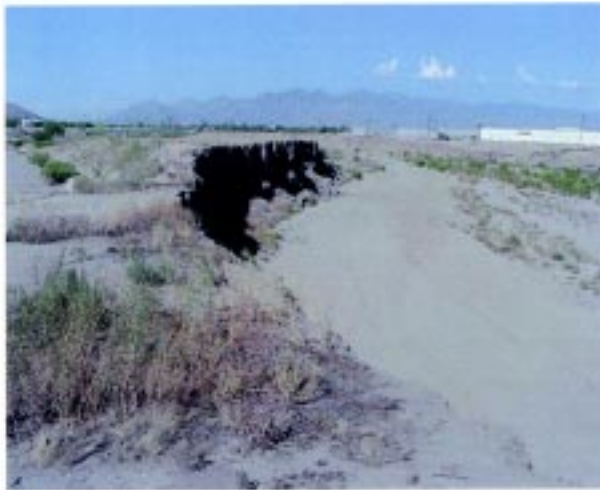
#23: Santa Cruz channel west bank, south of Irvington (view to north)

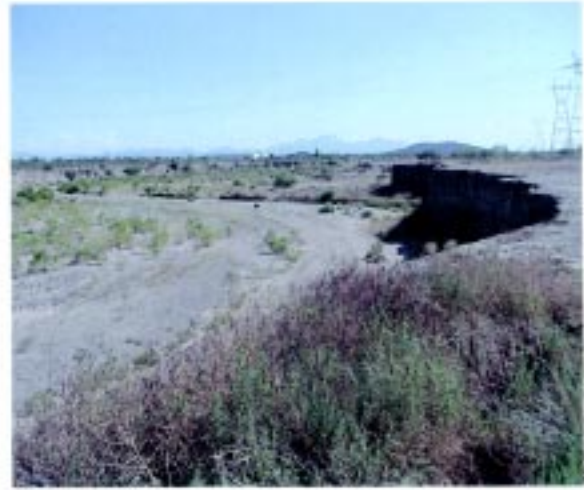
#24: Santa Cruz channel bank, south of Irvington (view to south)

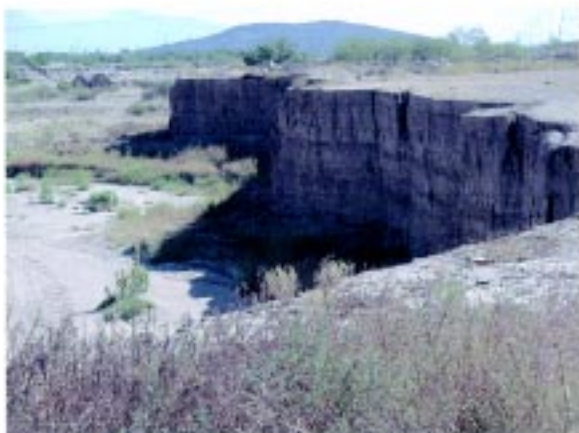
#25: Santa Cruz Riv. bank, south of Irvington (view to south) (closeup of previous photo)

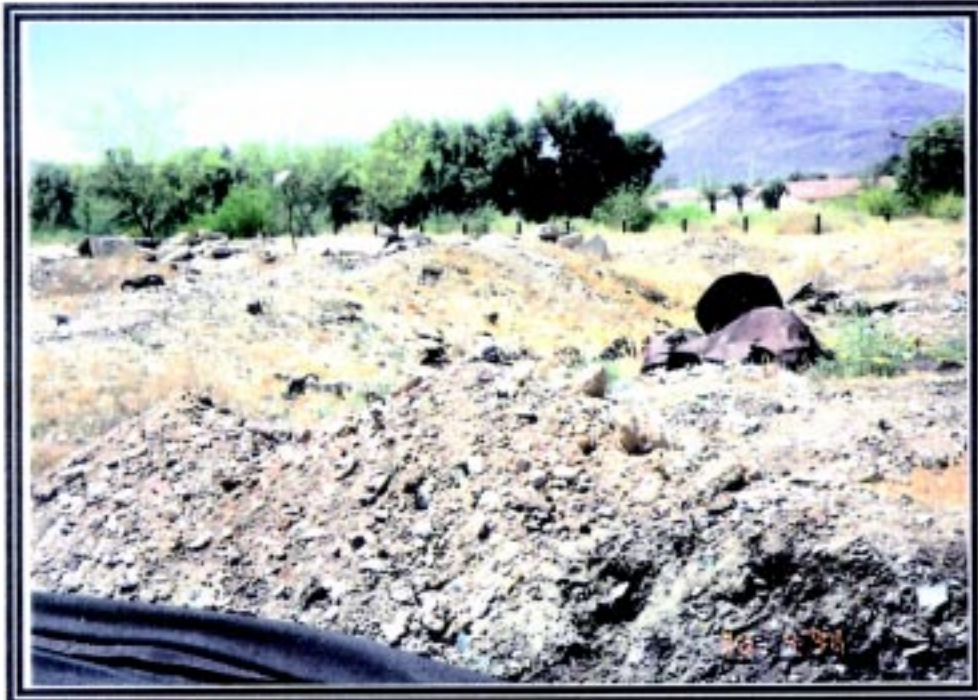
Photograph 1. Partially exposed landfill at Site 4, view toward the west-northwest.

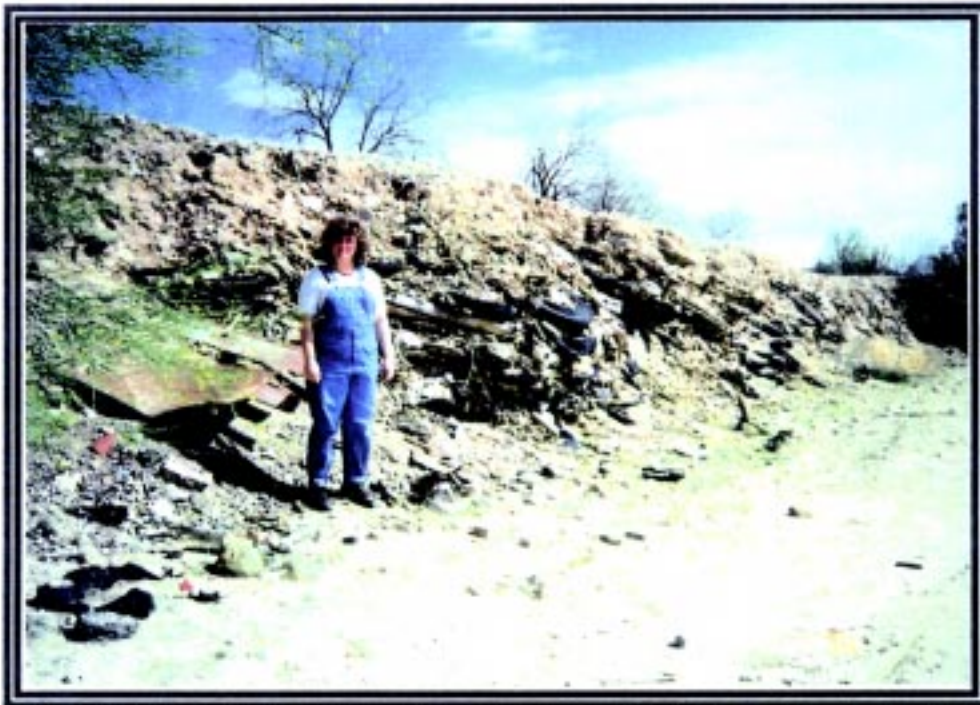
Field Description: Ryland Landfill was located at this site. The landfill material exposed along the river bank included glass, cans, paper, wood, plastic, concrete and asphalt debris, bricks, rubber tires, newspaper, and household waste. Photograph #5 shows most of the bank edge of the landfill. Rubber tires were also seen on the surface of the landfill. Access was available from Ajo Way along a dirt road. The surrounding land uses included the river with no bank protection to the west, I-19 to the east, and vacant lots to the north and south. The surface of the landfill was extremely hummocky, which was probably due to differential settling. PAG staff did not see any change in the appearance of the site since the area had been visited in the Spring of 1993.

Photograph 5. Bank edge of Ryland Landfill at Site 22, view toward the southeast.

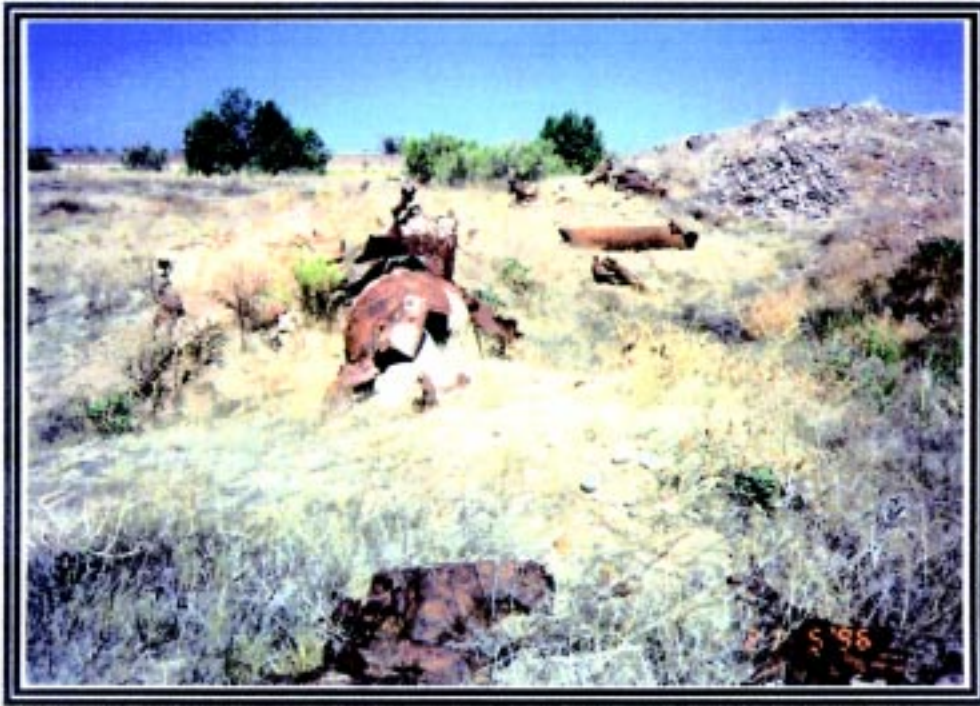
Photograph 13. Piles of concrete debris, dirt, and metal at Site 56, view toward the northwest.
