FINAL REPORT
PANTANO JUNGLE RESTORATION
CIENEGA CREEK NATURAL PRESERVE

PARTNERS FOR WILDLIFE PROJECT
FWS Agreement No. 1448-00002-95-0901

May 19, 2009

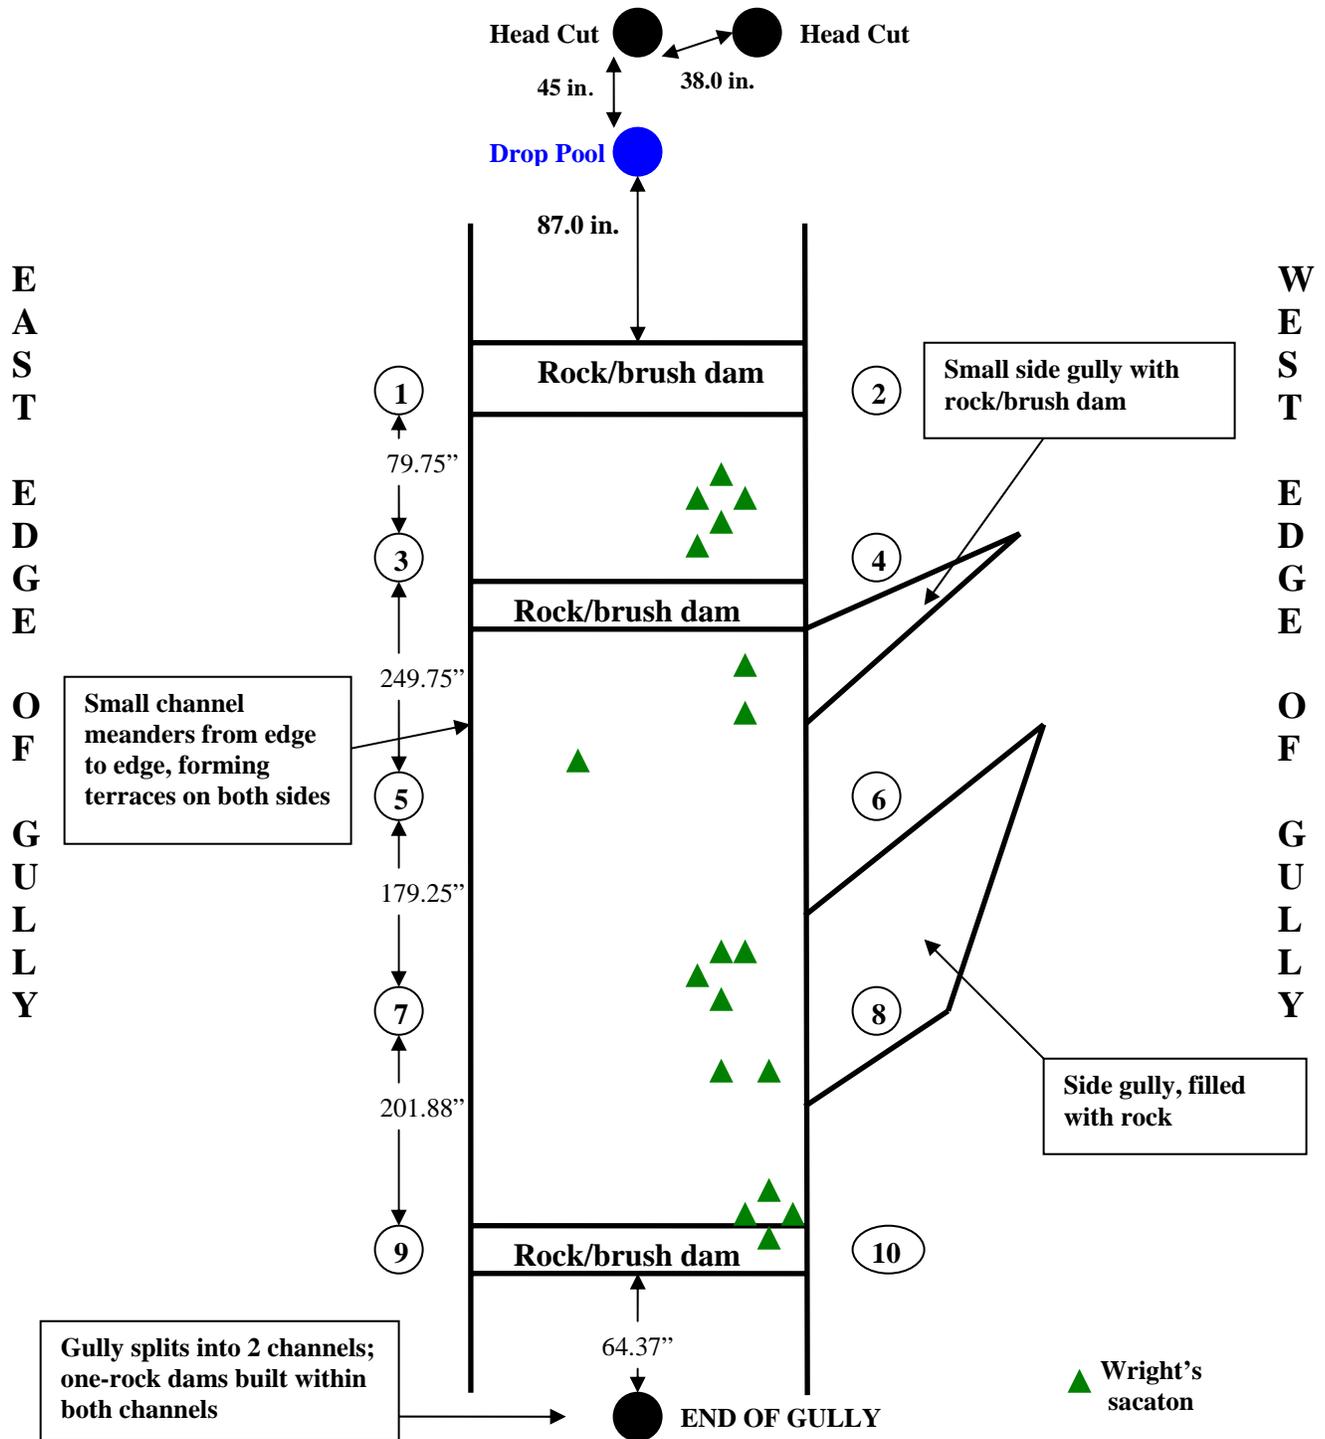
Figure 7. Gully Description (May 23, 2008)

Figure 7 abstractly displays the current configuration of the gully based on monitoring conducted in May 2008. As indicated in the figure, the headcut of the gully has migrated 132 inches (11 feet) upstream over the last 11 years. A secondary headcut, approximately 38 inches to the west of the other headcut, was created between June 2007 and June 2008. A drop pool is located between the two headcuts and the first rock and brush dam, built between Markers 1 and 2.

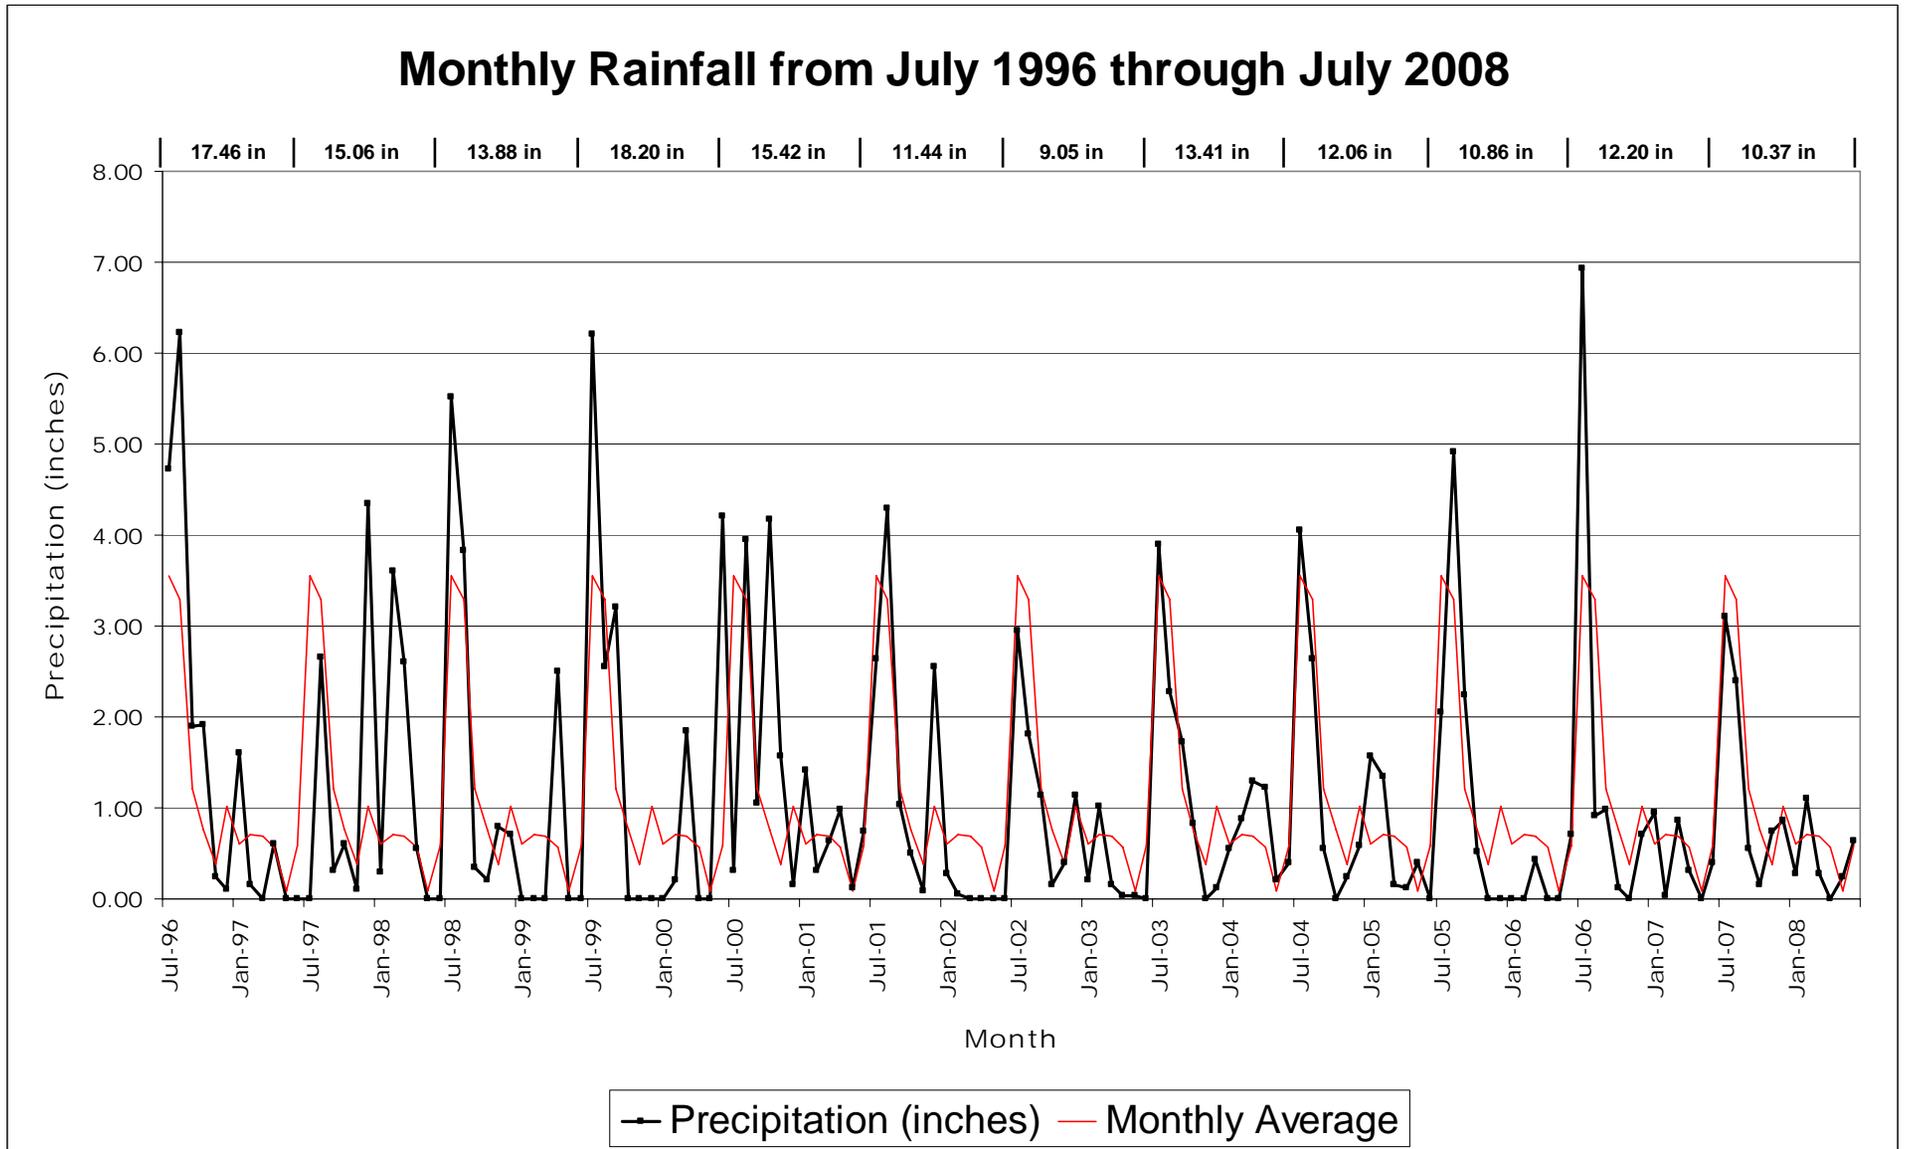
Figure 8. Rainfall measured at the Pantano Jungle site (data provided by caretakers and/or ALERT Flood Warning System)

A display of monthly rainfall is provided in **Figure 8**. Average rainfall at the project site during the 12-year period was 13.28 inches. However, the largest annual rainfall totals occurred during the first five years (16-inch average). Except for July 2003 through June 2004, annual averages over the last seven years have been one to over four inches below the average for the project duration. The decrease in precipitation is reflected in water levels measured at a monitoring well located at the northeastern corner of the project site (**Figure 9**). Water levels significantly rose from June 1999 to March 2002 in response to greater than average rainfall over the first five years of the project, but then fell sharply from April 2002 through August 2005 due to significant decreases in rainfall. Water levels have steadily increased over the last couple of years (July 2006 through June 2008). Mortality of the vegetation reflected the rainfall and water level patterns, with 20 out of the 26 total dead plants (77 percent) perishing during the dry period.

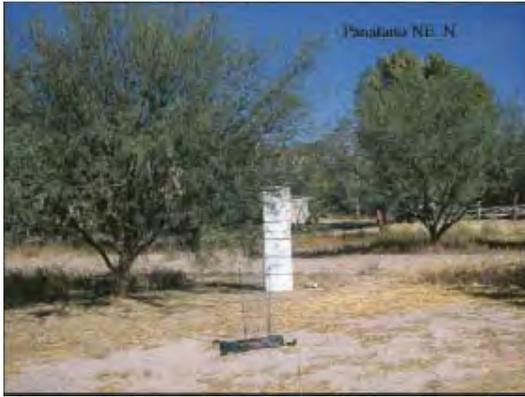
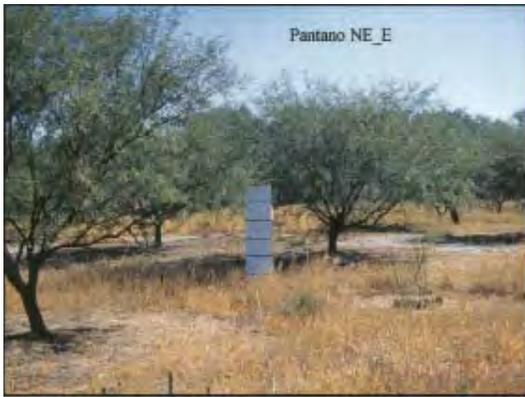
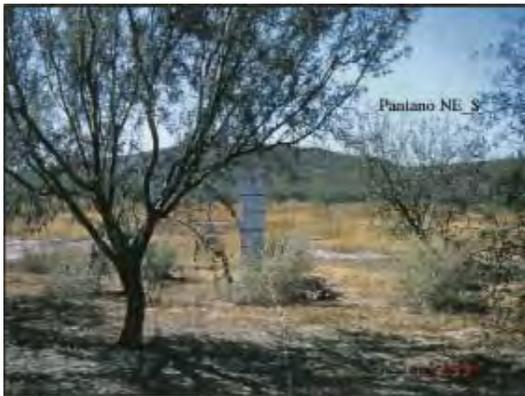
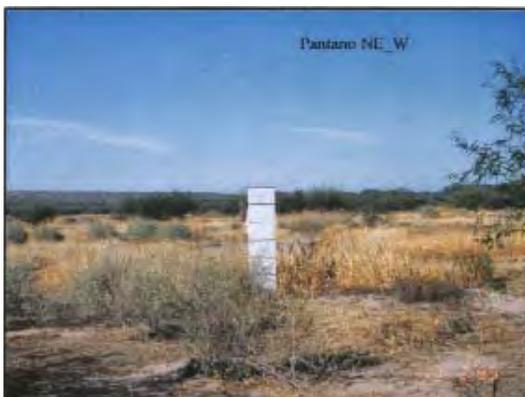
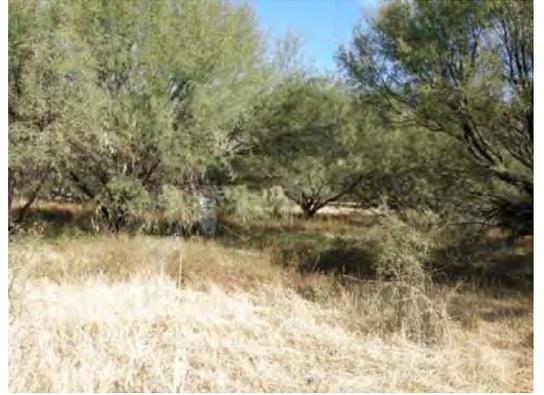
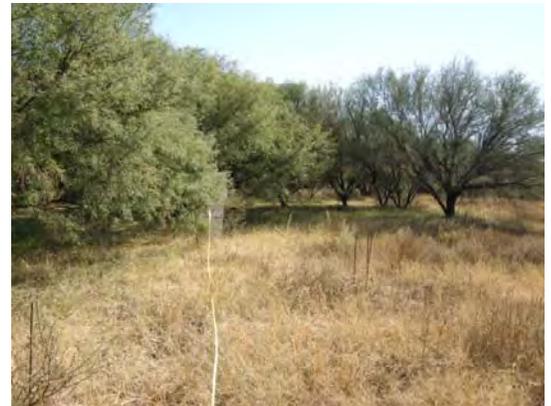
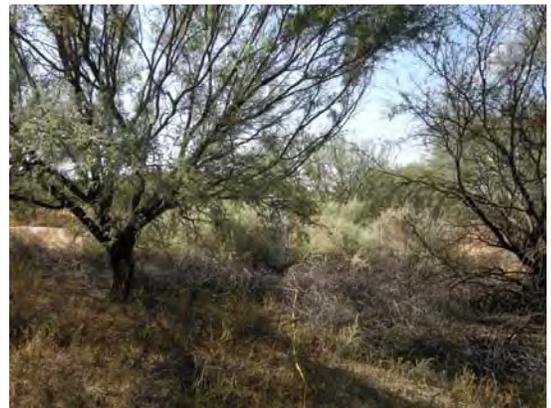
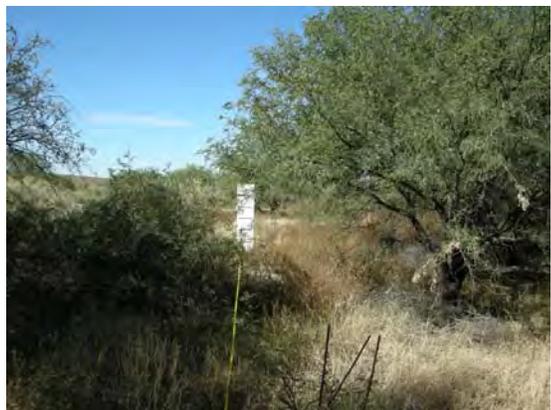
Appendix C displays a comparison of photographs taken in November 1999 and November 2007 within the four monitoring plots (NE Plot, SE Plot, Plot A and Plot B). Significant growth of the existing (pre-project) mesquite trees and the planted saltbush was the most notable change in the NE Plot. Growth of the existing and planted mesquite trees within and around the SE Plot was significant in the East and South facing photographs. Very little change can be seen in the photographs taken in Plots A and B, apart from some growth of the existing mesquite trees.

As depicted in a number of the photographs located in **Appendix C**, invasive weeds provided a great amount of competition for space and soil moisture at the project site. Two nonnative species, Russian thistle (*Salsola tragus*) and Bermudagrass (*Cynodon dactylon*), covered most of the abandoned agricultural field. Both species were mechanically cleared from the vegetated area, but there was no concerted effort to control the weeds with herbicide. Weed mats were not effective in controlling weeds around the planted trees and shrubs.

- **Weed maintenance:** Aggressive weed maintenance is essential for revegetation efforts in areas that have been disturbed for a long period of time. The vast extent of weeds at the project site was the most visible challenge to the establishment of planted trees and shrubs and the recruitment of native vegetation. Weed mats may have been more effective if the area was recently disturbed and the invasive species were not already established. A concerted effort to remove the weeds before planting and constant maintenance of the planted areas would most likely have increased the success of this project.

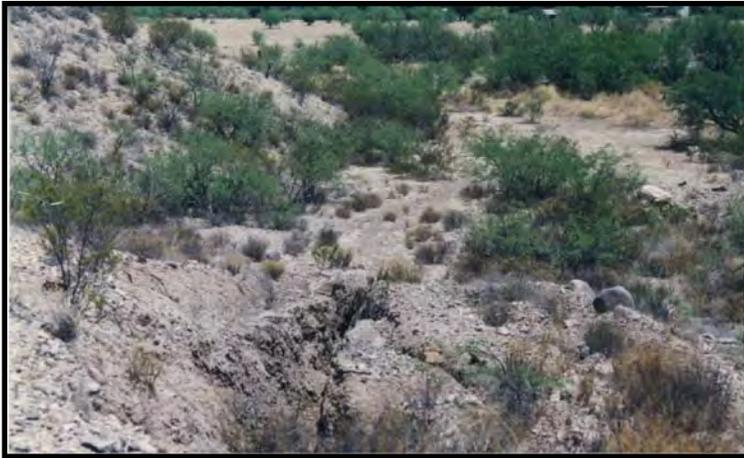
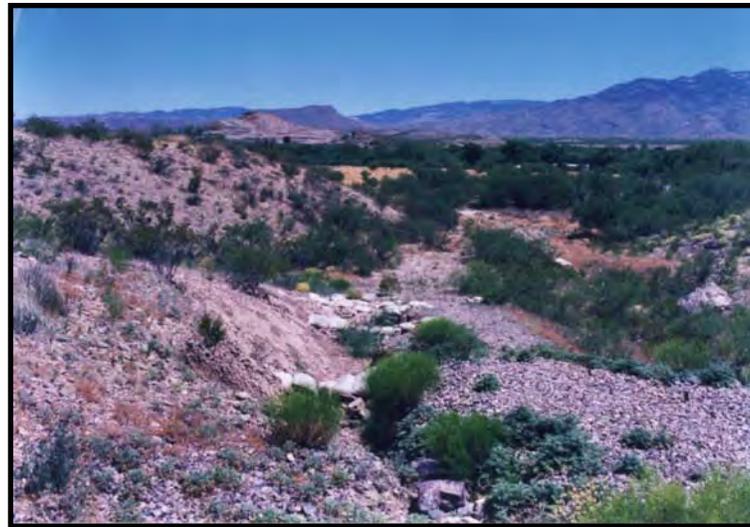
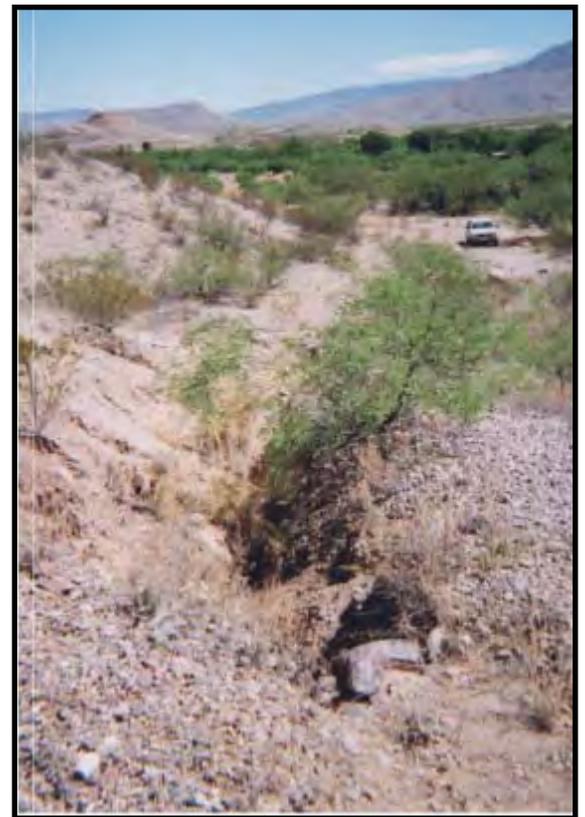
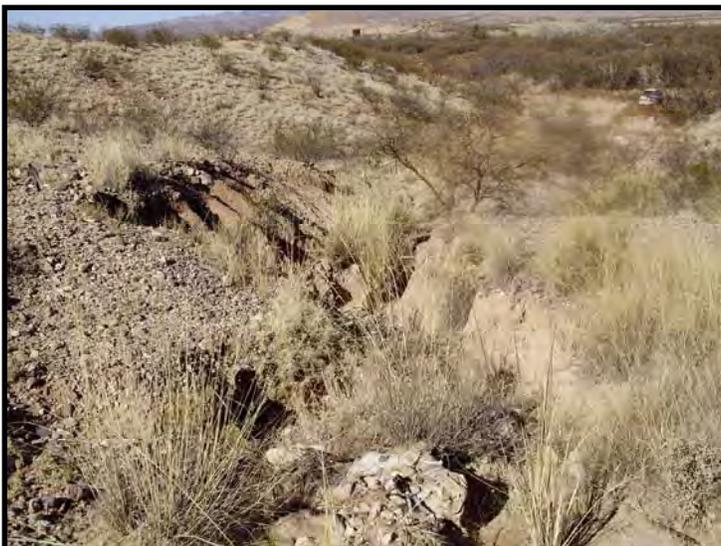
Appendix F. Photographs taken from gully headcut, looking downstream (towards North)

Appendix F displays a comparison of photographs taken during the following project milestone events: pre-restoration (May 1996), post-construction of check dams (June 1998), deterioration of check dams (June 2002), and construction of rock and brush dams (May 2008). The pictures help depict the transformation of the channel from a highly entrenched, V-shaped gully to a meandering channel with terraces and established vegetation.

The sandbag check dams were initially effective in slowing flow velocities and allowing the accumulation of sediment behind them. Over time, however, flows were cutting around the dams and deteriorating the sandbags, thus making them ineffective to reduce lateral erosion and downcutting of the channel. Small rock and brush dams were recently constructed in 2007 to replace the check dams. Future maintenance of these dams will be required to maintain their integrity and help keep the channel from reverting back to a V-shaped gully.

- **Ongoing monitoring and maintenance:** In addition to monitoring, maintenance is essential to restore a degraded watershed to a more natural condition. Many of the efforts to restore the tributary watershed on the hill slope south of the revegetation project were conducted on a trial and error basis. The sandbag check dams needed to be modified with a spillway in the middle to allow stormwater to flow over the top so that flows would not try to force their way around the dams. Sacaton grasses were planted along terraces that formed in the channel to help strengthen banks and reduce flow velocities. Small rock dams were constructed and modified as flows changed their course over time. Rock and brush dams were constructed after the sandbags deteriorated to take advantage of available natural materials.
