**UNDERGROUND STORAGE FACILITY
PERMIT APPLICATION**

**HIGH PLAINS EFFLUENT RECHARGE PROJECT
MARANA, ARIZONA**

Underground Storage Facility Permit Report

**Pima County Regional Flood Control District
Water Resources Division
and
Town of Marana
Water Department
June 2007**

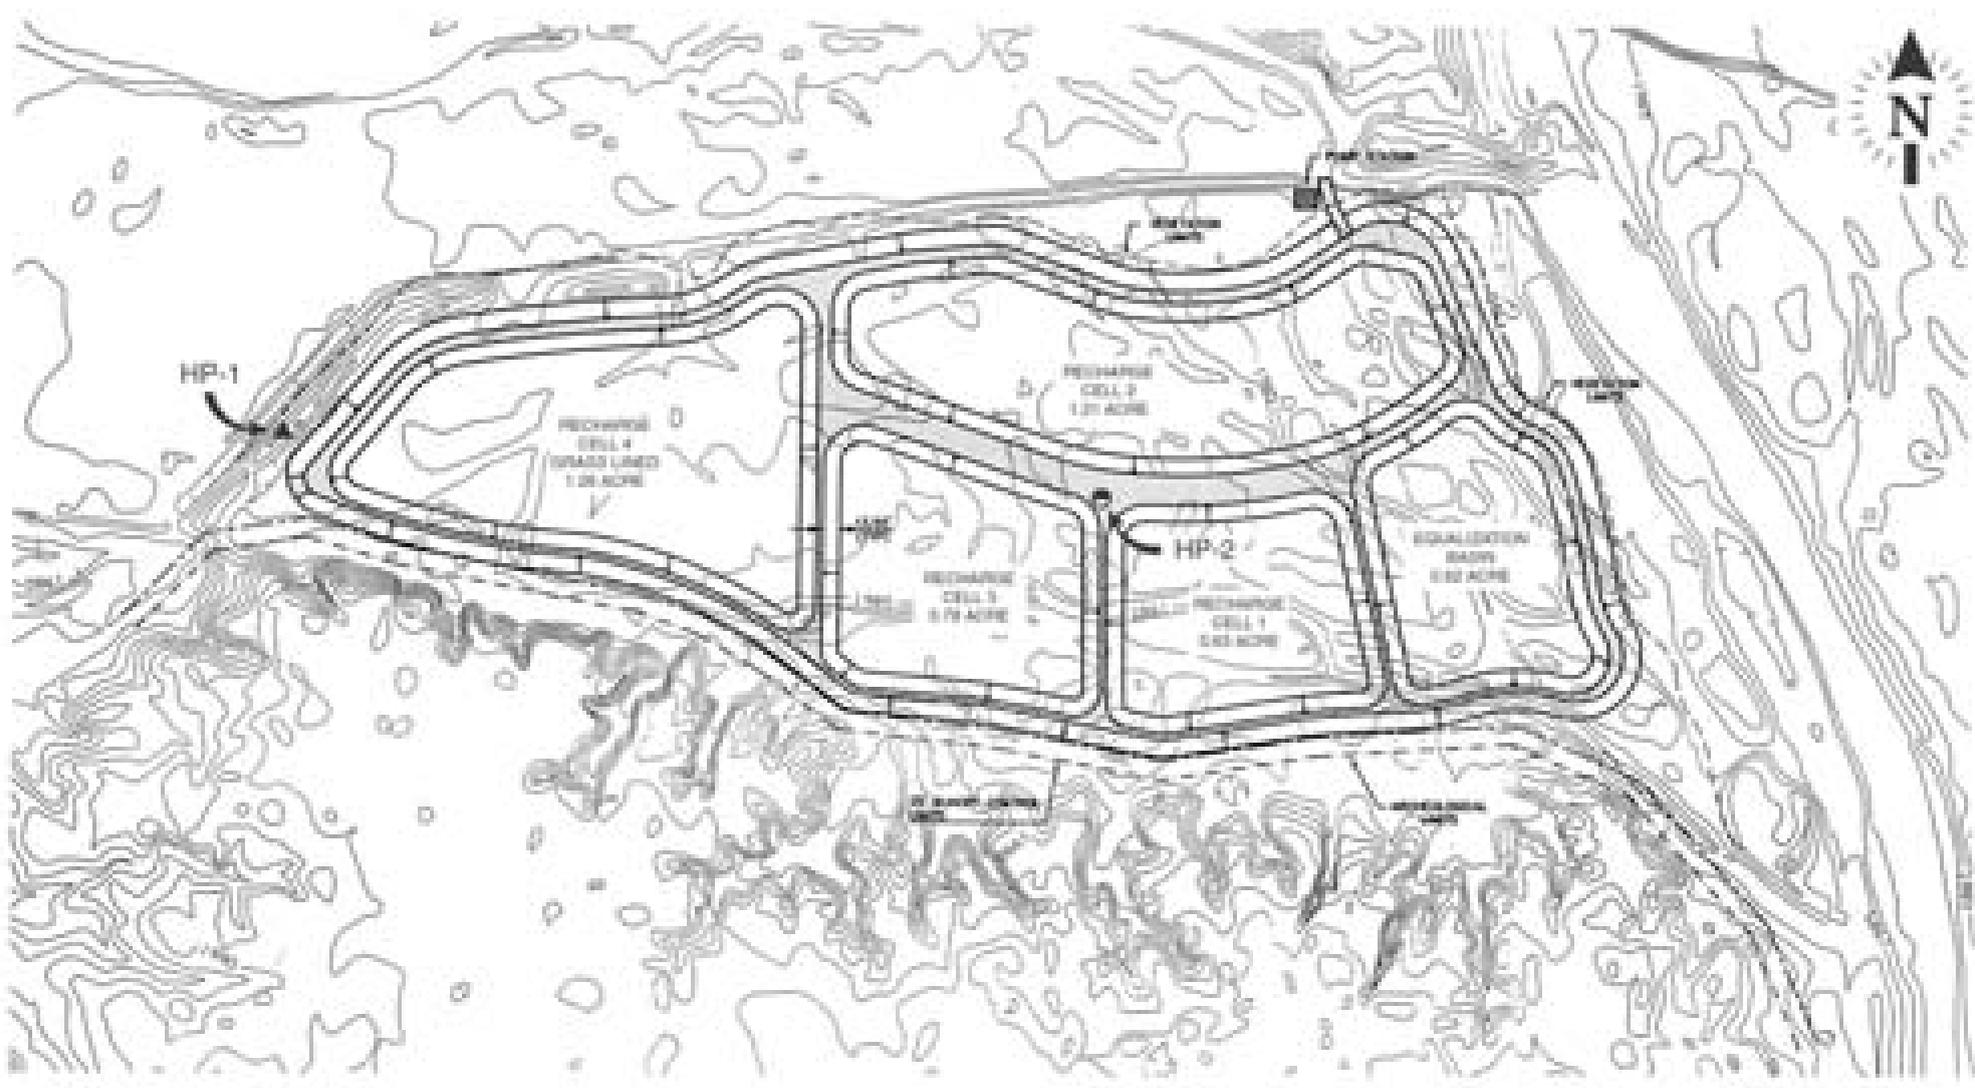
FIGURE 2
Facility Map

TOTAL RECHARGE AREA = 3.88 ACRES
ESTIMATED RECHARGE VOLUME = 290 ACRE-FT/YR

The Project consists of five constructed basins: one equalization basin and four recharge cells that total 4.5 acres (**Table 1**). Recharge is currently not calculated for the equalization basin, since the basin is used to store water for delivery to the recharge cells and as a settling pond for particulate materials. However, the basin is not lined, so infiltration does occur. Recharge is calculated for the four recharge cells, which have a total area of 3.88 acres. These cells were constructed using different configurations and landscapes to study the effects of these treatments on infiltration rates. As-built drawings showing the construction details and recharge components are provided in **Appendix B**.

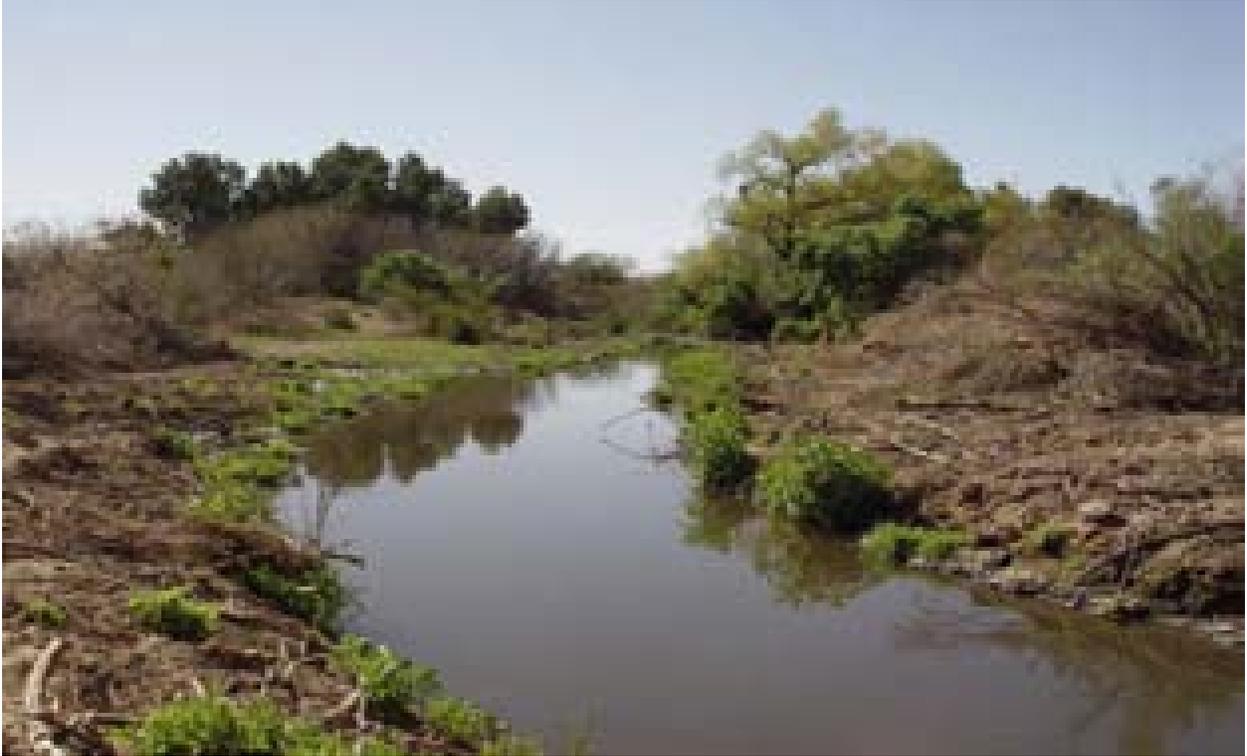
Figure 3. Oxbow channel, March 2006

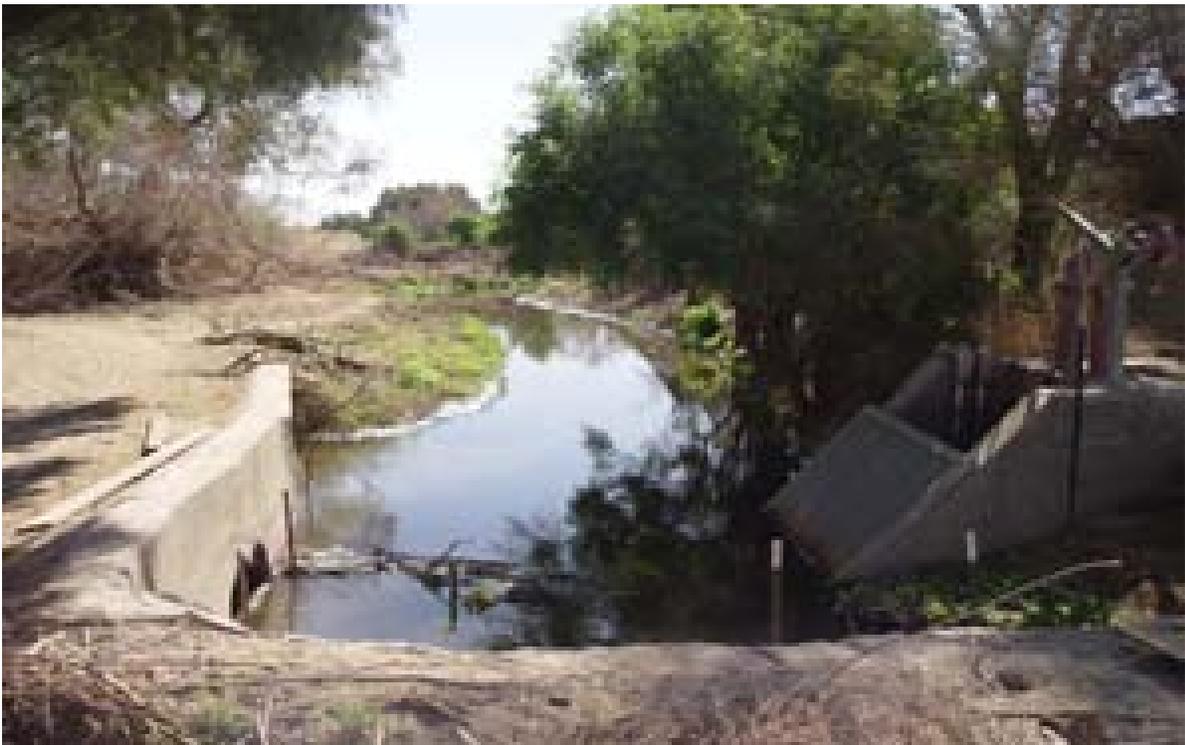
Figure 4. Wet well for the Project, March 2006

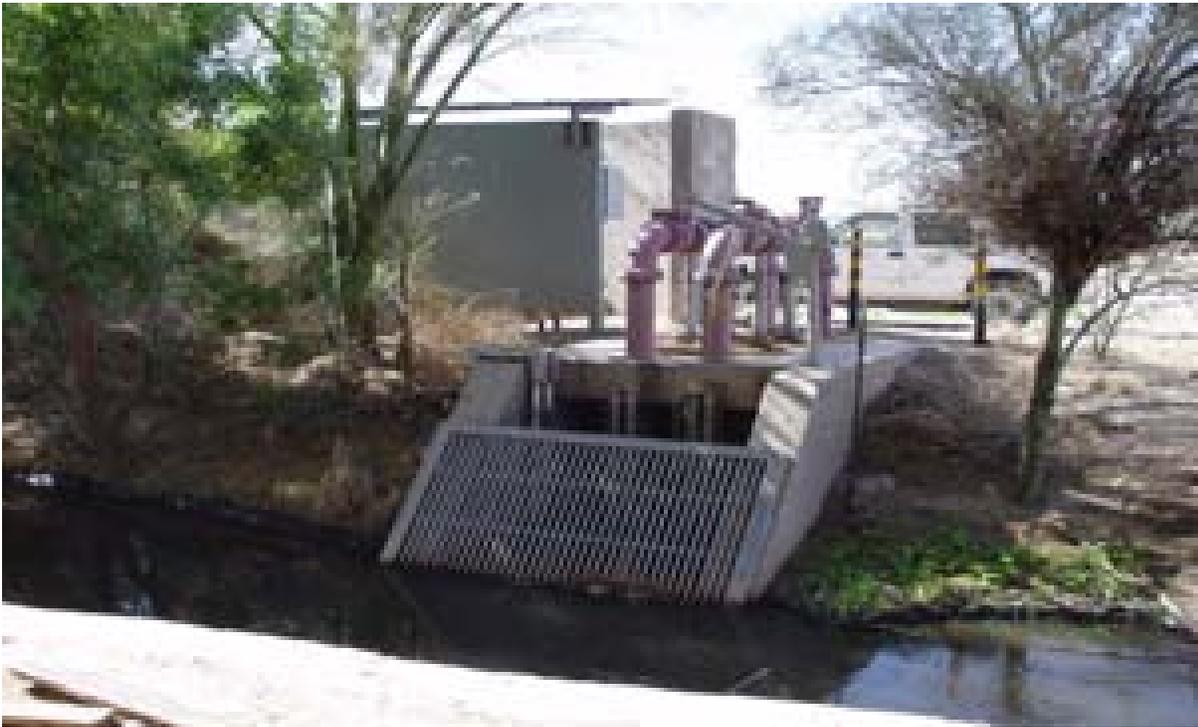
Figure 5. Submersible pumps for the Project, March 2006

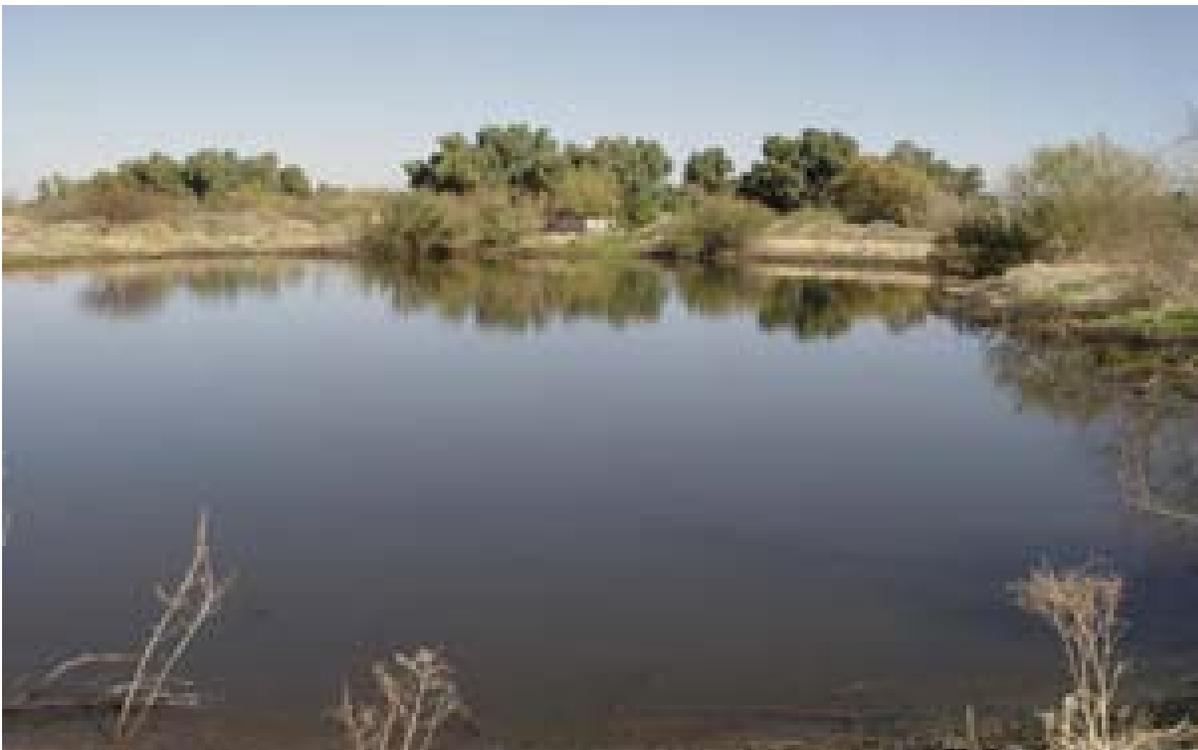
Figure 6. Equalization basin, March 2006.

A review of past recharge accounting has indicated that a fair amount of infiltration occurs within the Equalization Basin. This basin is not lined and has been occasionally maintained to clear weedy vegetation that is unwanted within the facility confines. District staff estimates that approximately 80 af/yr is incidentally recharged within this basin. In the future, we wish to operate and maintain this basin more frequently to increase recharge capacity for the Project.

The Equalization Basin will now be included as a recharge component for the facility. This basin covers approximately 0.62 acres. It contains up to five feet of water and would be used to distribute effluent to the four recharge cells as well as to infiltrate water. The two submersible pumps that feed water into the Equalization Basin will be equipped with totalizing, electro-magnetic flow meters to ensure better accuracy and less interruption of water deliveries.¹ The basin will be regularly maintained, cleared of vegetation and scraped at least once a year during the normal down time for facility operations (probably during the monsoon season). Wet-dry cycles will be used as necessary.

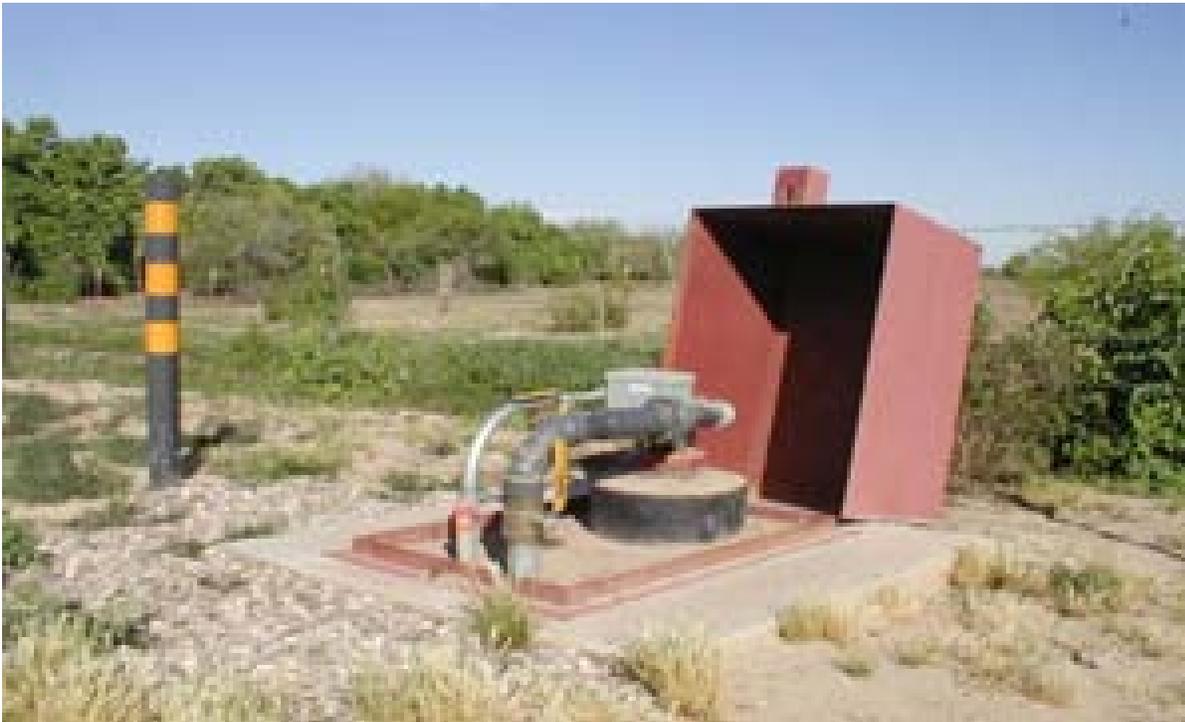
Figure 7. Monitoring well for the Project, HP-1.

Due to the Project’s limited area of impact, groundwater levels will only be measured for one on-site well (HP-1) and one off-site well (SC-10), as shown in **Table 2**. District staff will measure HP-1 (**Figure 7**) and SC-10 monthly using an electric sounder. A pressure transducer and data logger may

be installed in HP-1 well to collect the data on a daily basis. Schematics, as-built diagrams and the authorized Notice of Intent to Drill for each well are provided in **Appendix C**.

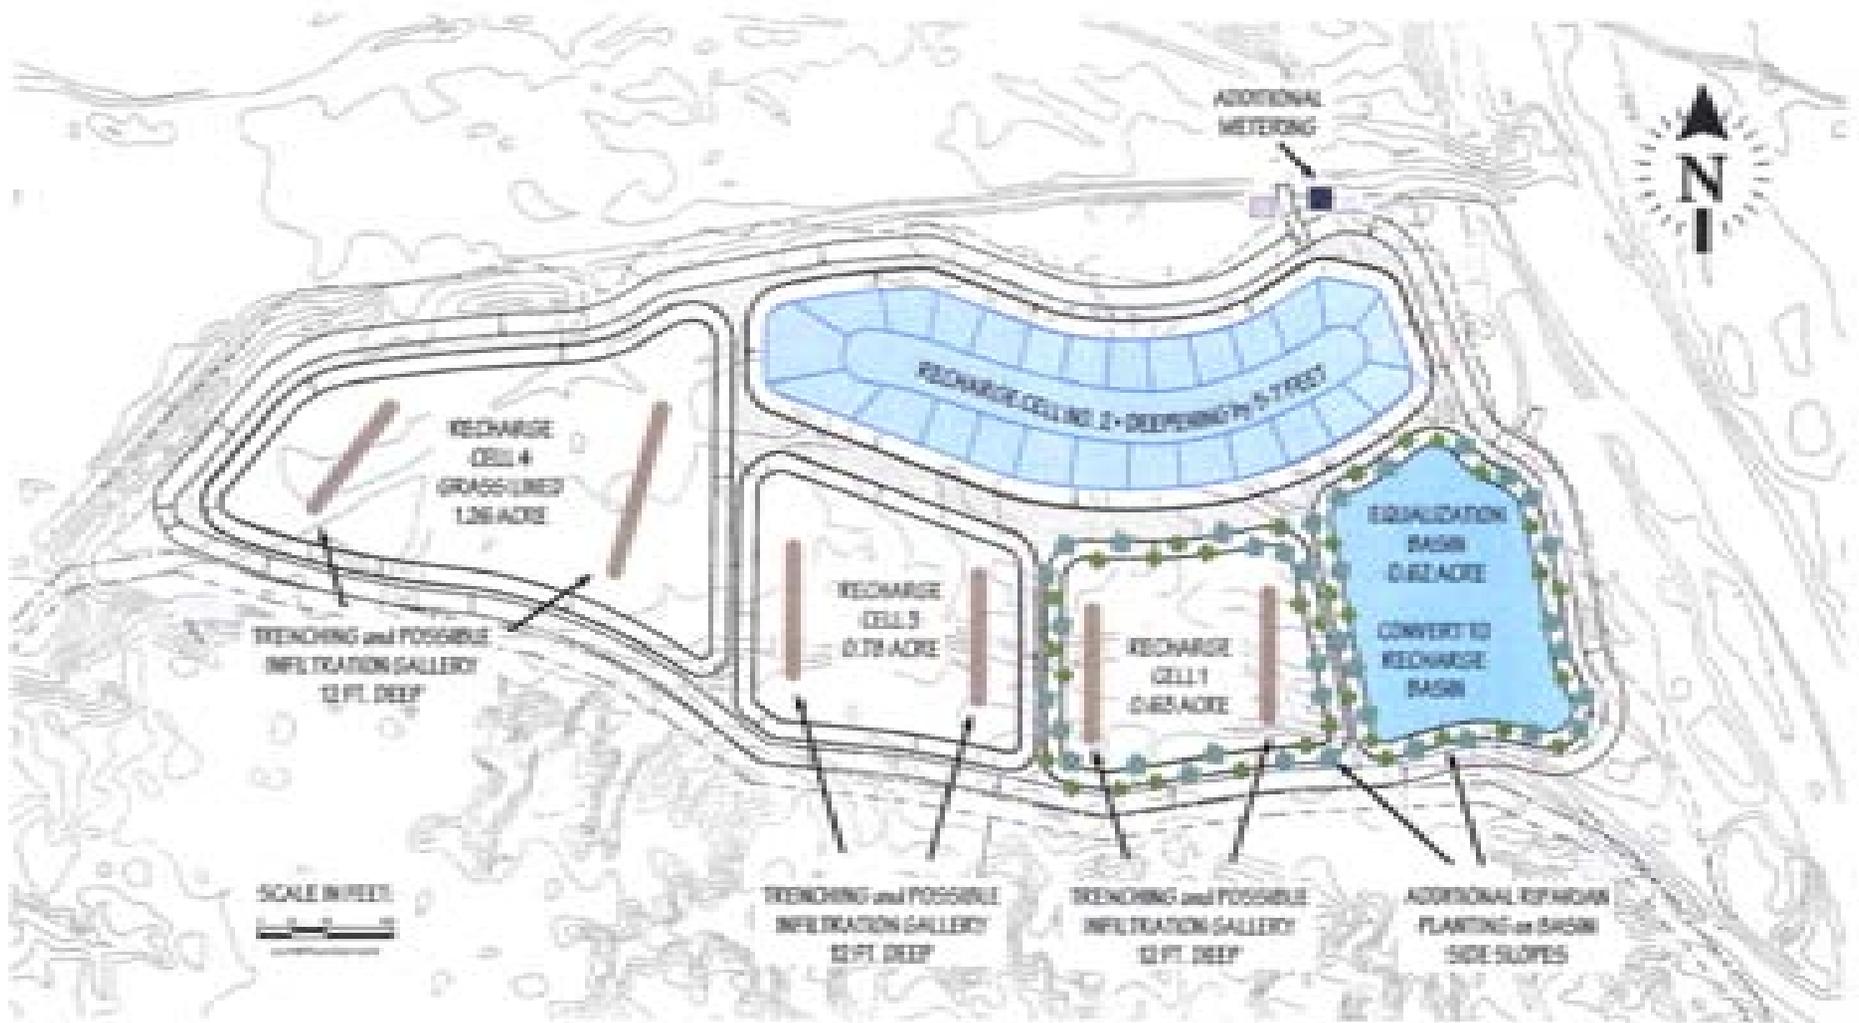
FIGURE 8. Proposed Facility Plan for Future Permit (2008)

Recharge Cells 1 through 4 will maintain their current size and shape, but the bottoms will be modified to gain access to coarser grained materials (**Figure 8**). Two trenches will be excavated in each of Recharge Cells 1, 3 and 4 to depths of about 12 feet. These trenches will range from 100-150 feet in length, about 3-4 feet in width, and be filled in with river rock material to allow for greater infiltration (**Figure 9**). A twenty-foot wide trench will be excavated down 5-7 feet throughout much of the length of Recharge Cell 2. The side slopes of the basin will be contoured up from the bottom of the trench to allow easy access for shorebirds and waterfowl. Riparian vegetation will be planted around the Equalization Basin and Recharge Cell 1 to increase cover for nesting migratory birds. Recharge Cell 4 will be cleared of some shrubby vegetation and be replanted with native grasses that are tolerant of periodic flooding.

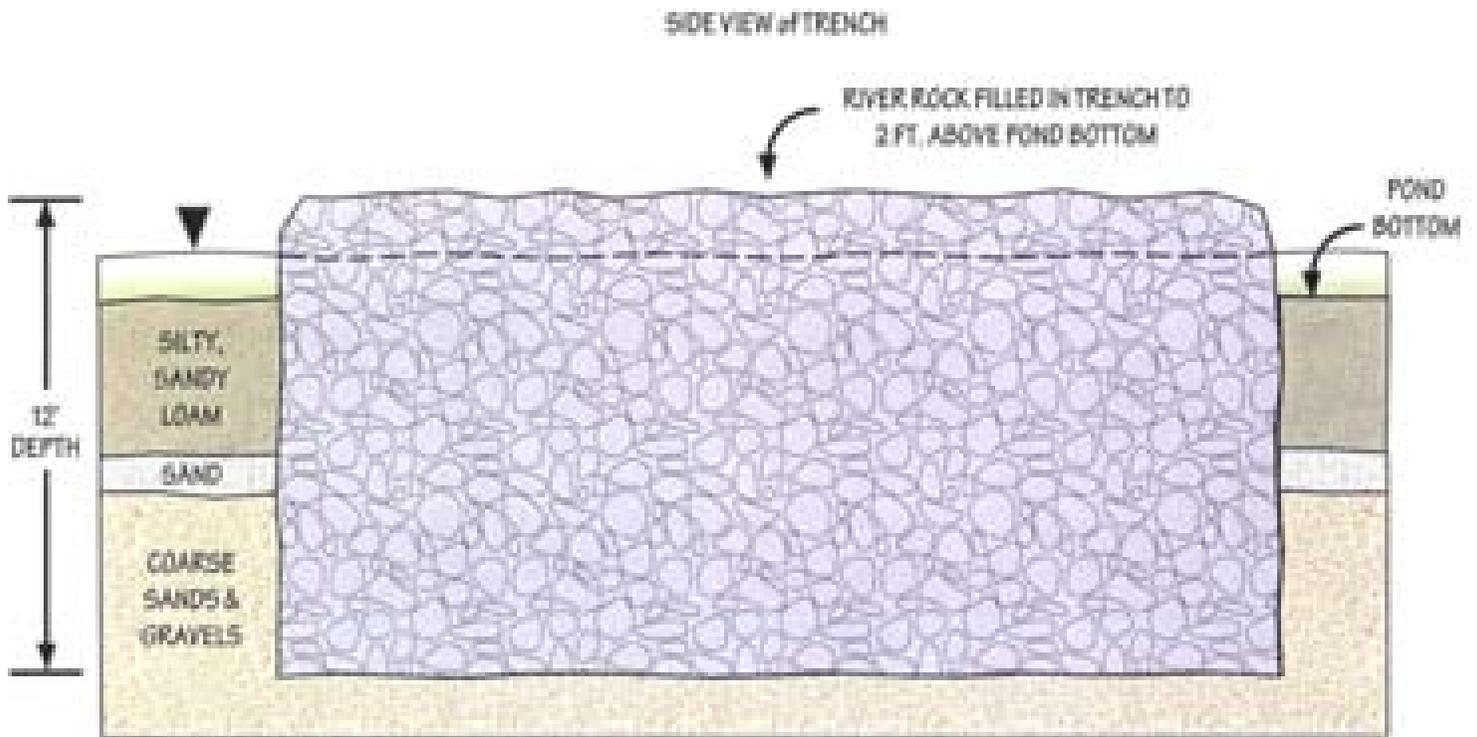
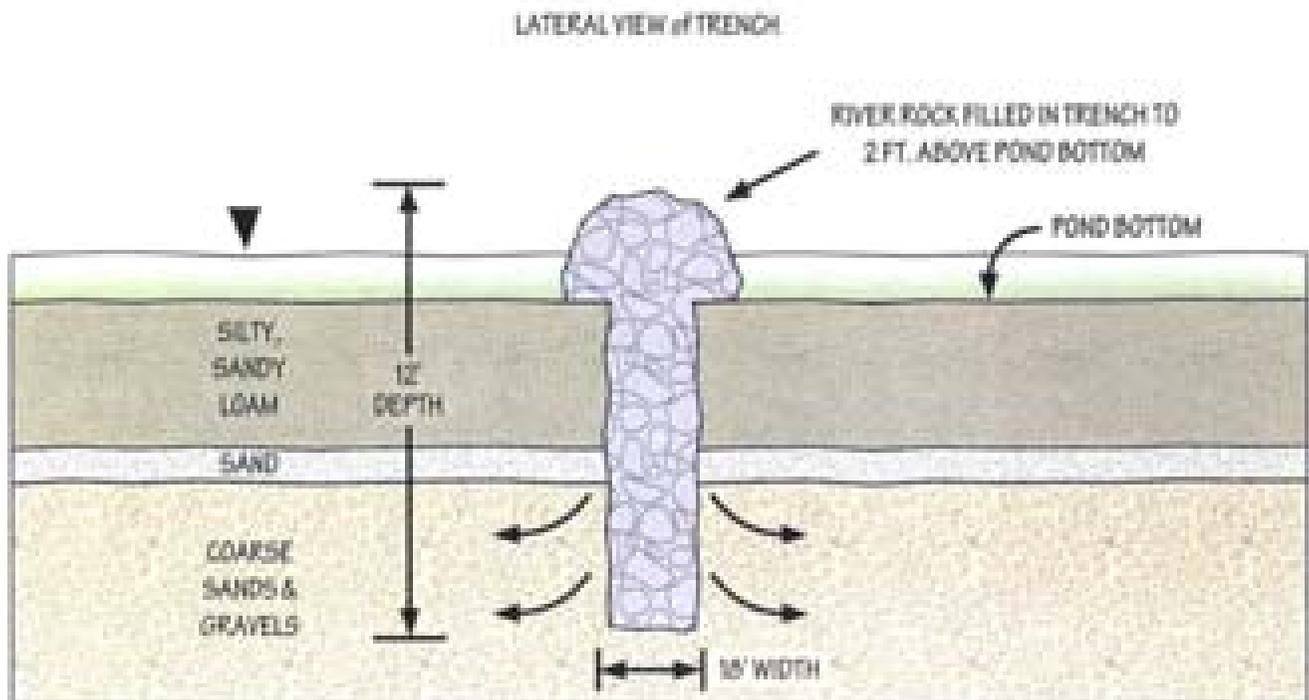
FIGURE 9. Conceptual Drawing of Recharge Enhancement Trenches

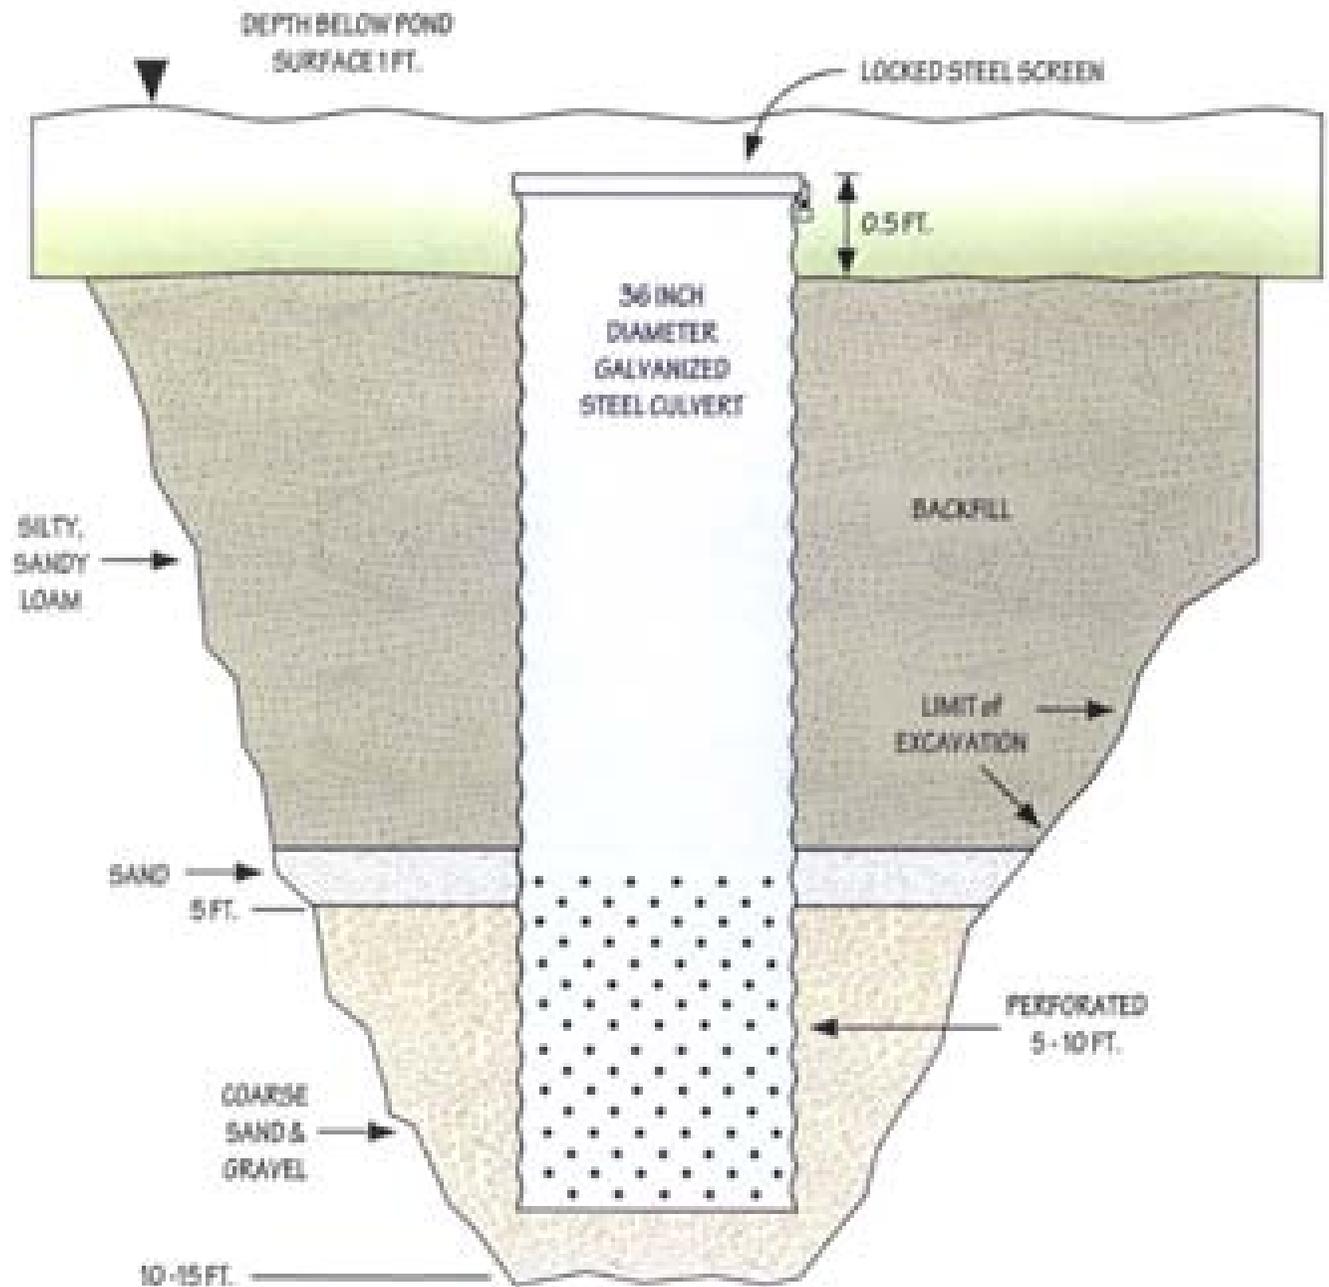
FIGURE 12. Conceptual Drawing of Recharge Dry Well

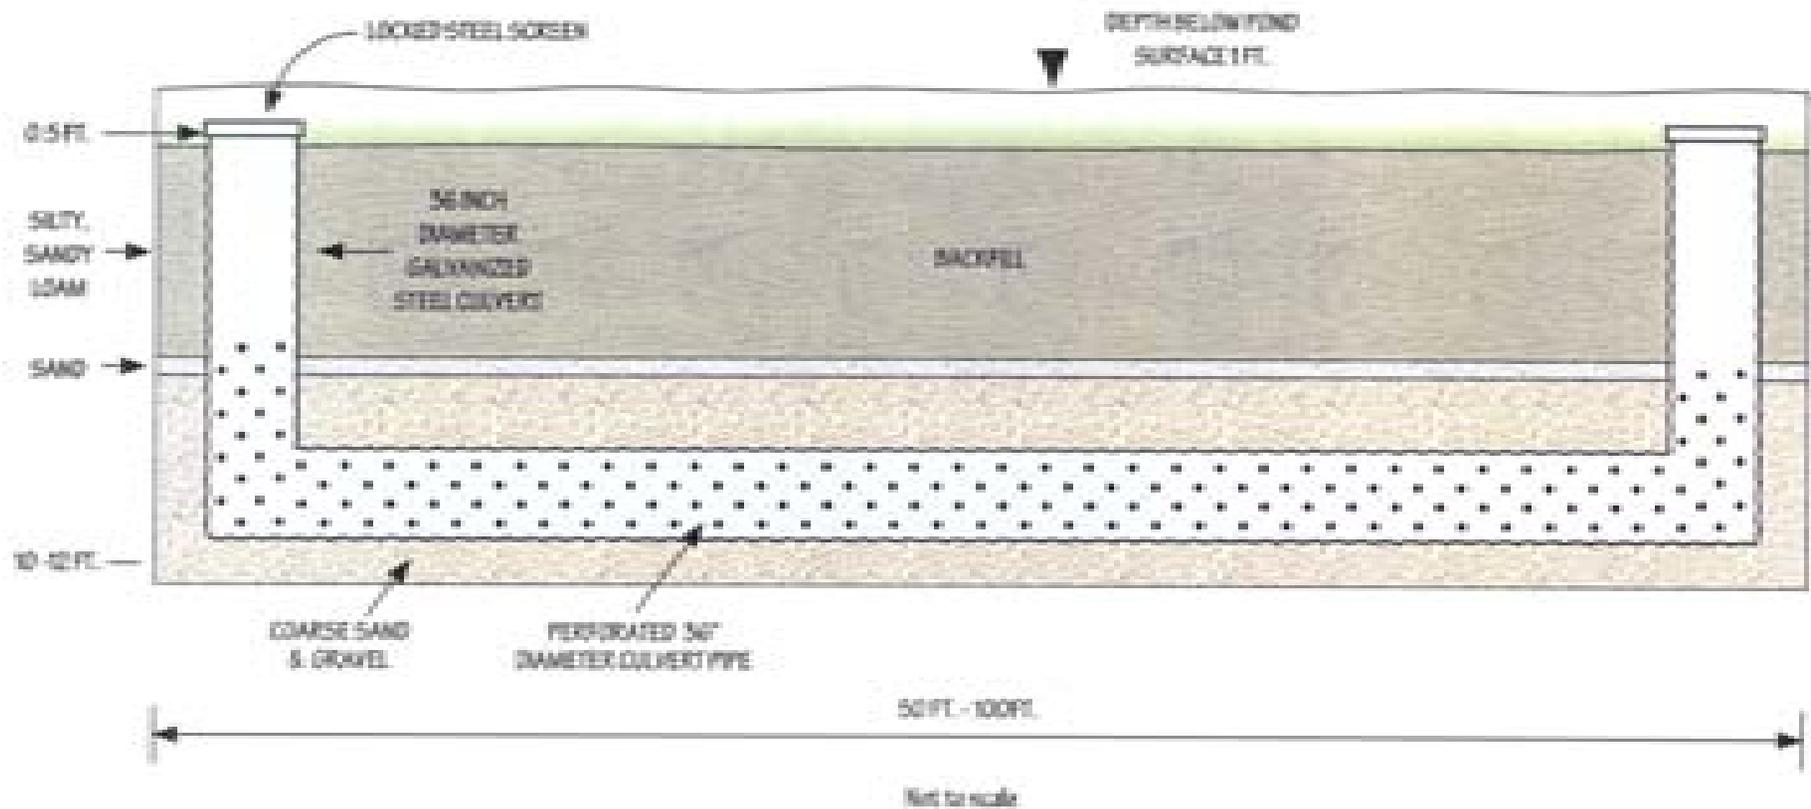
FIGURE 13. Conceptual Drawing of Horizontal Recharge Dry Well

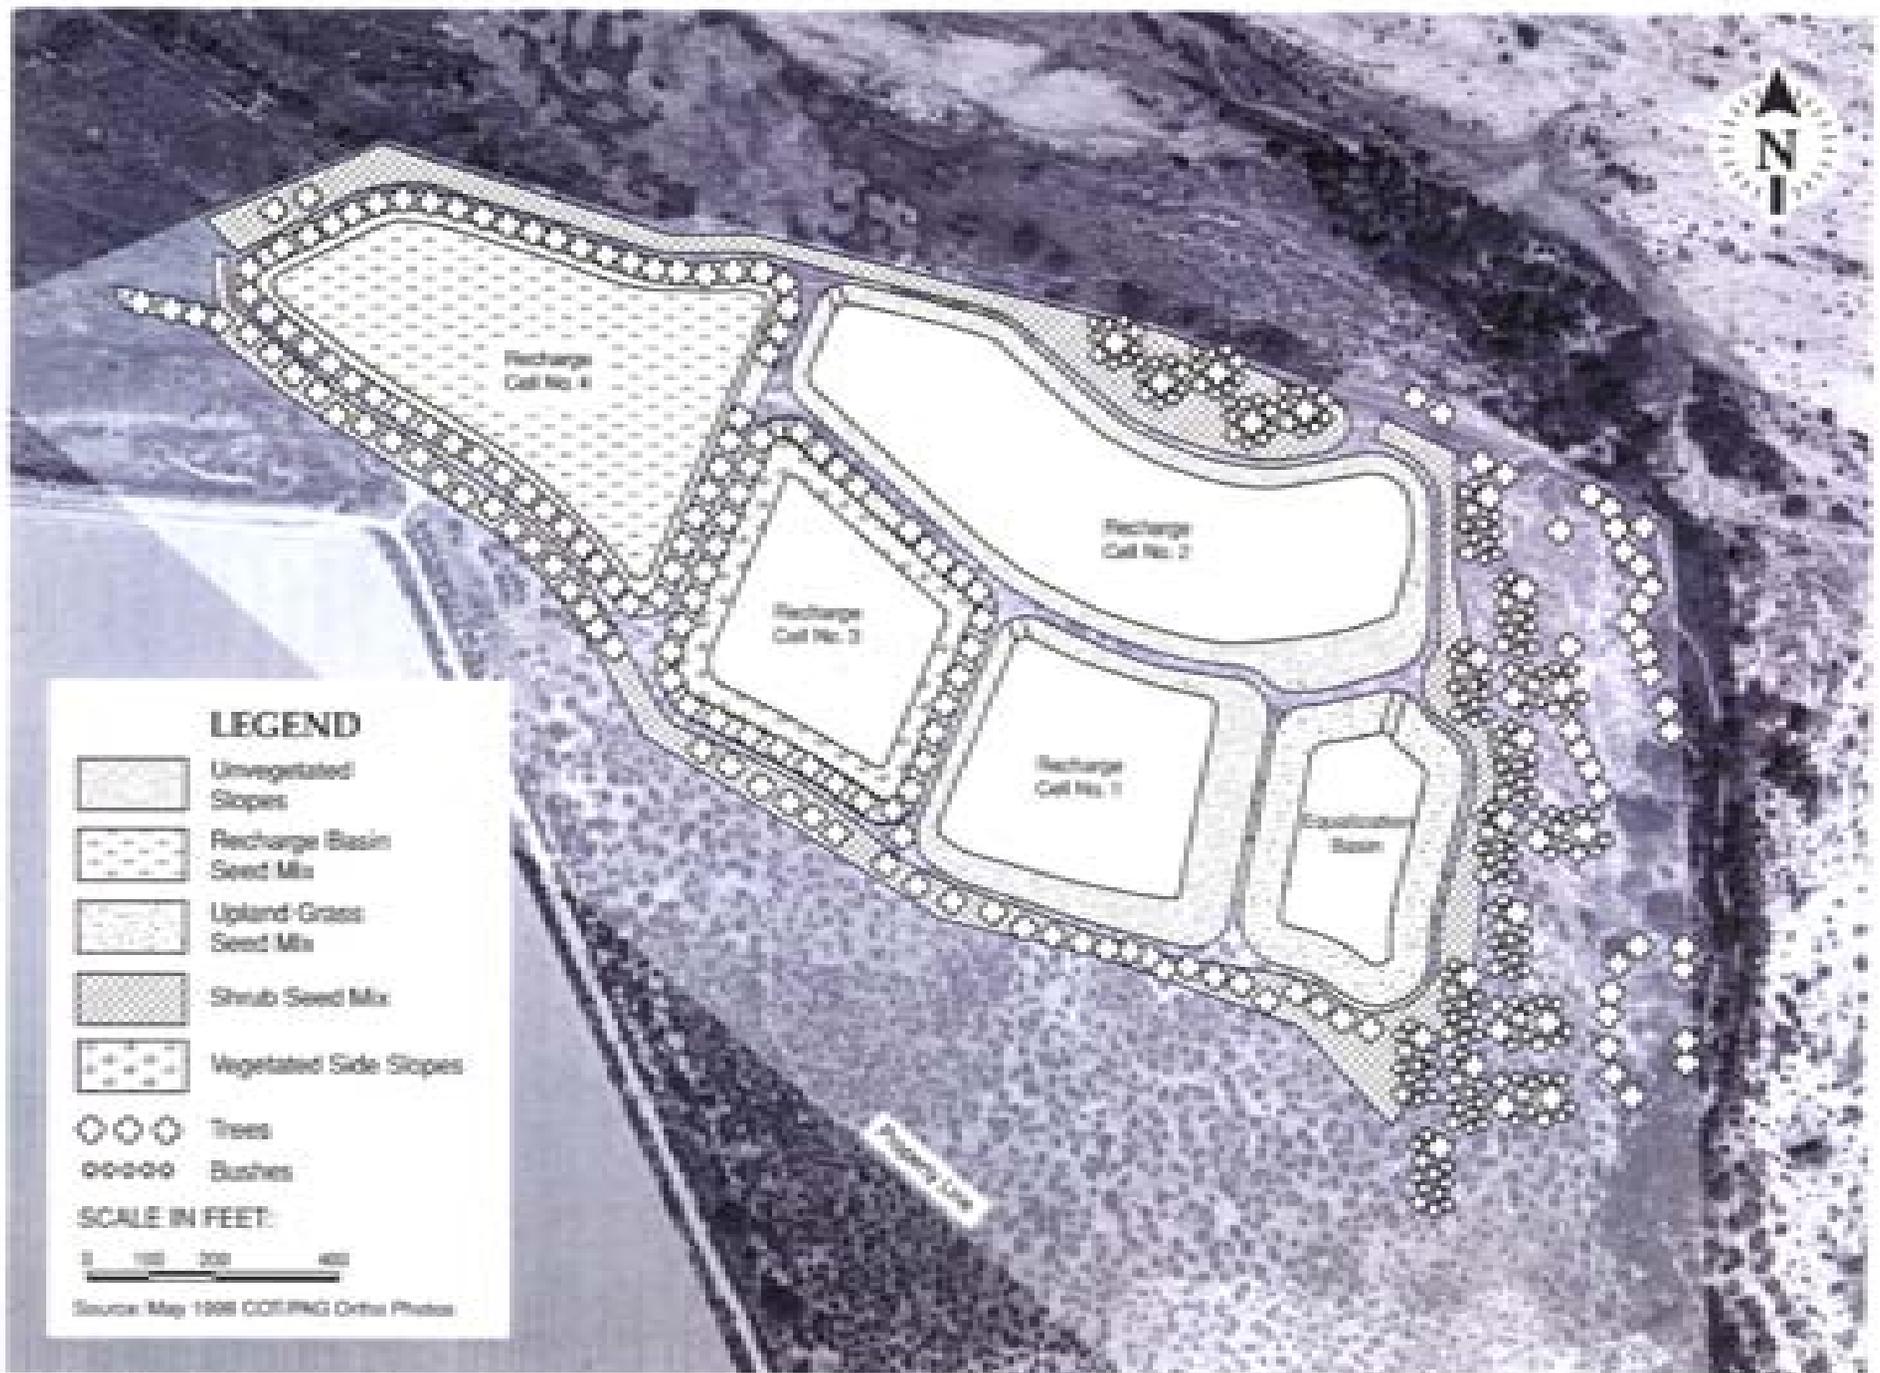
FIGURE 14 Riparian Vegetation Establishment Plots

Figure 14 displays where riparian vegetation was planted to increase habitat value of the site. Cottonwood poles were planted along the “oxbow” channel to take advantage of perennial streamflow and help increase high quality riparian habitat. Various upland tree and shrub species were planted along the eastern and northeastern boundaries of the recharge site to provide food and cover for wildlife. Riparian tree species were planted around both recharge Cells 3 and 4 to provide

cover for nesting waterfowl and shorebirds. The swales along the southern boundary of the Project were planted with xero-riparian trees and shrubs to take advantage of local storm water runoff. The larger riparian habitat along the ox-bow channel, which leads up to the project site, contributes to the habitat conservation plan that Marana is preparing for U. S. Fish and Wildlife Service.

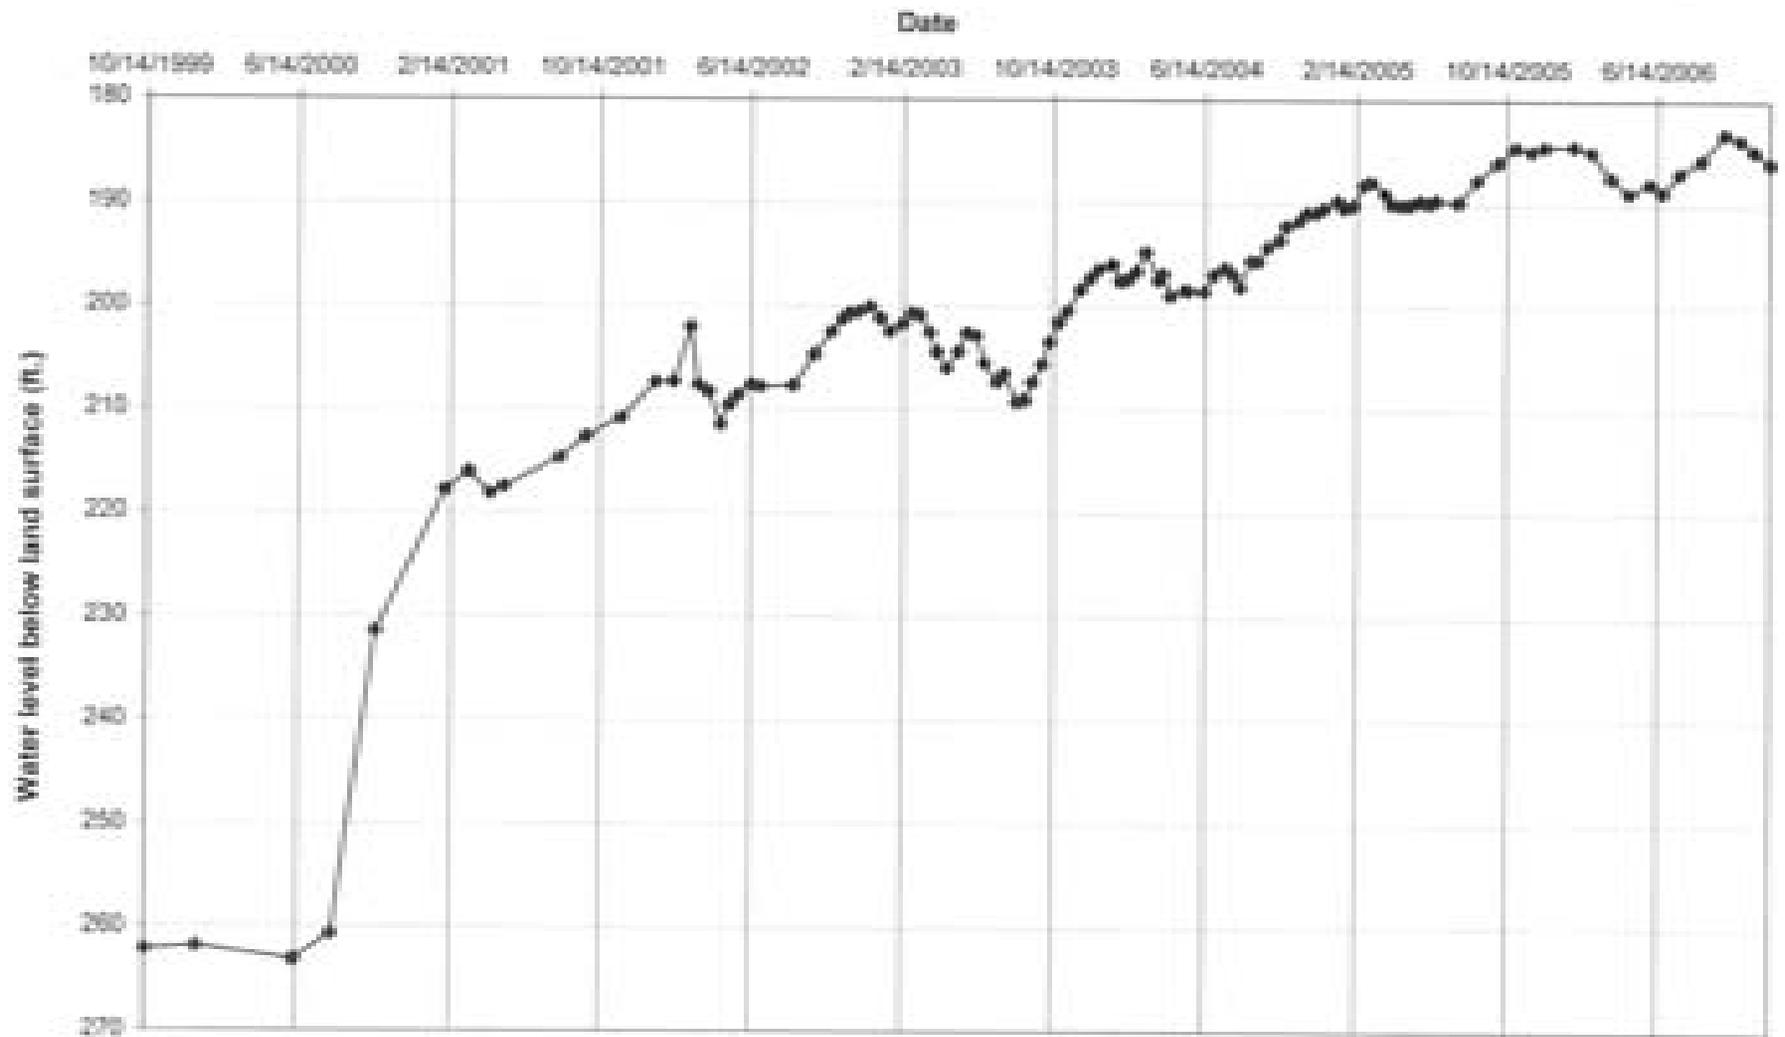
FIGURE 20
DEPTH TO WATER HYDROGRAPH
ON-SITE MONITOR WELL HP-1
 D (11-11) 33 cad

Water level measurements from 1999 to December 2006 in the vicinity of the Marana High Plains Facility revealed a significant rise in water level of approximately 9-10 ft/year (**Figure 20**). Water level in on-site well HP-1 has risen approximately 76 feet since construction in 1999. However, since early 2001, water levels have risen at a slower rate of 5-6 feet/year. This compares favorably with mounding estimates from the two up-gradient CAP recharge projects mentioned above. These offsite projects largely cause recovery of water levels at HP-1.

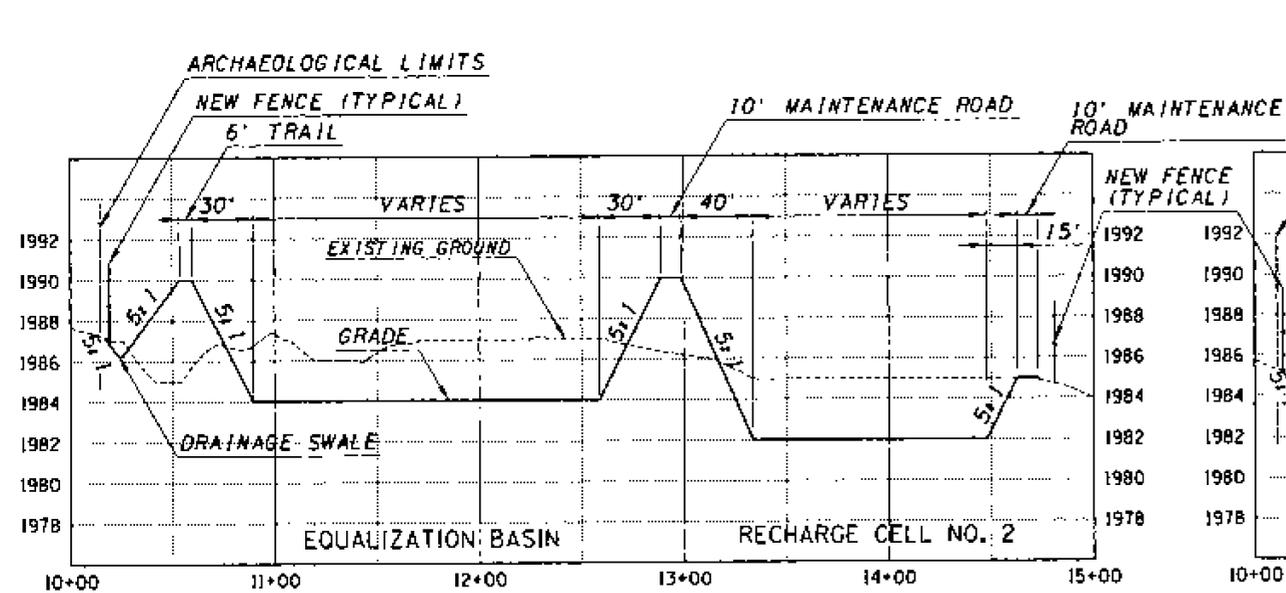
(A) CROSS SECTION
 VERTICAL SCALE: 1"=40'
 HORIZONTAL SCALE: 1"=4'

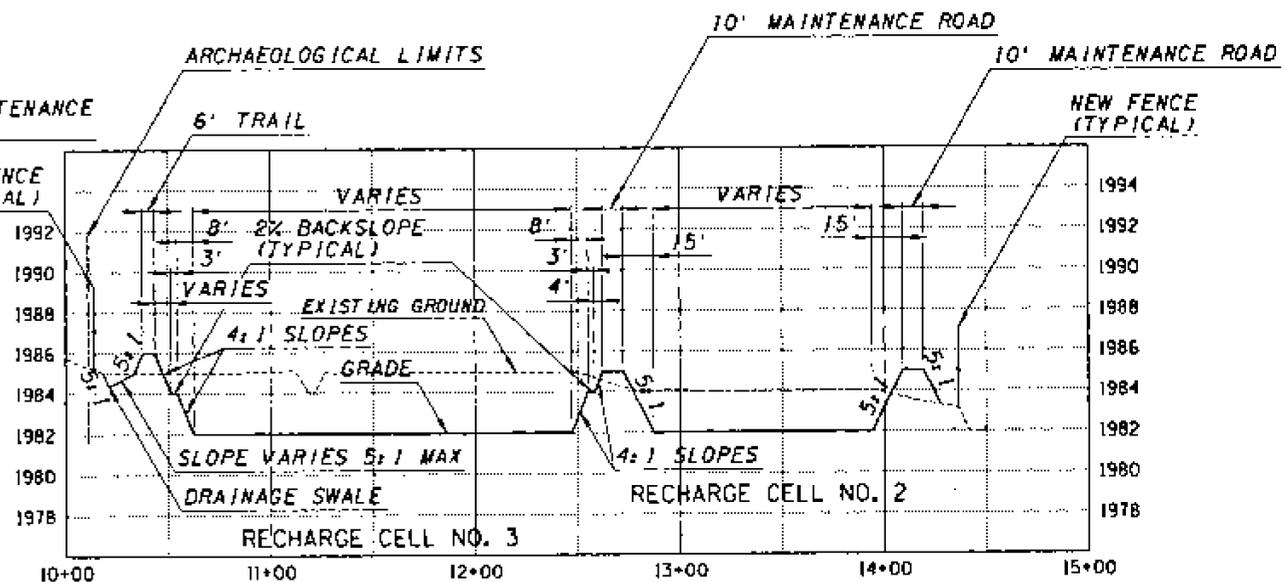
(C) CROSS SECTION
 VERTICAL SCALE: 1"=40'
 HORIZONTAL SCALE: 1"=4'

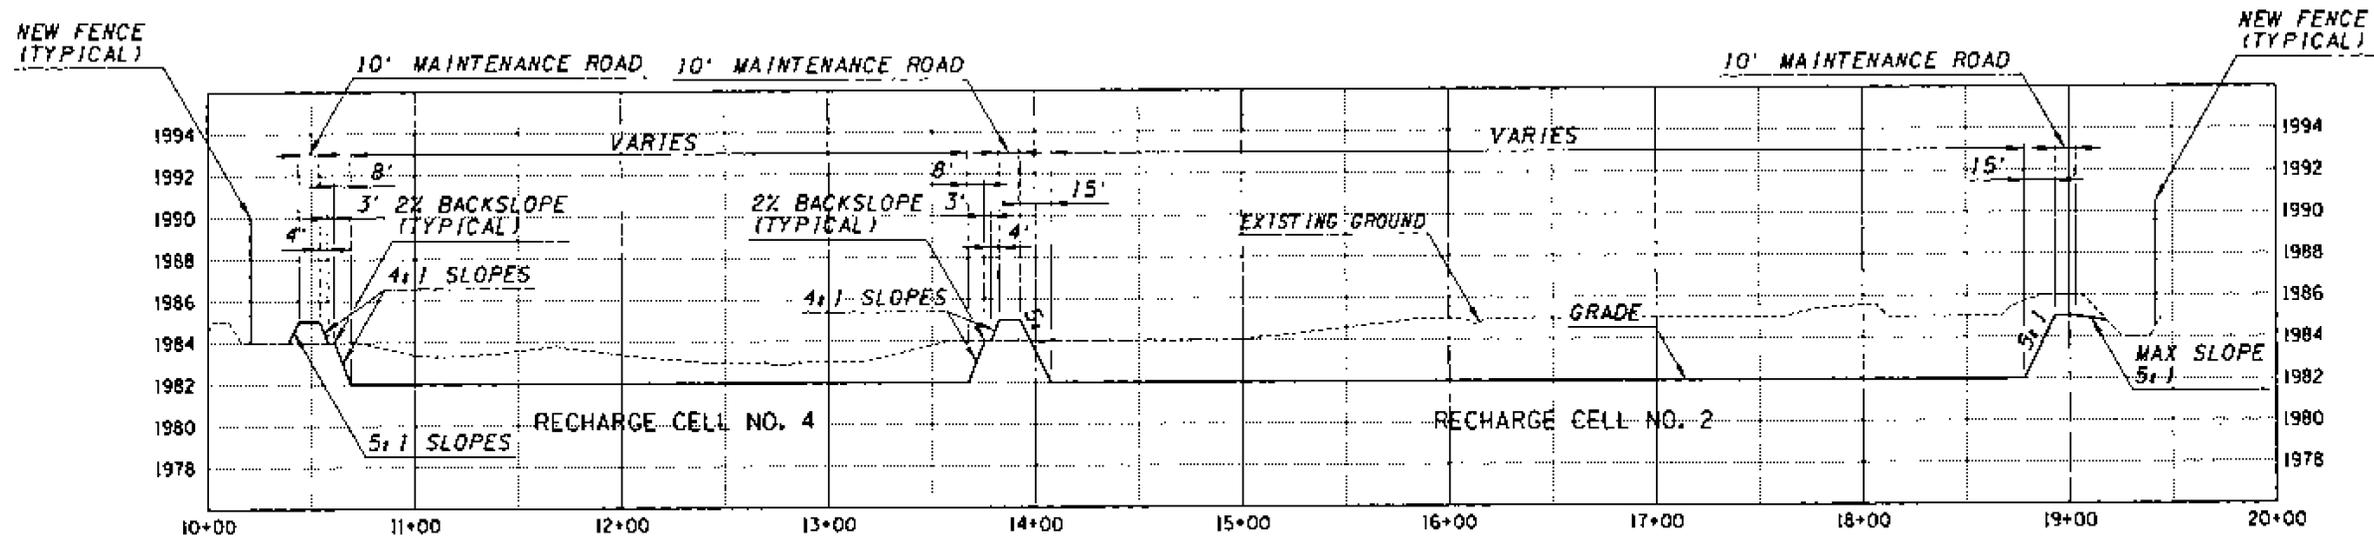
(E) CROSS SECTION
(C-1) VERTICAL SCALE: 1"=40'
 HORIZONTAL SCALE: 1"=4'
