**UNDERGROUND STORAGE FACILITY
PERMIT APPLICATION**

**HIGH PLAINS EFFLUENT RECHARGE PROJECT
MARANA, ARIZONA**

Underground Storage Facility Permit Report

**Pima County Regional Flood Control District
Water Resources Division
and
Town of Marana
Water Department
June 2007**

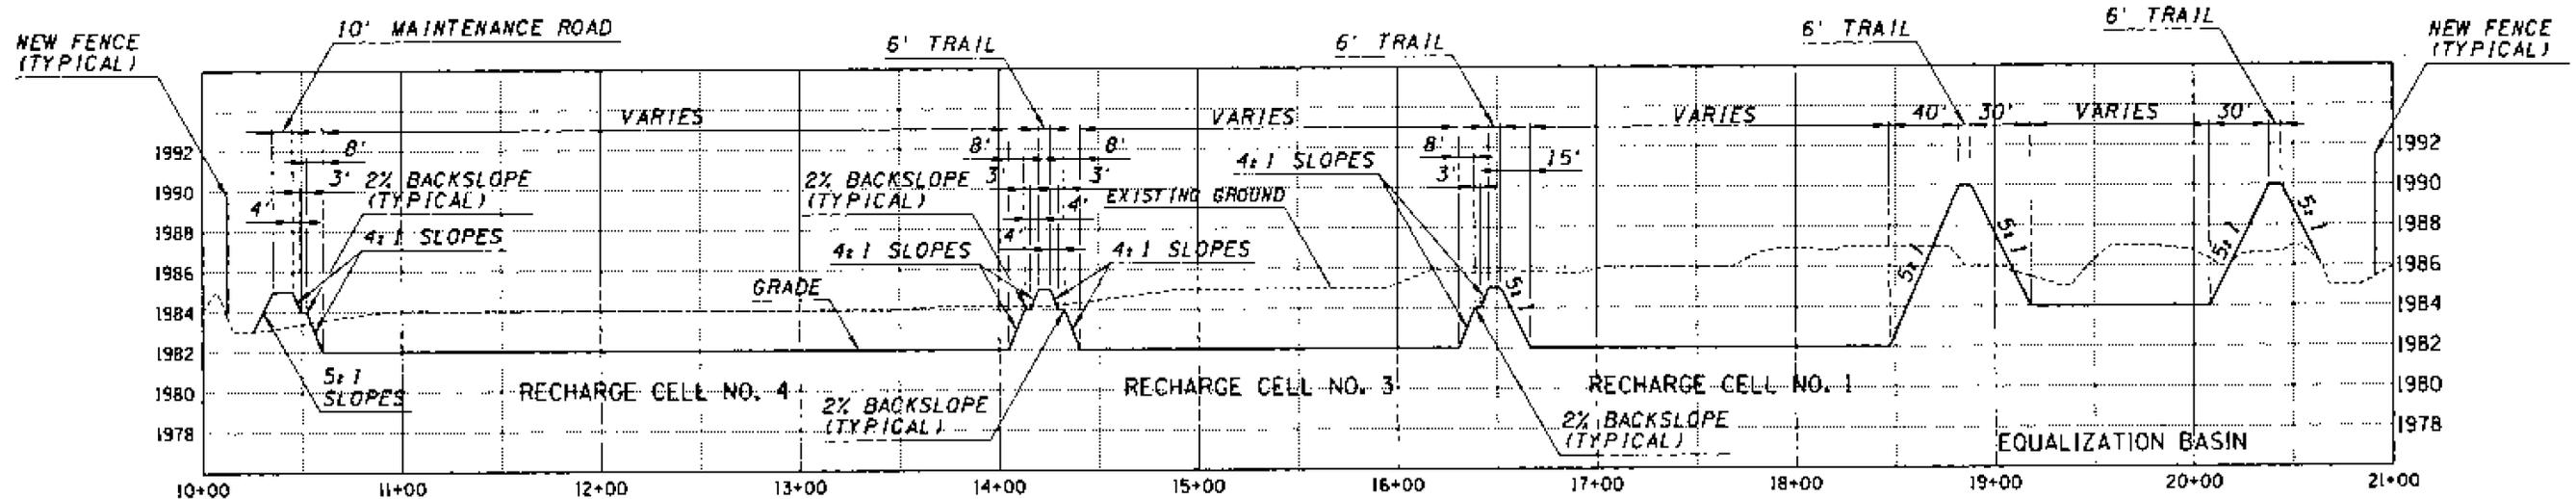
(F) CROSS SECTION
(C-1) VERTICAL SCALE: 1"=40'
 HORIZONTAL SCALE: 1"=4'

NOTE:
 OVER EXCAVATION LIMITS ARE SPECIFIED IN SECTION 203 AND SHOWN IN THE TYPICAL OVER EXCAVATION DETAIL ON SHEET C-11 SEE SPECIFICATIONS SECTION 203.

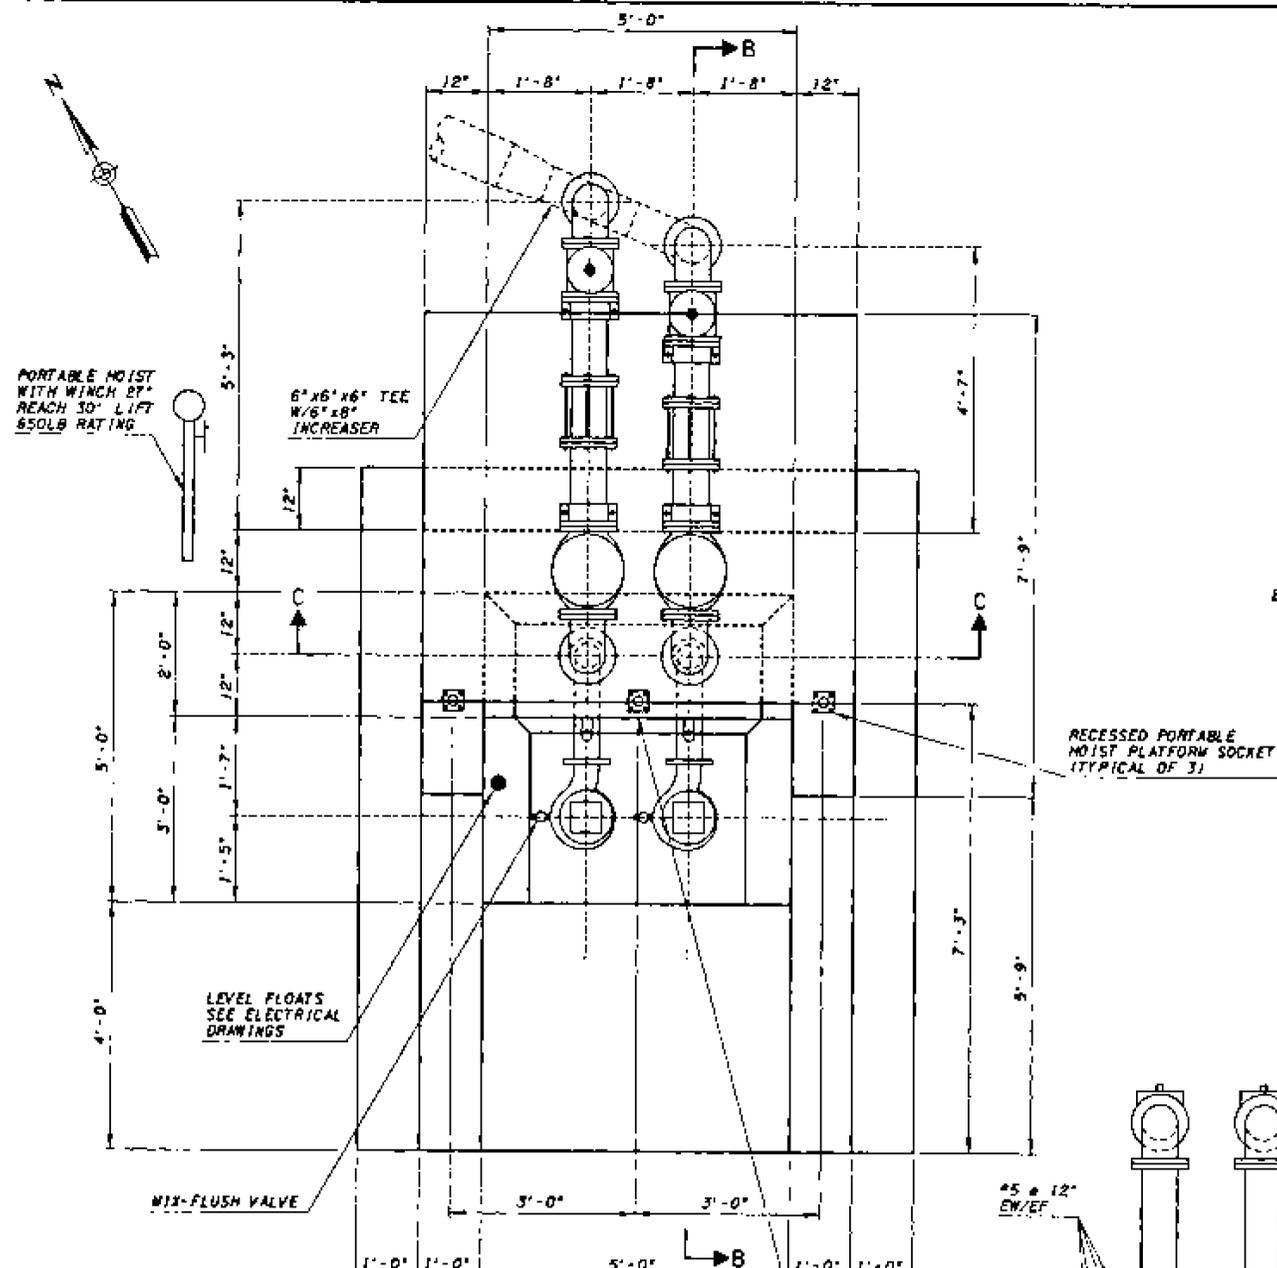
P1	P2
PRIMARY RATING		
FLOW (GPM)	420	420
TDH (FT)	10.5	10.5
EFFICIENCY (MIN)	45	45
SECONDARY RATING		
FLOW (GPM)	375	375
TDH (FT)	12	12
MINIMUM SHUTOFF HEAD (FT)	30	30
RPM (MAX)	1800	1800
HP (MAX)	3	3

A PLAN-PUMP STATION
SCALE: 1/4" = 1'-0"

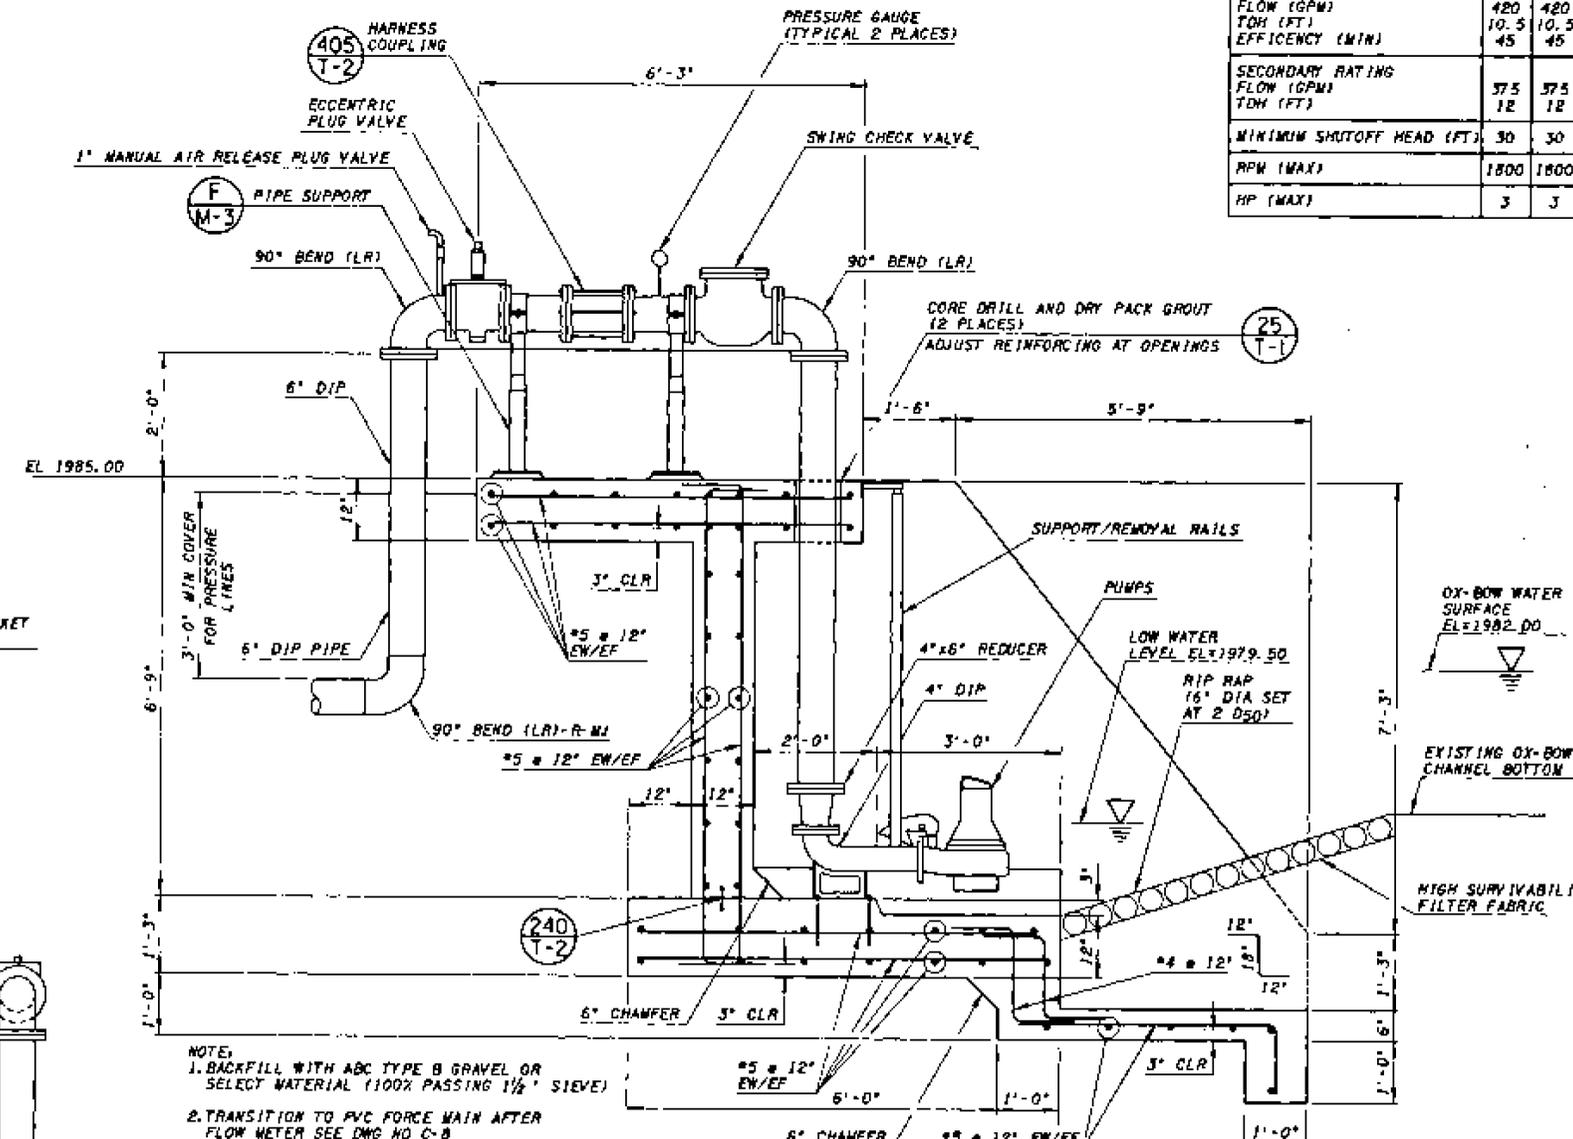
B SECTION
SCALE: 1/4" = 1'-0"

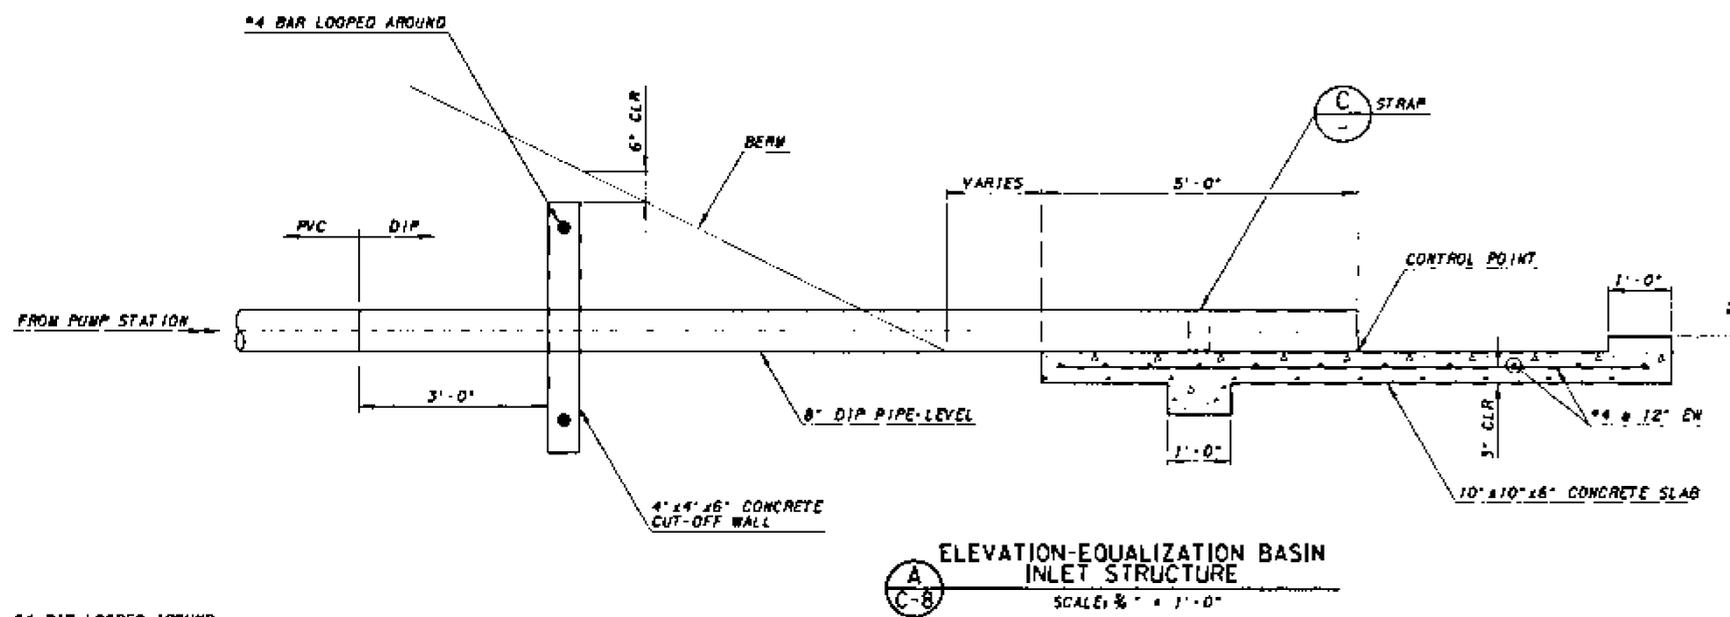
ELEVATION-EQUALIZATION BASIN INLET STRUCTURE
 SCALE: 1/4" = 1'-0"

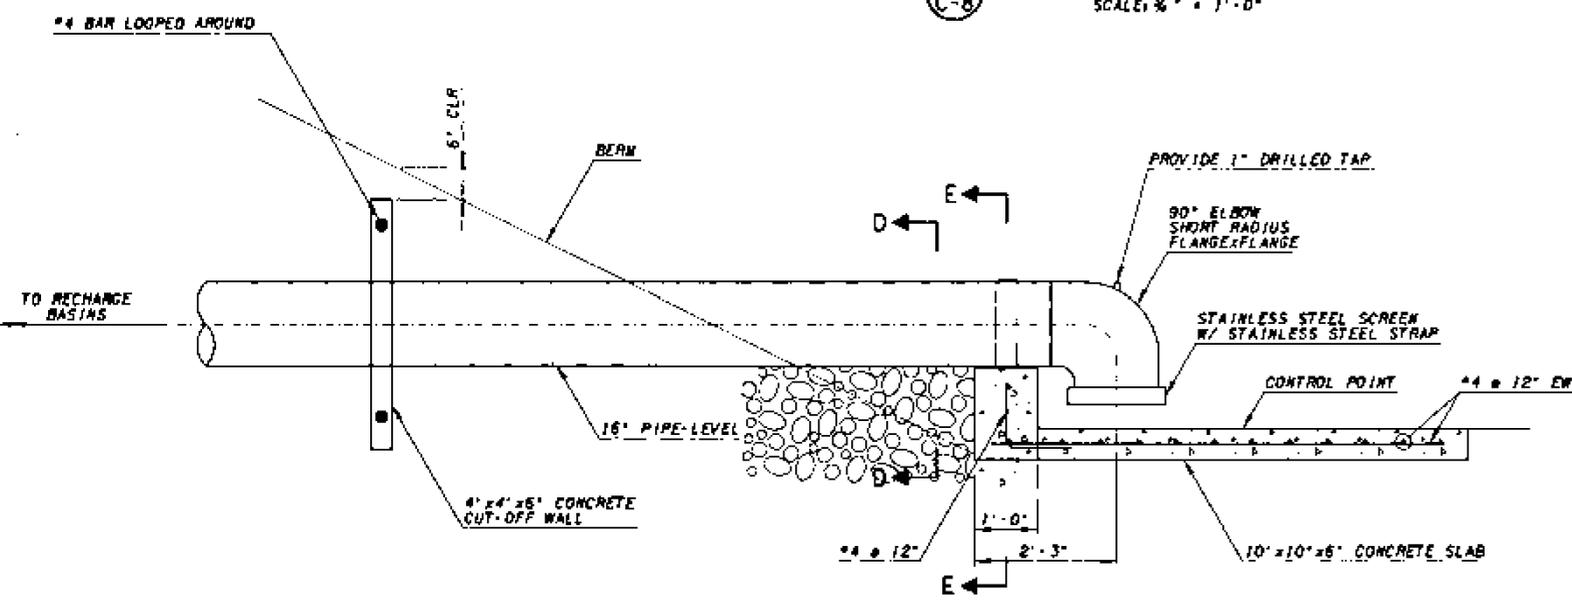
ELEVATION-EQUALIZATION BASIN OUTLET STRUCTURE
 SCALE: 1/4" = 1'-0"

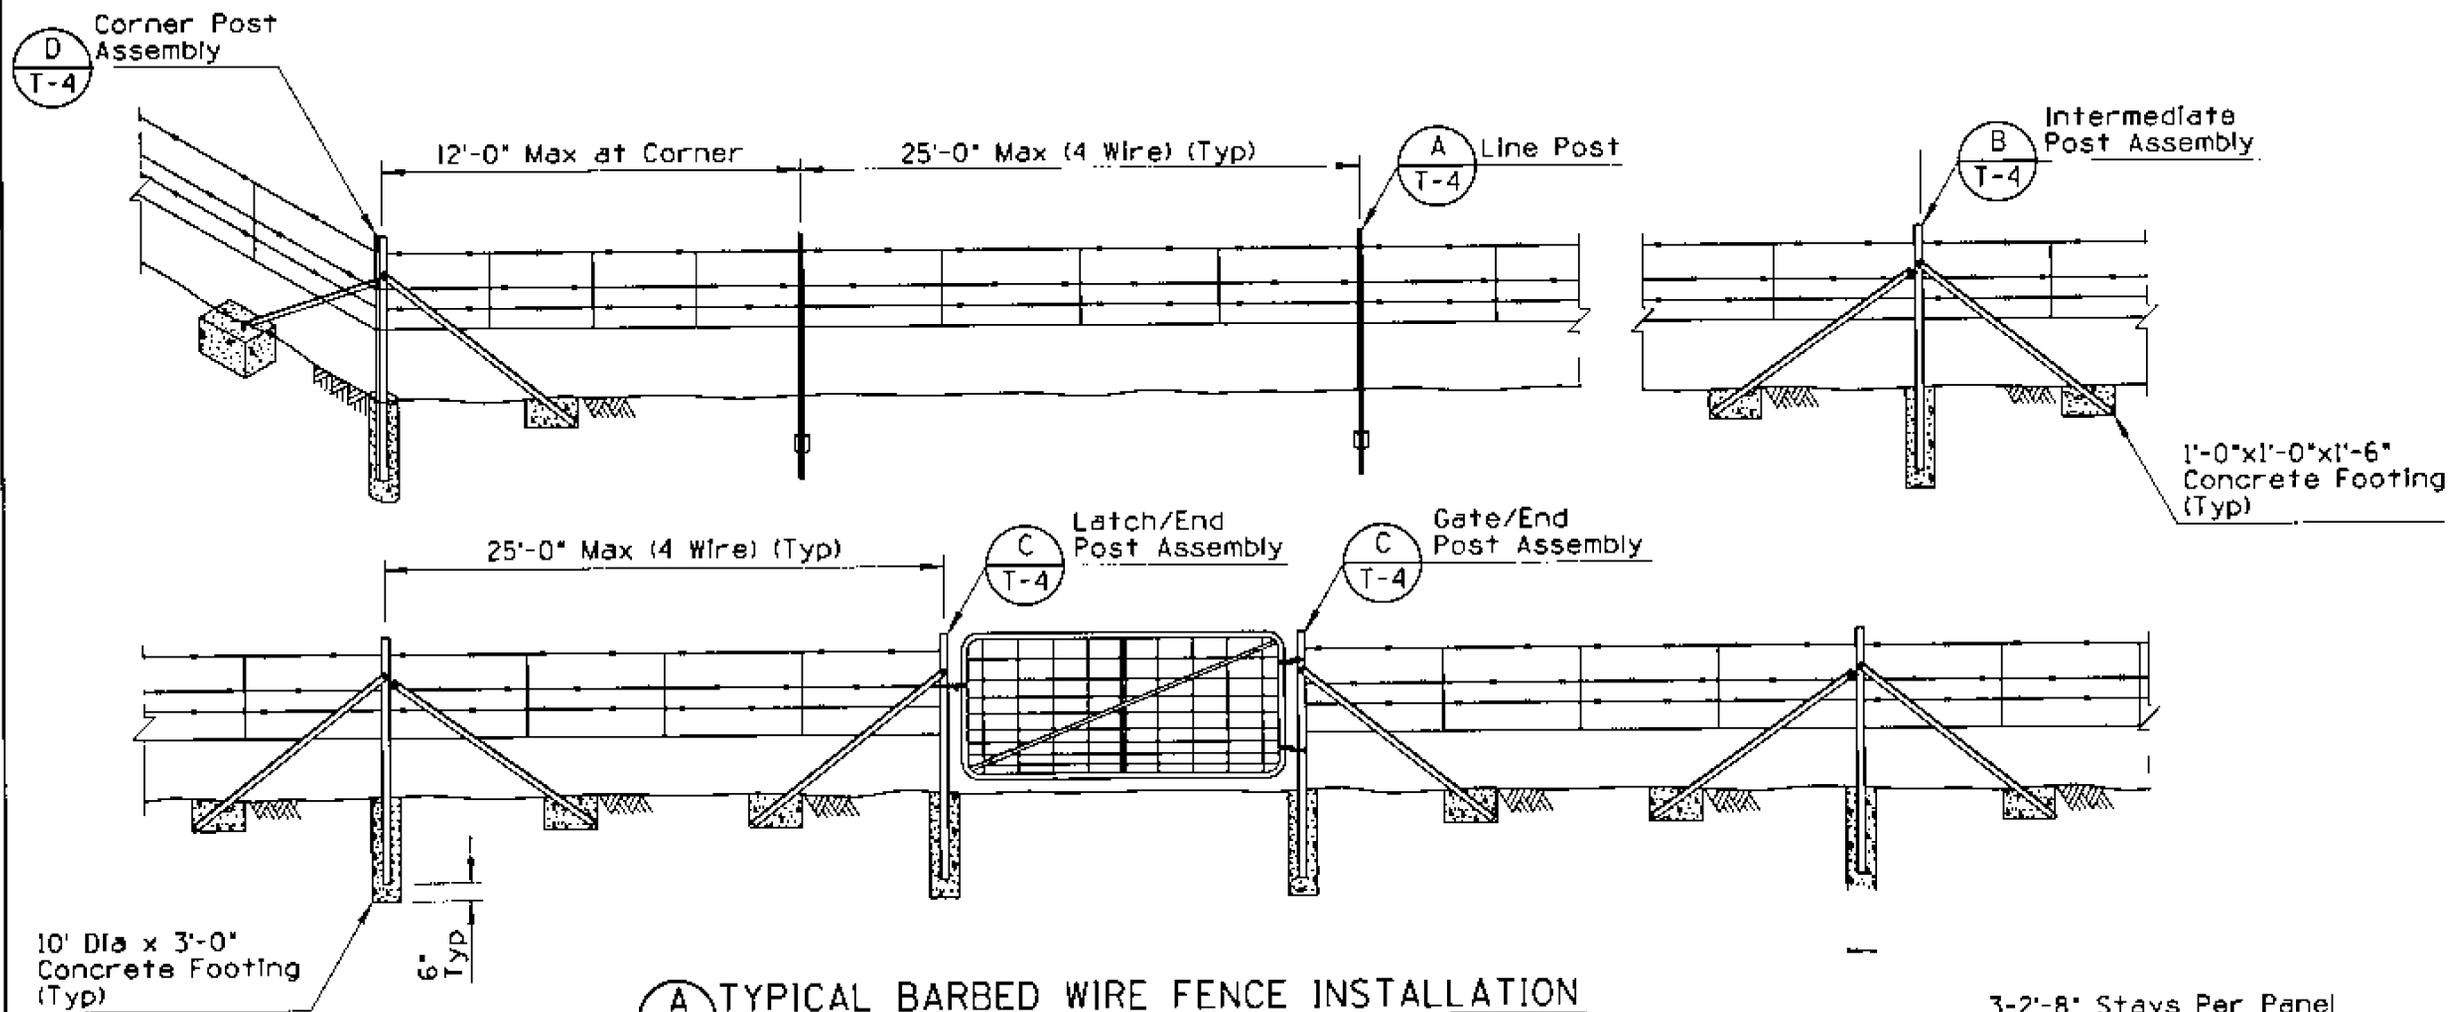
A TYPICAL BARBED WIRE FENCE INSTALLATION

10' Dia x 3'-0"
Concrete Footing
(Typ)

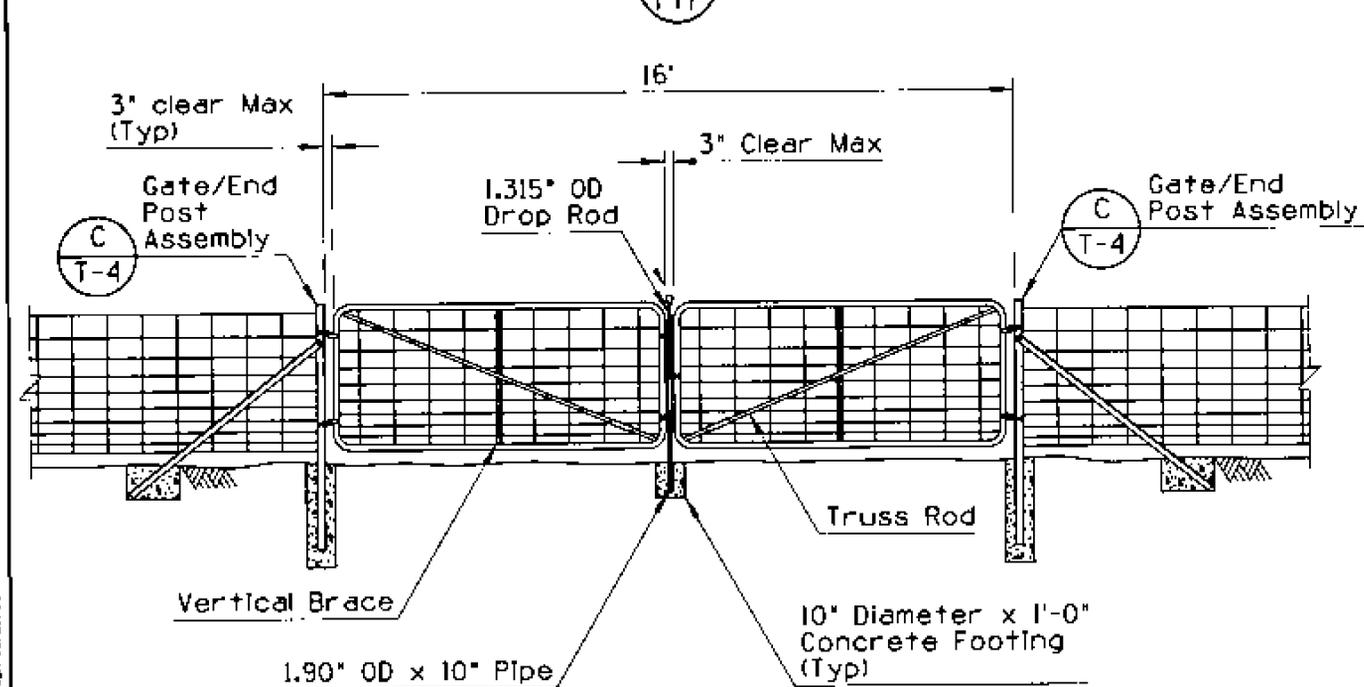
B BARBED WIRE GAME FENCE (GF)

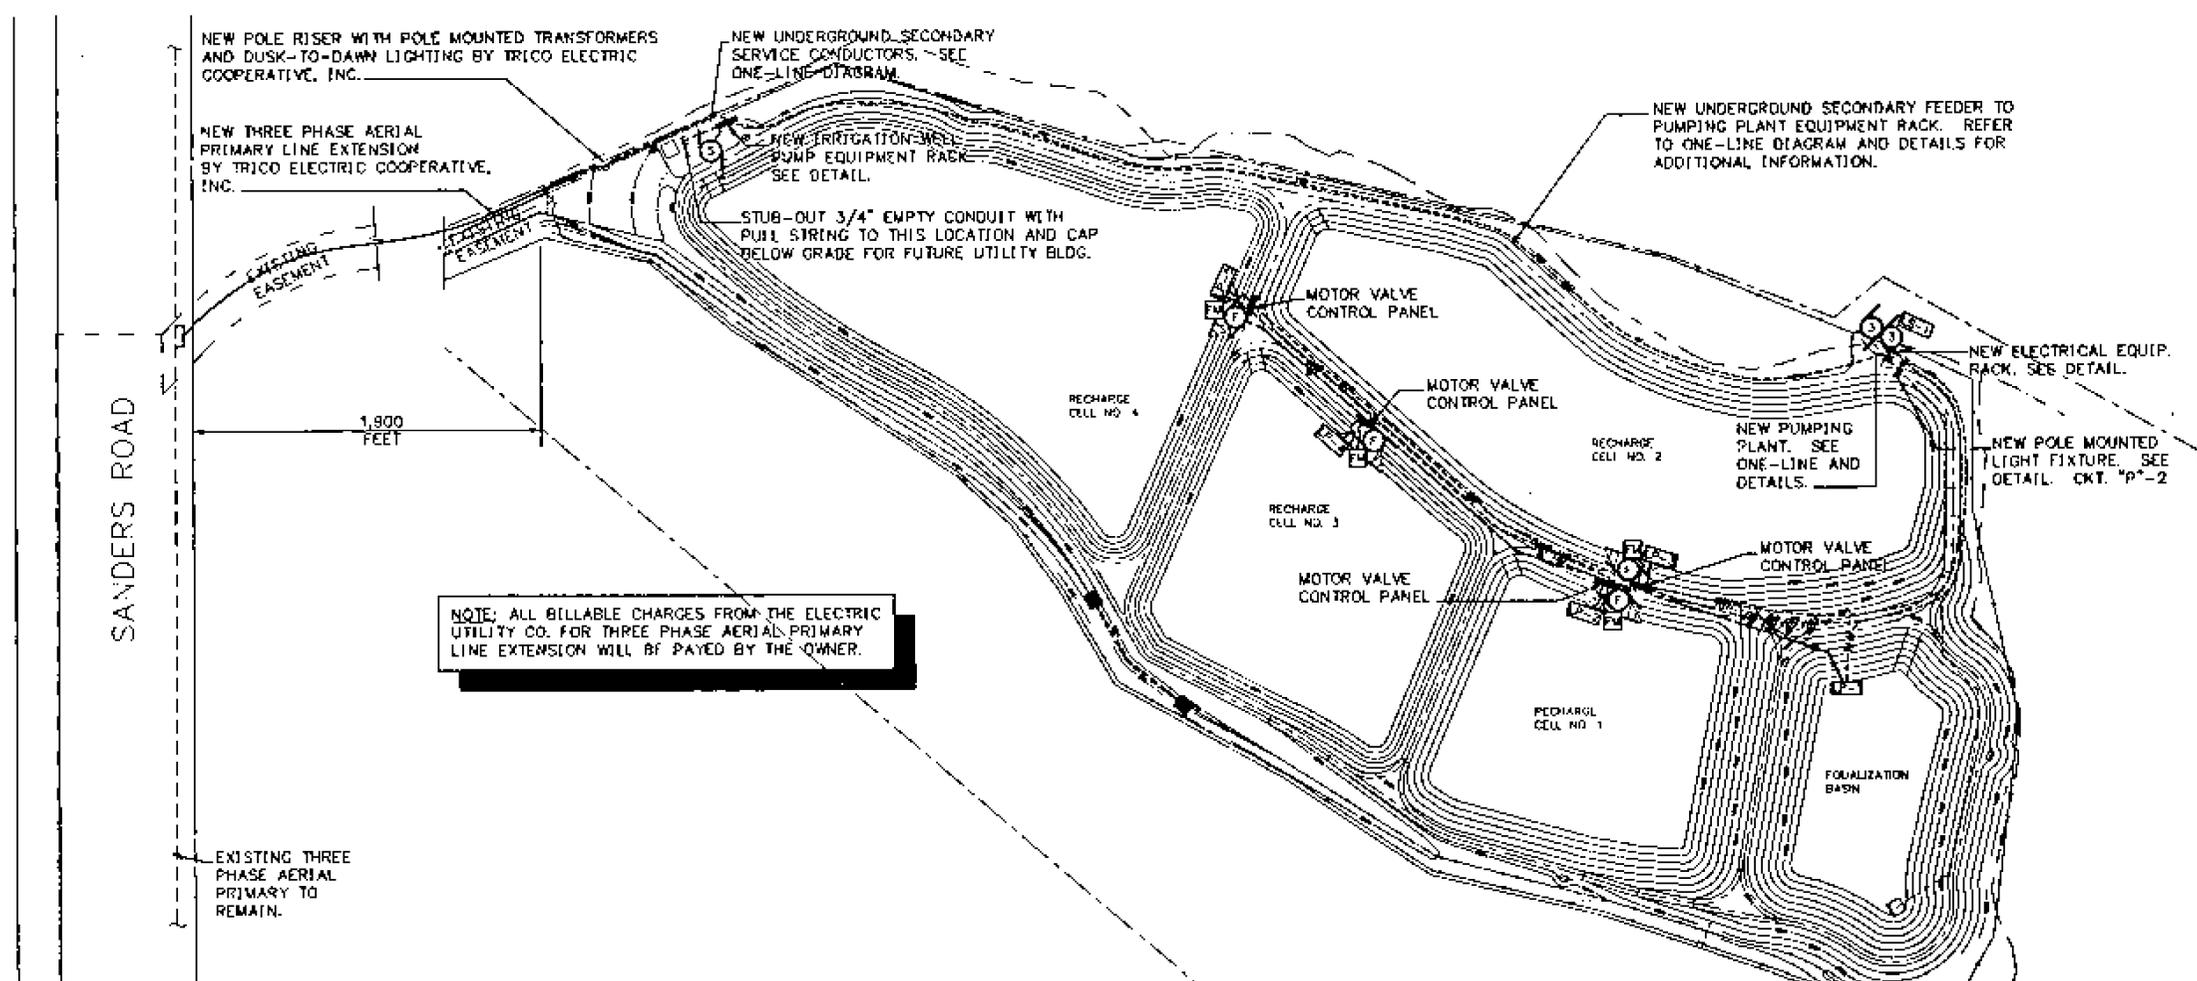
1 ELECTRICAL SITE PLAN
SCALE: 1" = 40'-0"

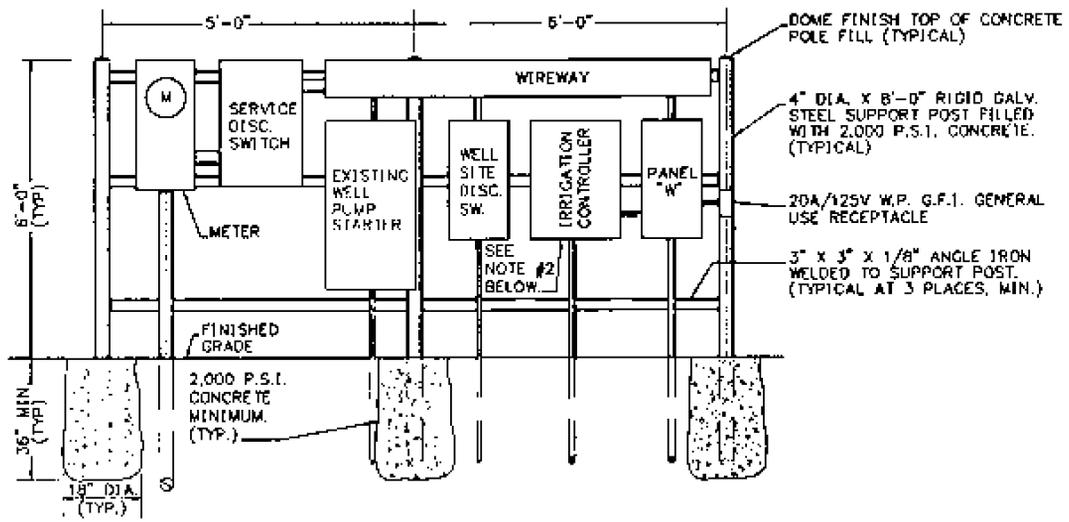
- 1) PAINT EQUIPMENT RACK IN ACCORDANCE WITH PROJECT SPECIFICATIONS.
- 2) PROVIDE 24"W X 24"H X 6"D NEMA 4X STAINLESS STEEL ENCLOSURE FOR IRRIGATION CONTROLLER. MOUNT CONTROLLER IN ENCLOSURE AND MAKE ALL REQUIRED CONNECTIONS.

4 IRRIGATION WELL SITE ELECTRICAL EQUIPMENT RACK DETAIL
NOT TO SCALE

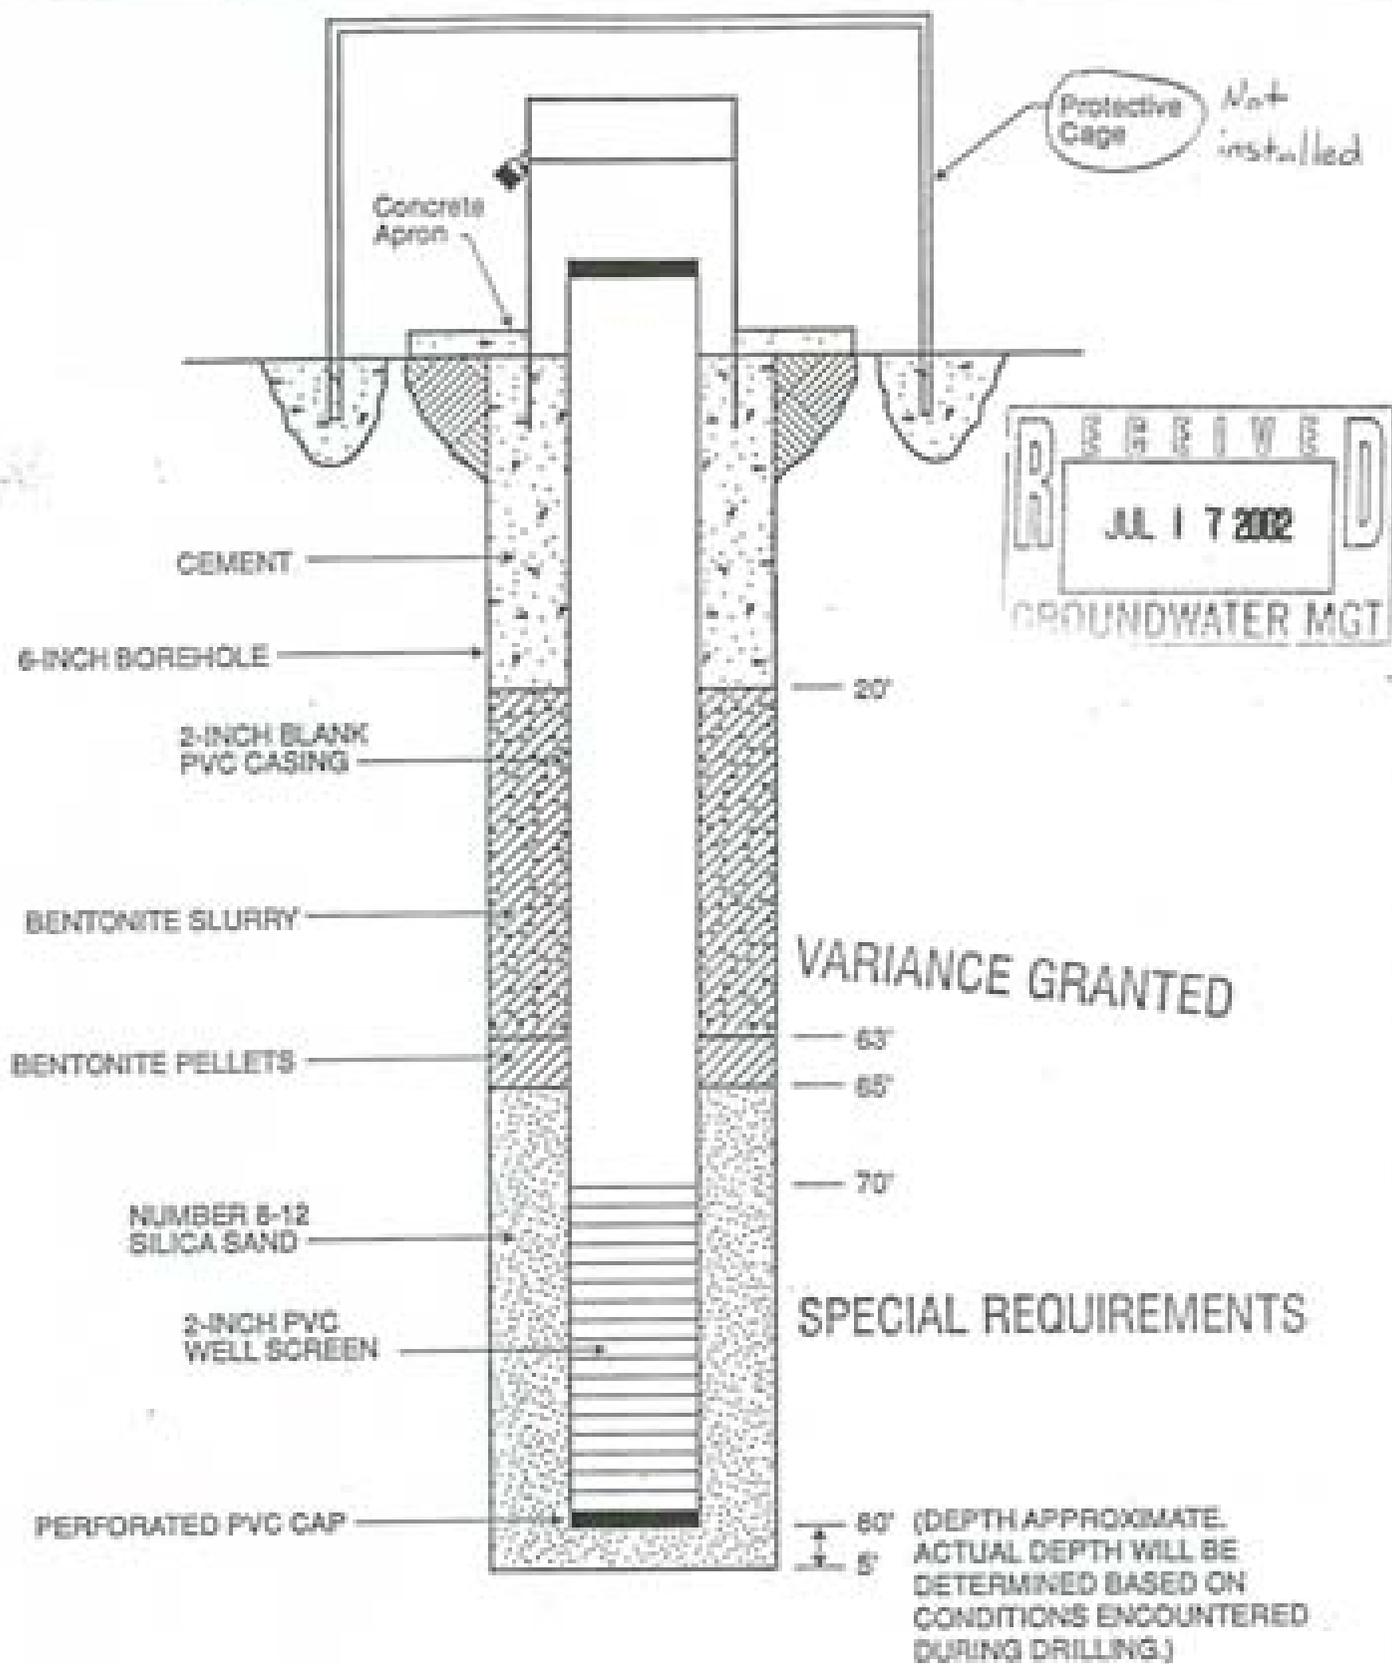
**CONSTRUCTION DIAGRAM
 PIEZOMETER HP-2**

Piezometer HP-2 is located in the center of the cluster of recharge basins and is used to monitor possible shallow groundwater mounding resulting from the presence of a low permeability soil layer. Based on existing geologic data, there appears to be perched aquifer conditions at approximately 80 feet in depth. Soils at this depth, and extending to about the 100-foot depth, contain significantly more fine-grained materials than soils above and below this interval. Lithologic descriptions indicate that perching at the Fort Lowell - Recent Alluvium contact is unlikely. No evidence of perched aquifer conditions was noted at this depth during the drilling of Borehole C (**Figure 17**). HP-2 is not equipped with a dedicated pump, but is constructed to allow for the collection of bailed samples in the event that groundwater mounding in the interval does occur. The general construction detail for HP-2 is located in **Appendix C**.

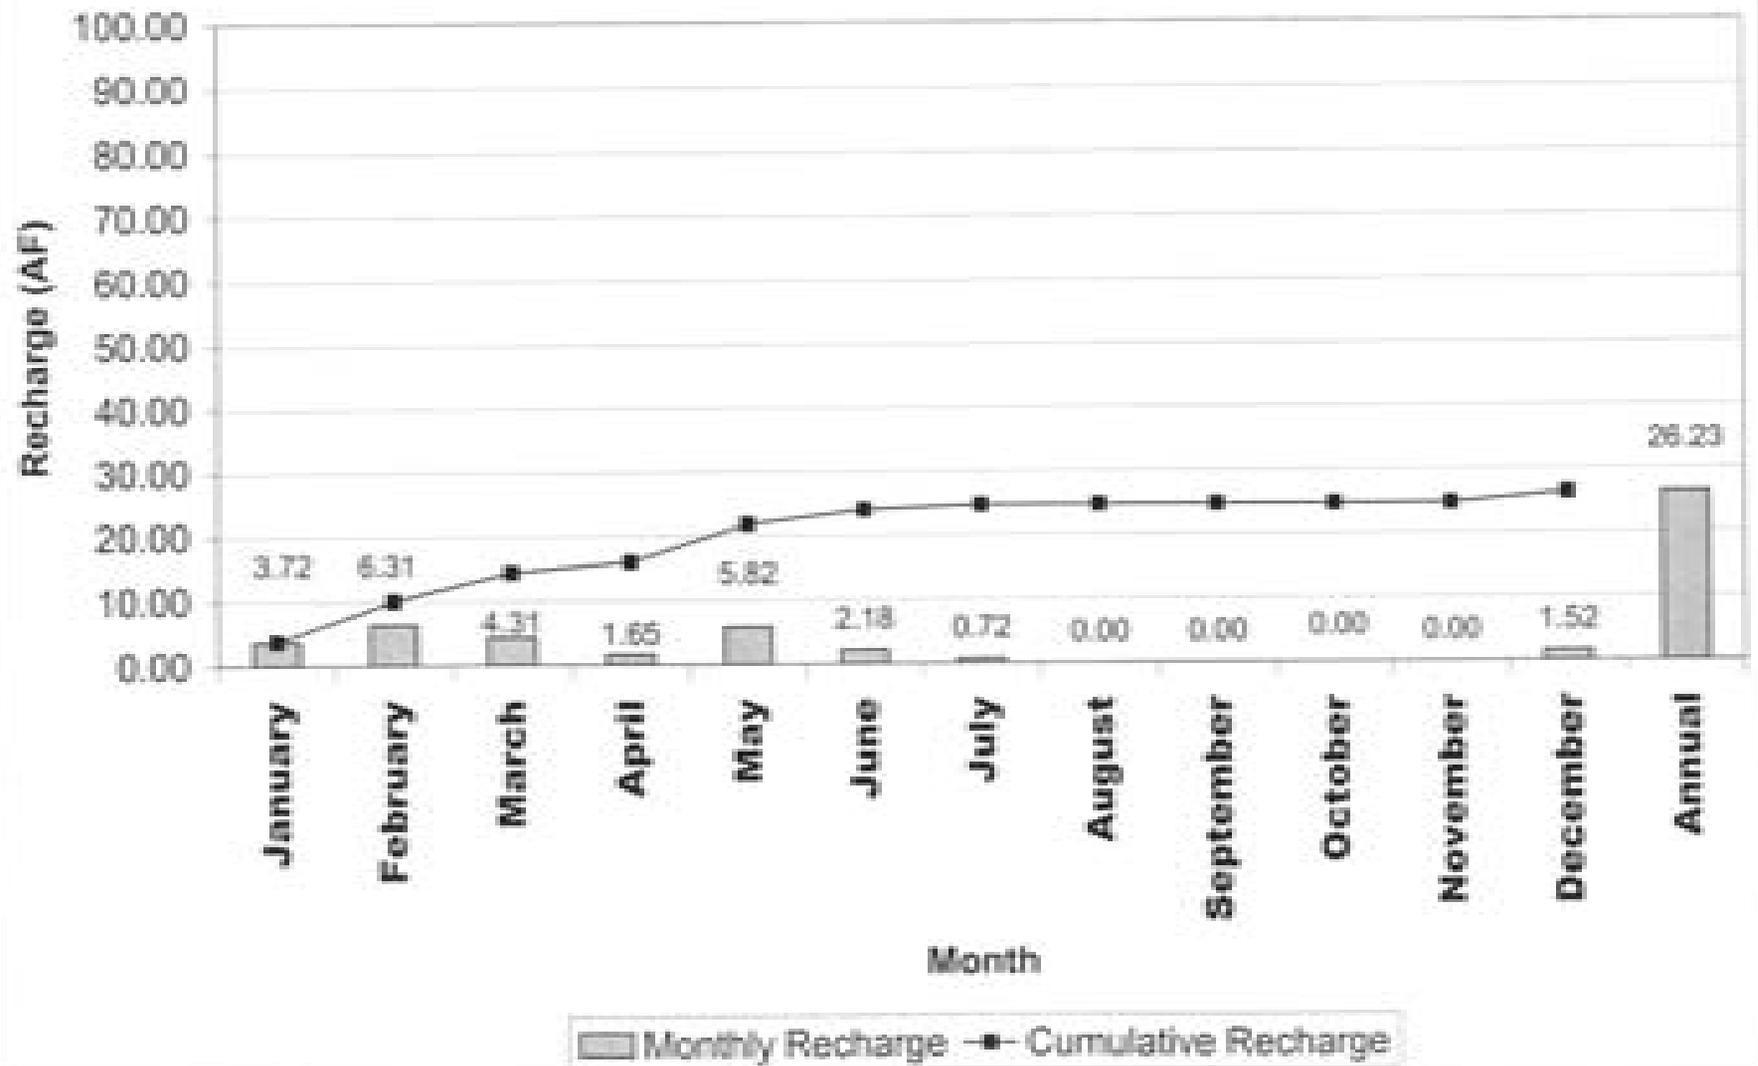
FIGURE 5
MARANA HIGH PLAINS EFFLUENT RECHARGE PROJECT
Cell 1 - 2006 Monthly and Cumulative Recharge

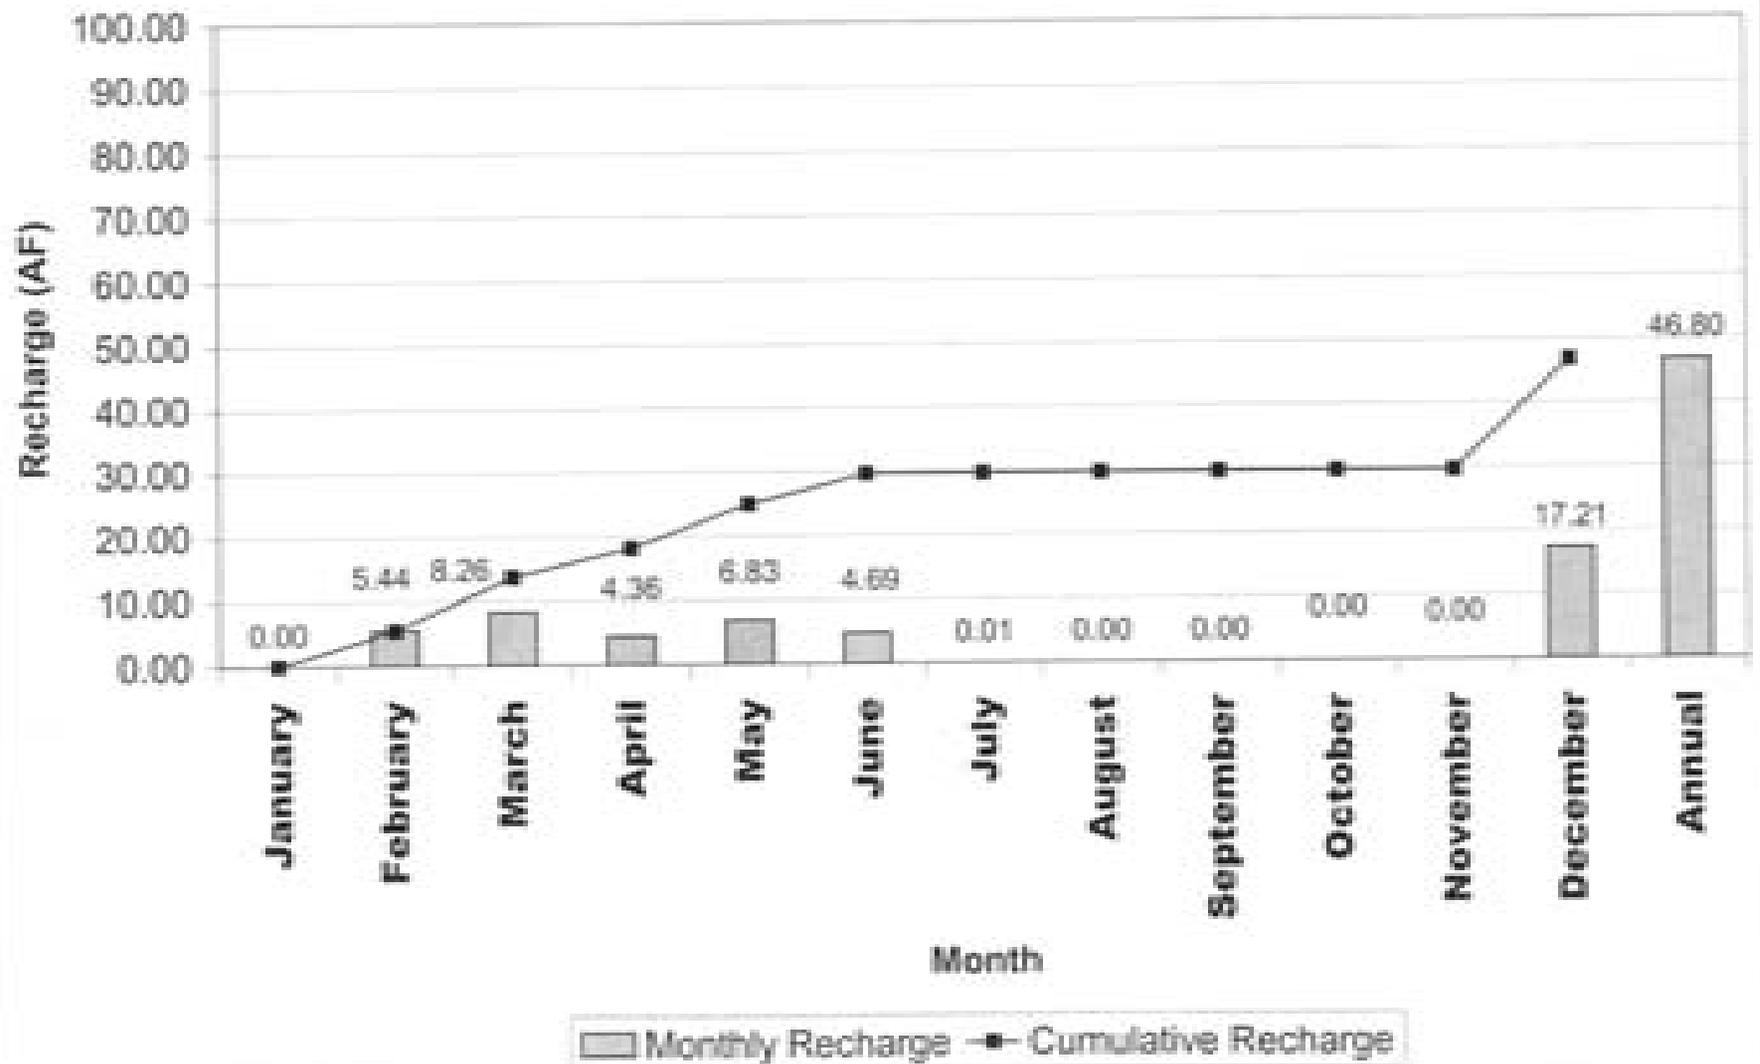
FIGURE 6
MARANA HIGH PLAINS EFFLUENT RECHARGE PROJECT
Cell 2 - 2006 Monthly and Cumulative Recharge

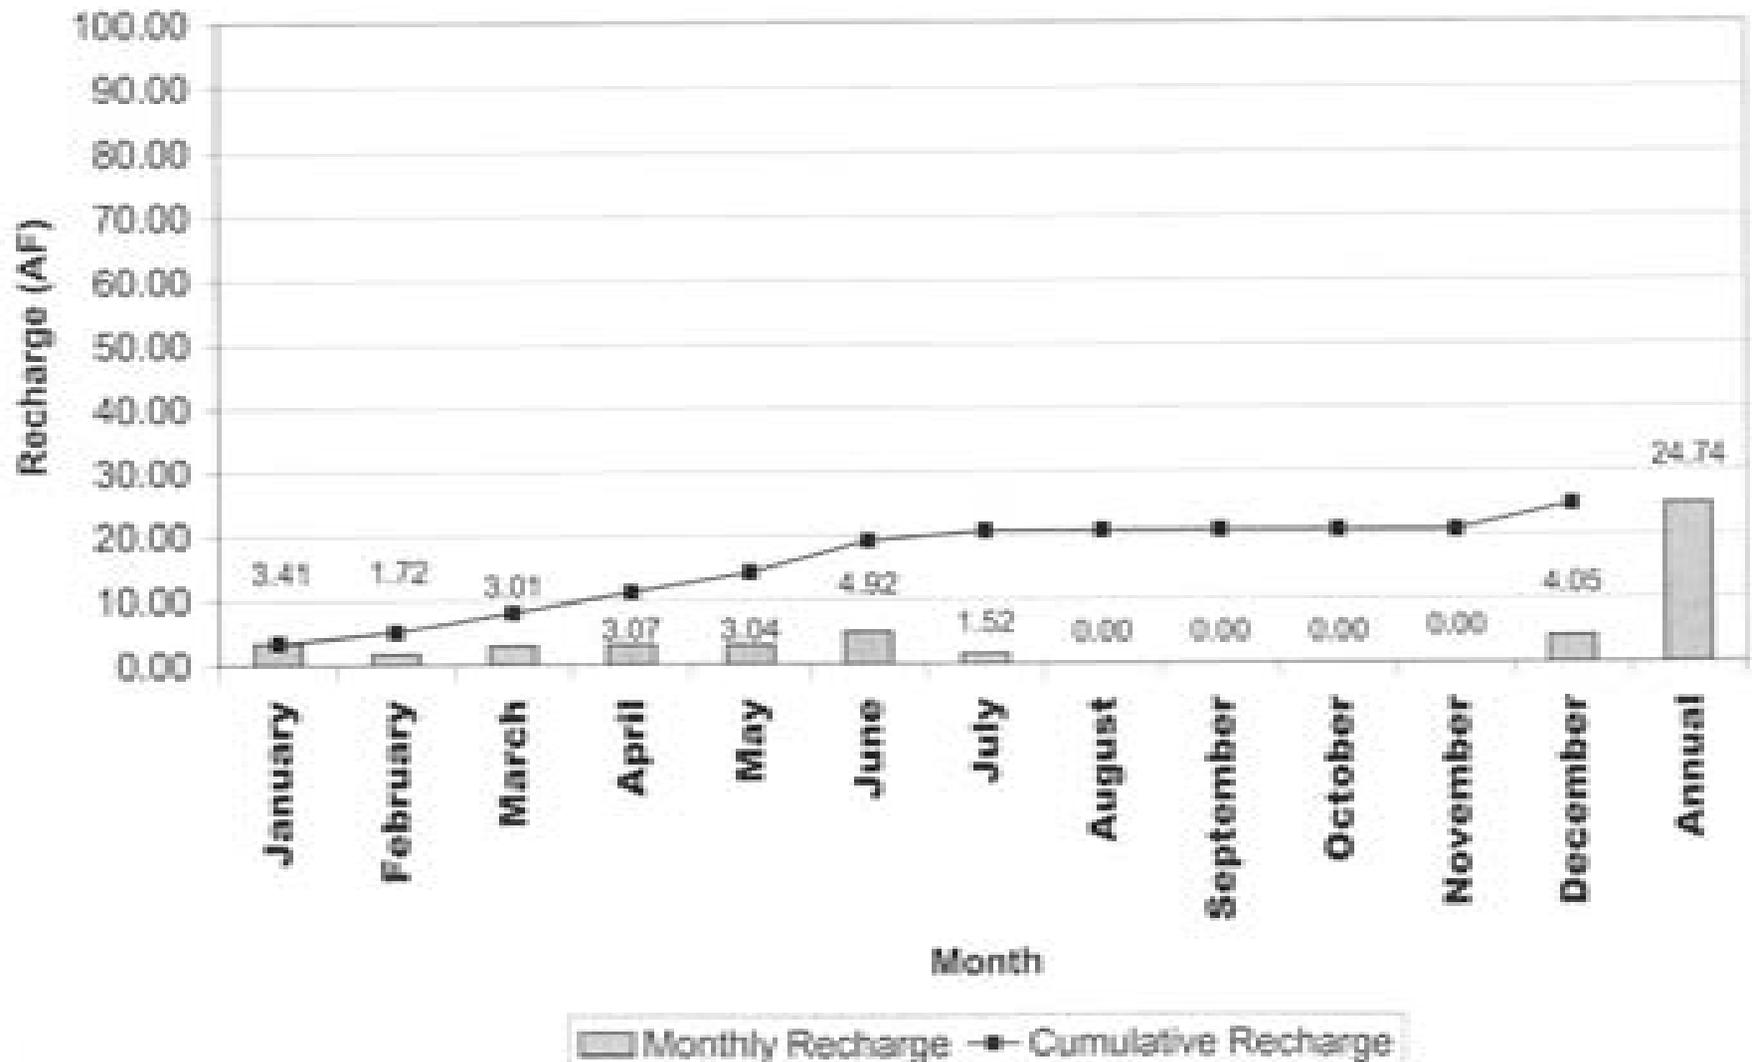
FIGURE 7
MARANA HIGH PLAINS EFFLUENT RECHARGE PROJECT
Cell 3 - 2006 Monthly and Cumulative Recharge

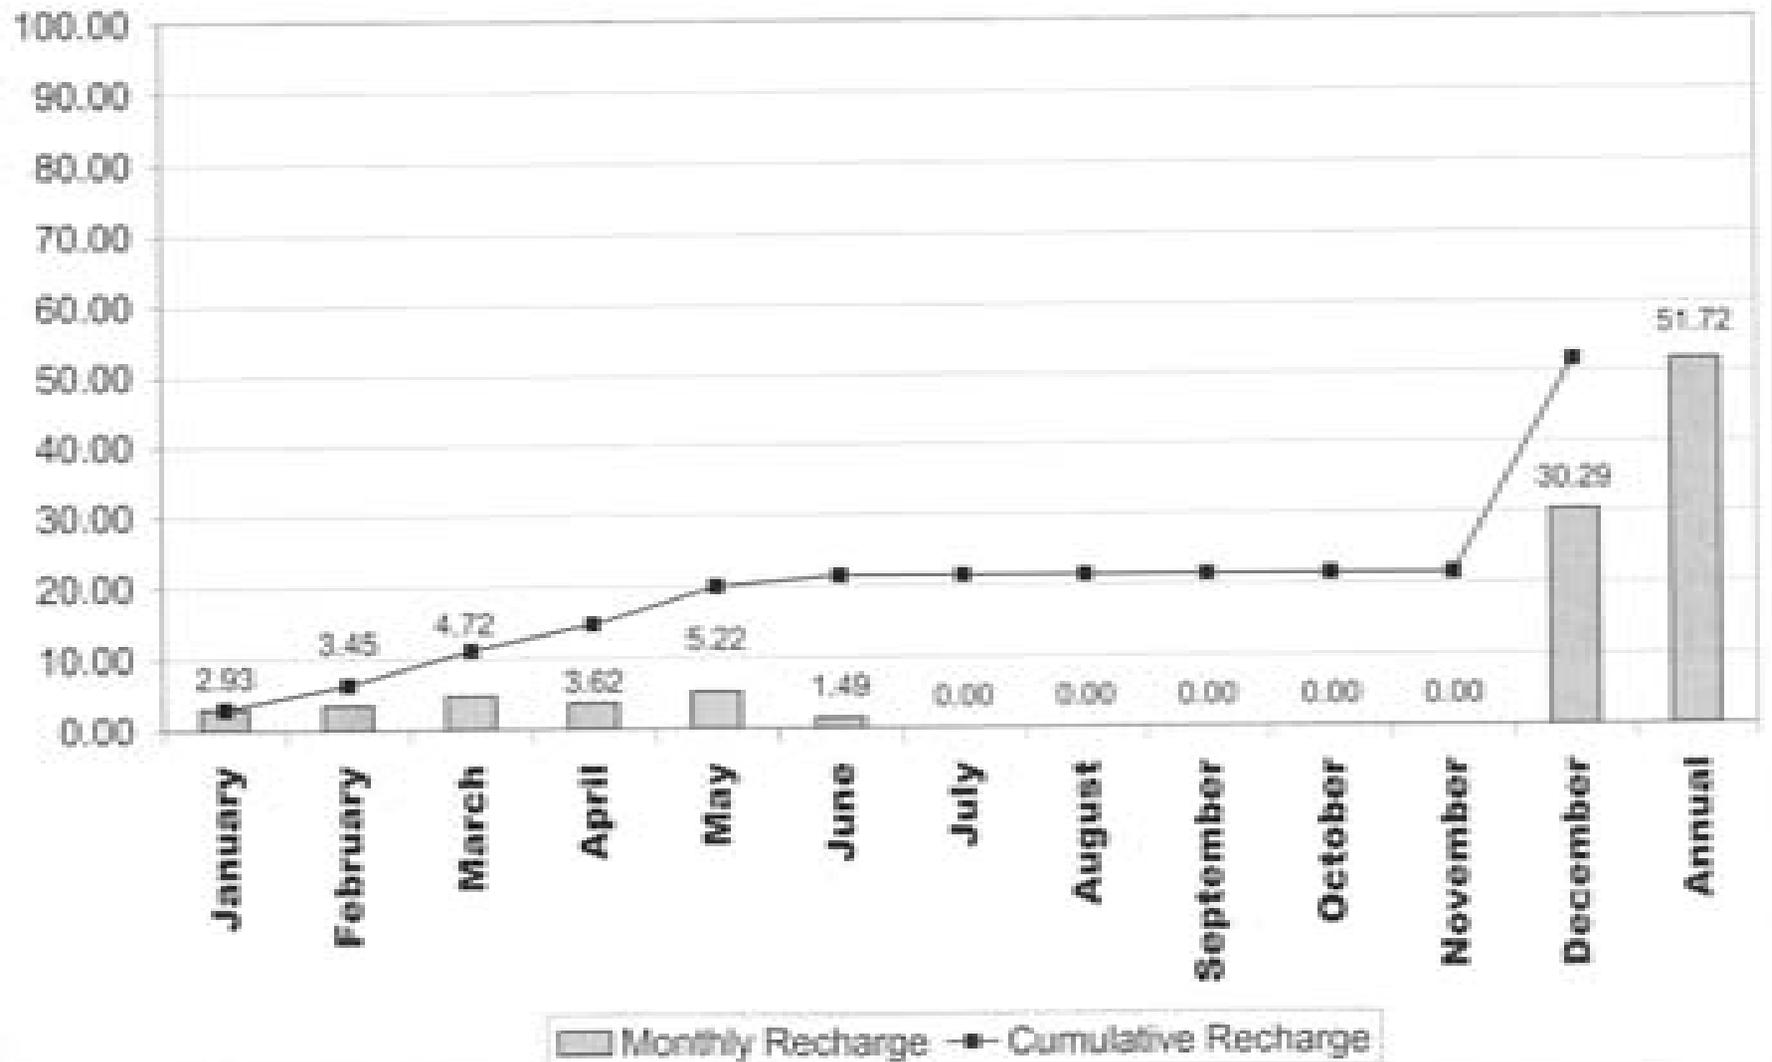
FIGURE 8
MARANA HIGH PLAINS EFFLUENT RECHARGE PROJECT
Cell 4 - 2006 Monthly and Cumulative Recharge
