**UNDERGROUND STORAGE FACILITY
PERMIT APPLICATION**

**HIGH PLAINS EFFLUENT RECHARGE PROJECT
MARANA, ARIZONA**

Underground Storage Facility Permit Report

**Pima County Regional Flood Control District
Water Resources Division
and
Town of Marana
Water Department
June 2007**

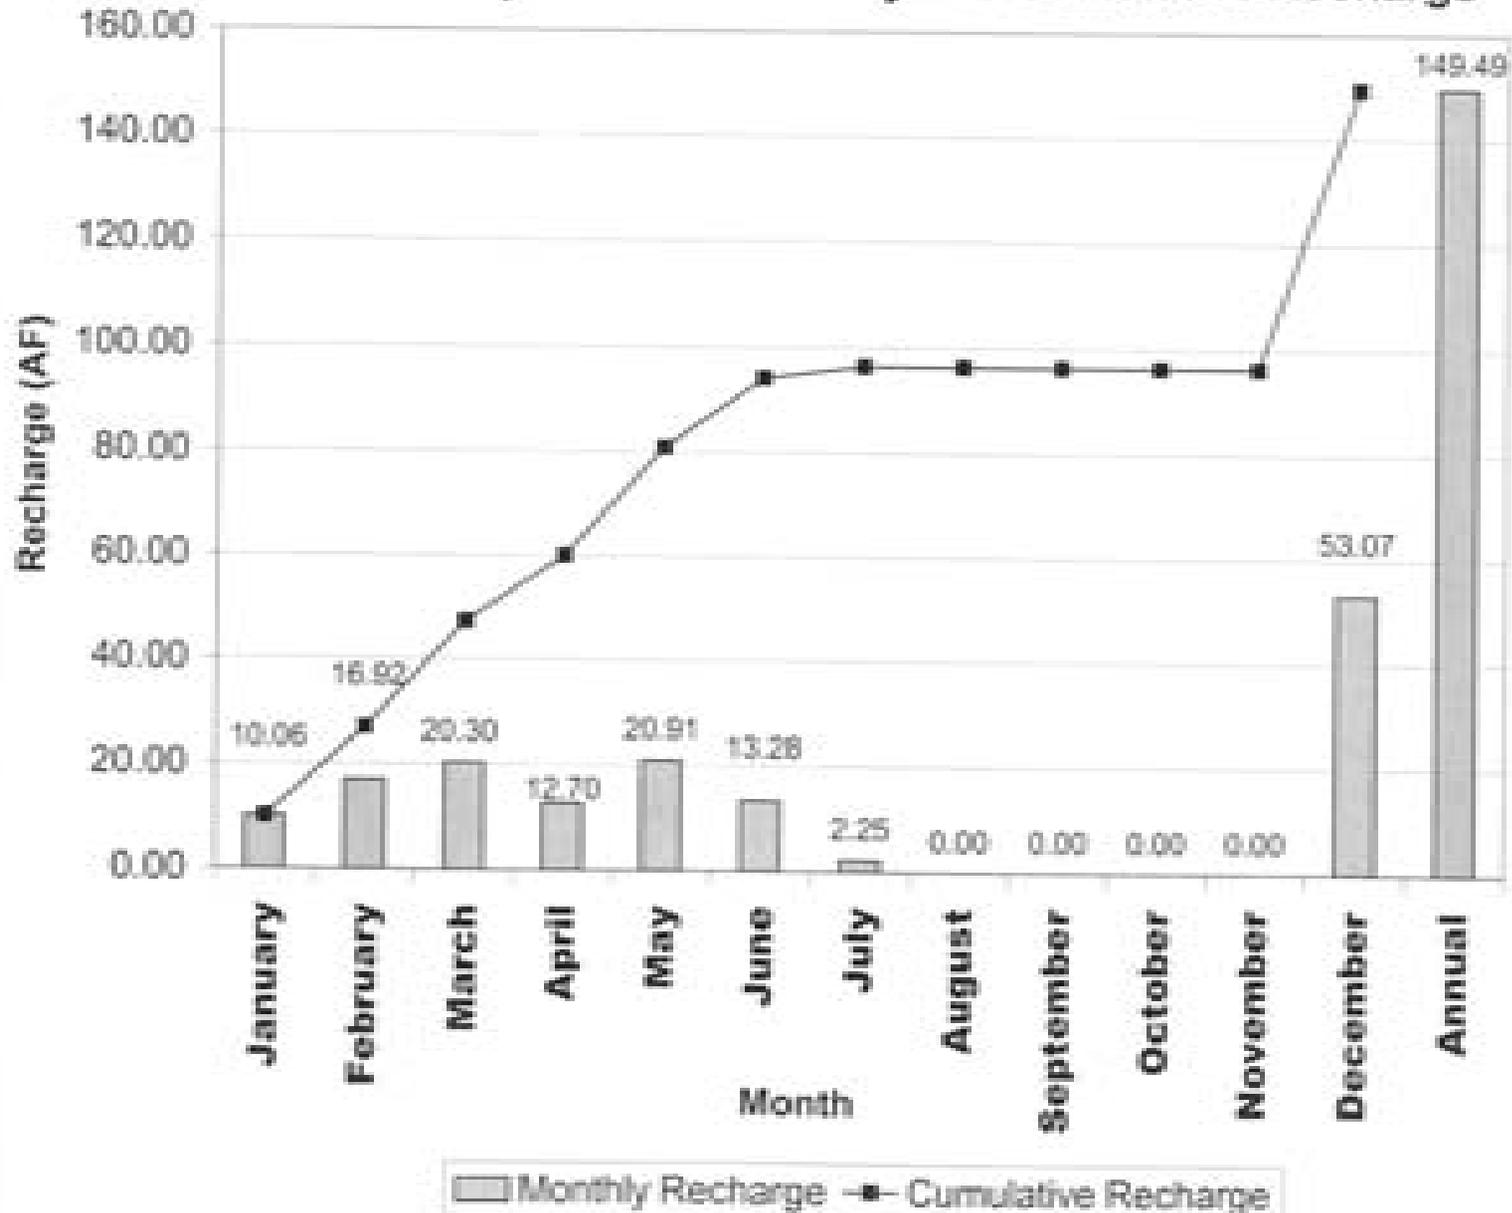
FIGURE 9
MARANA HIGH PLAINS EFFLUENT RECHARGE PROJECT
Total Project - 2006 Monthly and Cumulative Recharge

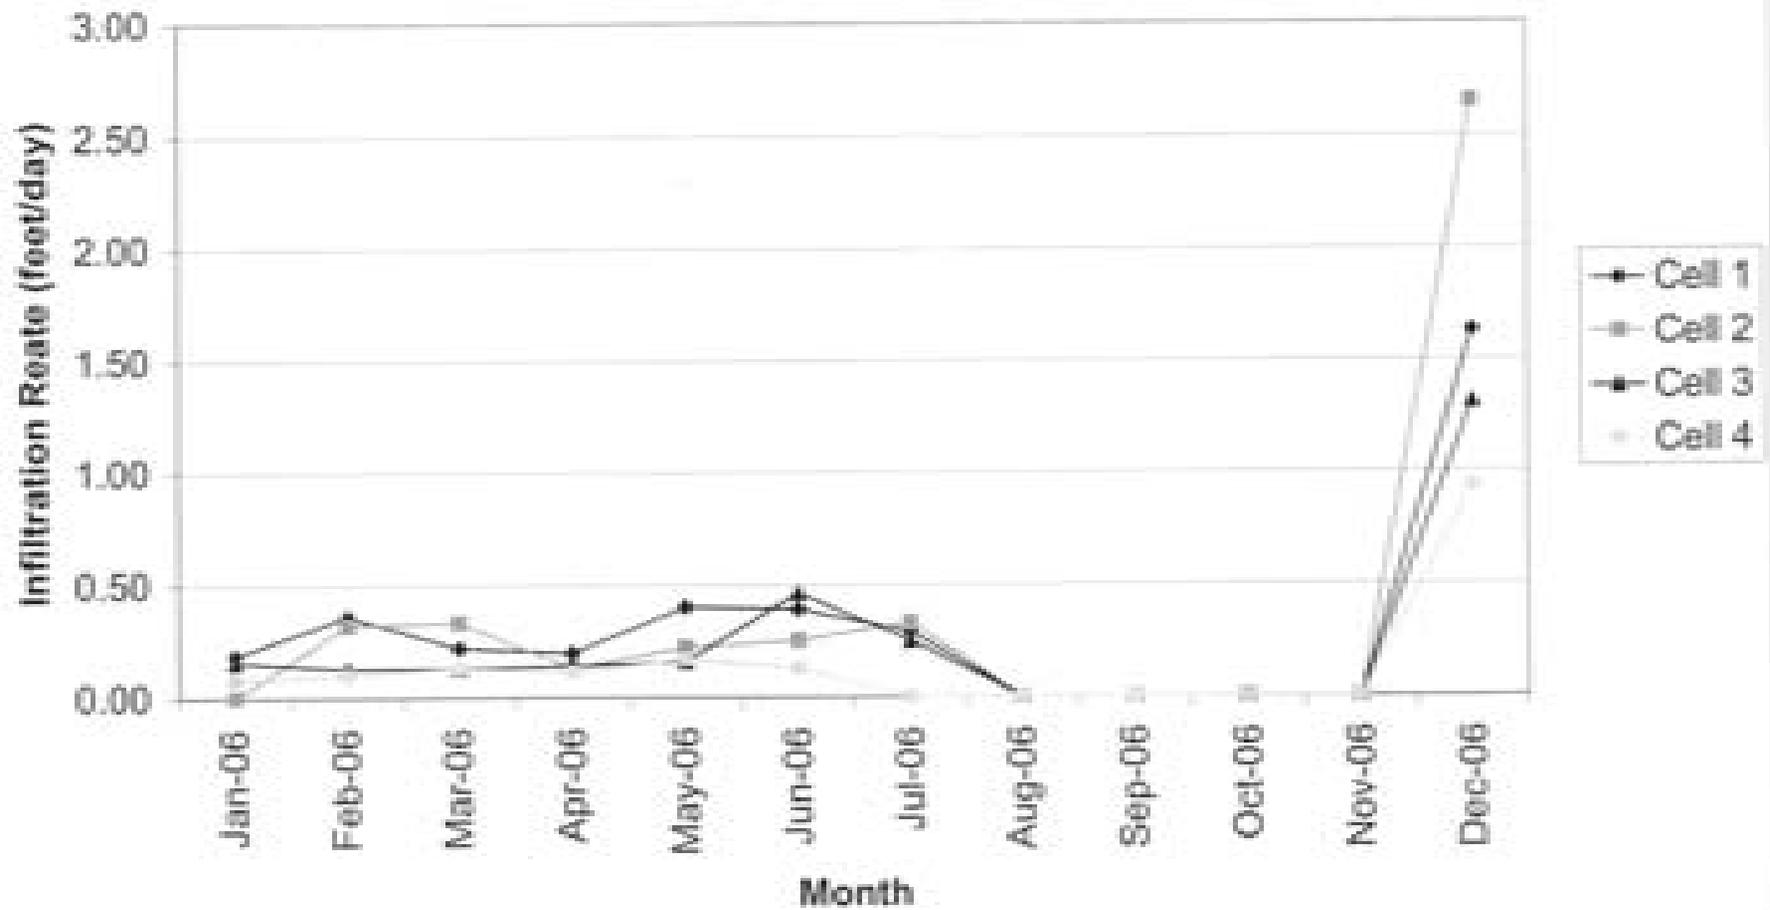
Figure 10
Marana High Plains Effluent Recharge Project
Average Monthly Infiltration Rates: CY 2006

Infiltration rates are calculated daily for each basin during operation of the recharge project using the “volumetric” method. The volumetric method utilizes flow and water level data taken from an area/velocity probe installed within each basin distribution system. Water level data, along with topography of the basin, is used to determine the aerial extent of water (wetted area) within the basin. An empirical equation allows conversion of the flow rate into each basin to be converted to volume over time. The volumetric method consists of dividing daily recharge volume, adjusted for evaporation losses, by daily wetted area of the basin.

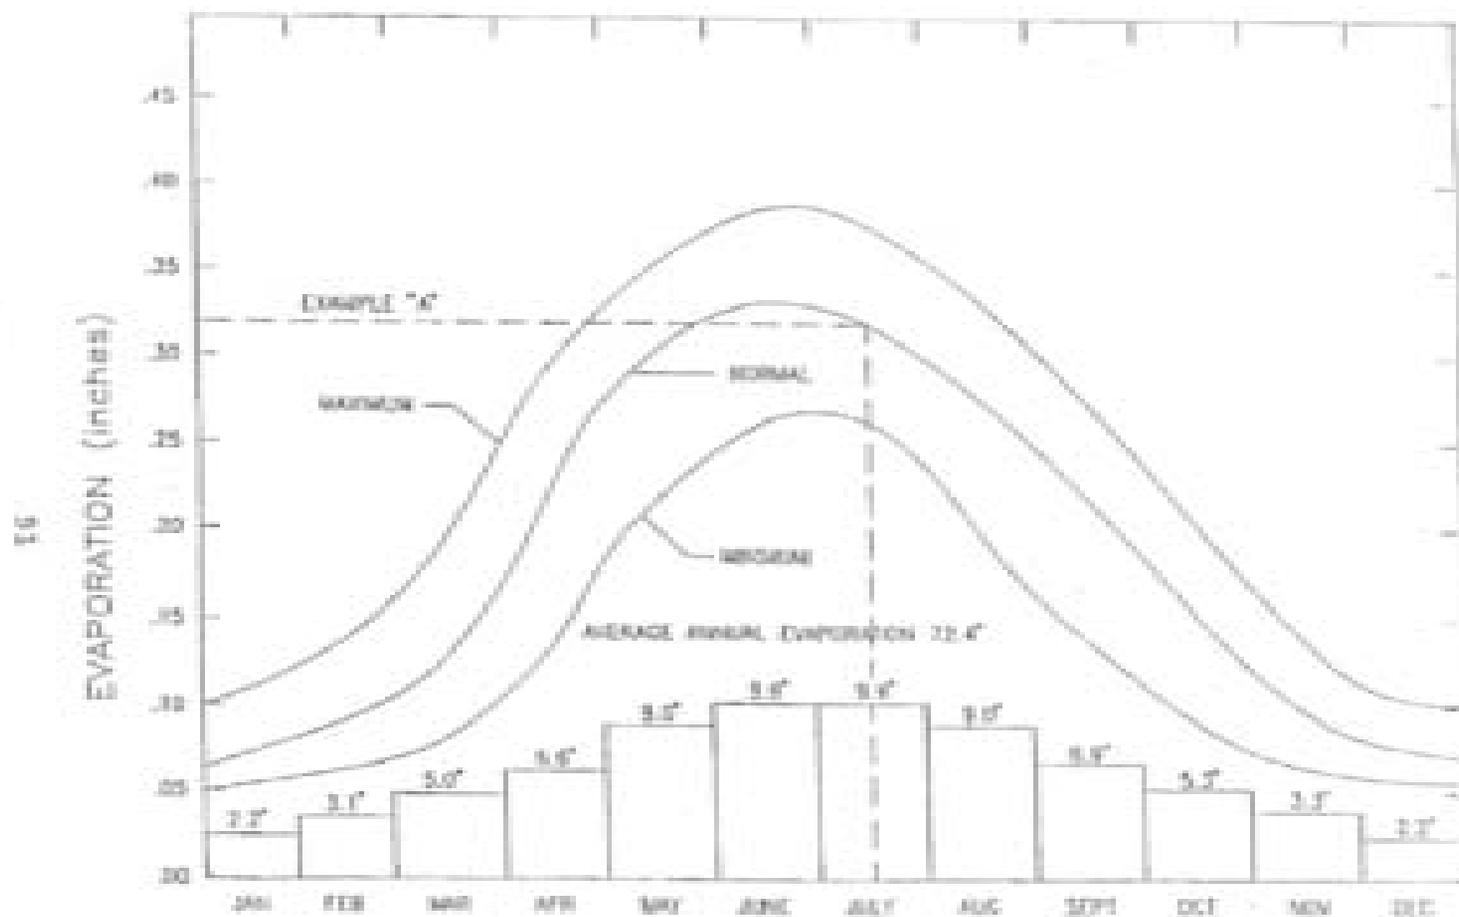
FIGURE 9. MAXIMUM, NORMAL AND MINIMUM DAILY EVAPORATION AND AVERAGE MONTHLY EVAPORATION FROM OPEN WATER SURFACES (Adjustment Factor = 1.00)

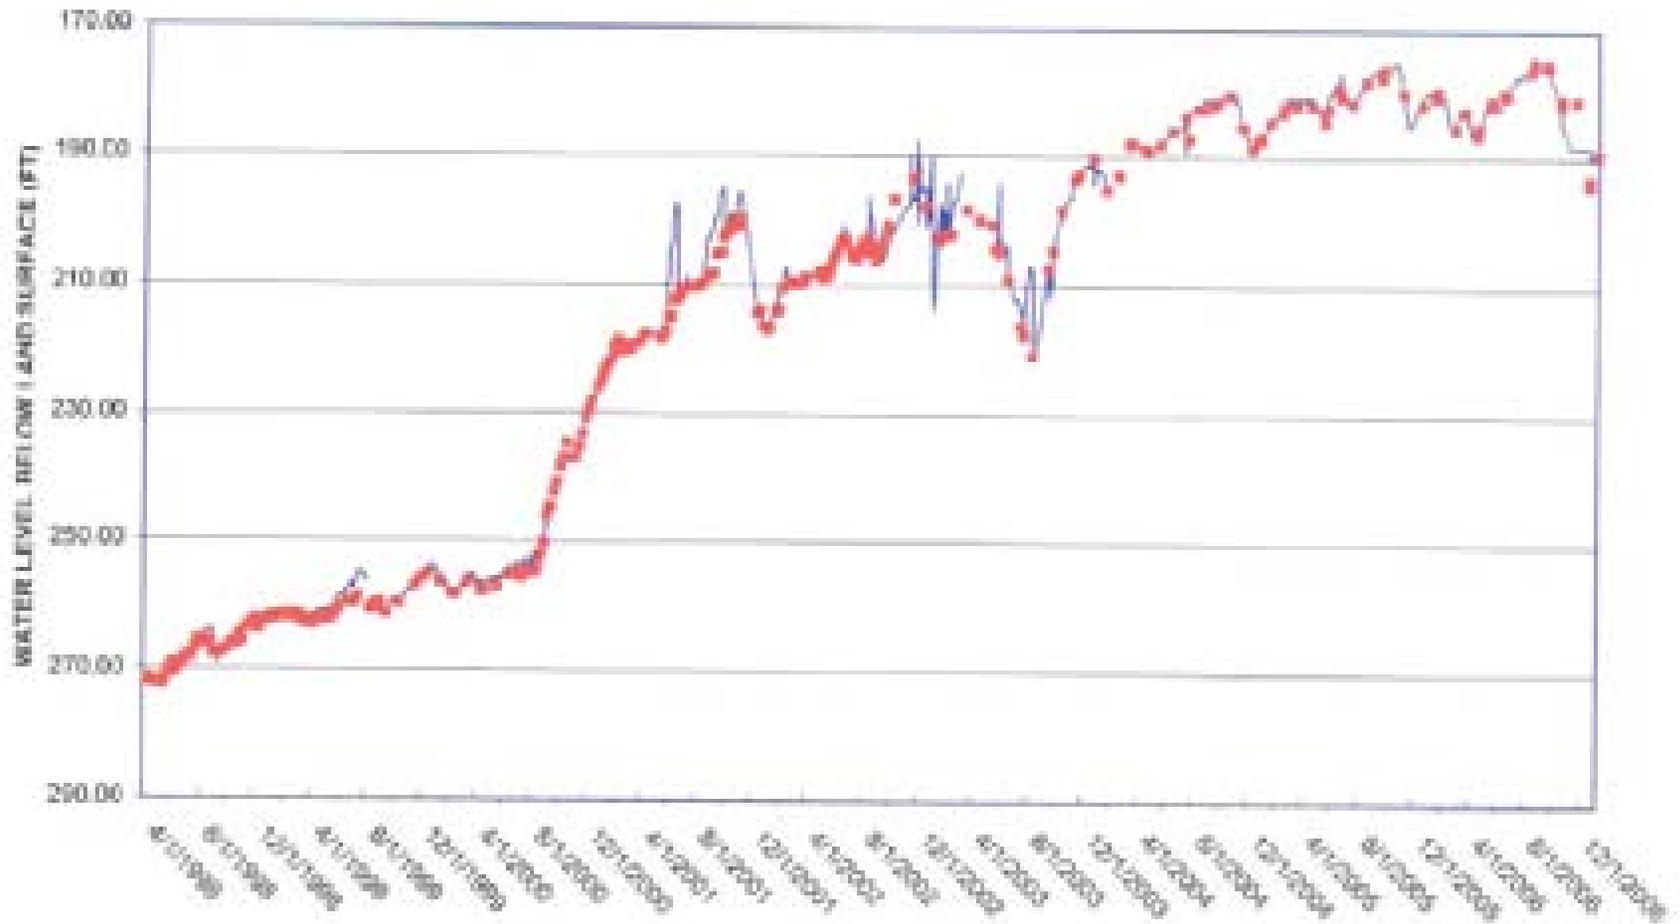
**APPENDIX E
DEPTH TO WATER HYDROGRAPH
MONITOR WELL AVMW-1**

Well hydrographs are also provided for monitor wells near the Project site, including SC-9, SC-10 and AVMW-1 (**Appendix E**). Data for these wells covers from 1988 to the present with significant early data gaps for both wells. Despite the limited data, annual fluctuations are apparent in the wells with the lowest levels in the late summer and the highest levels in early spring. The observed fluctuations could be the result of high capacity production wells located to the north of the project.

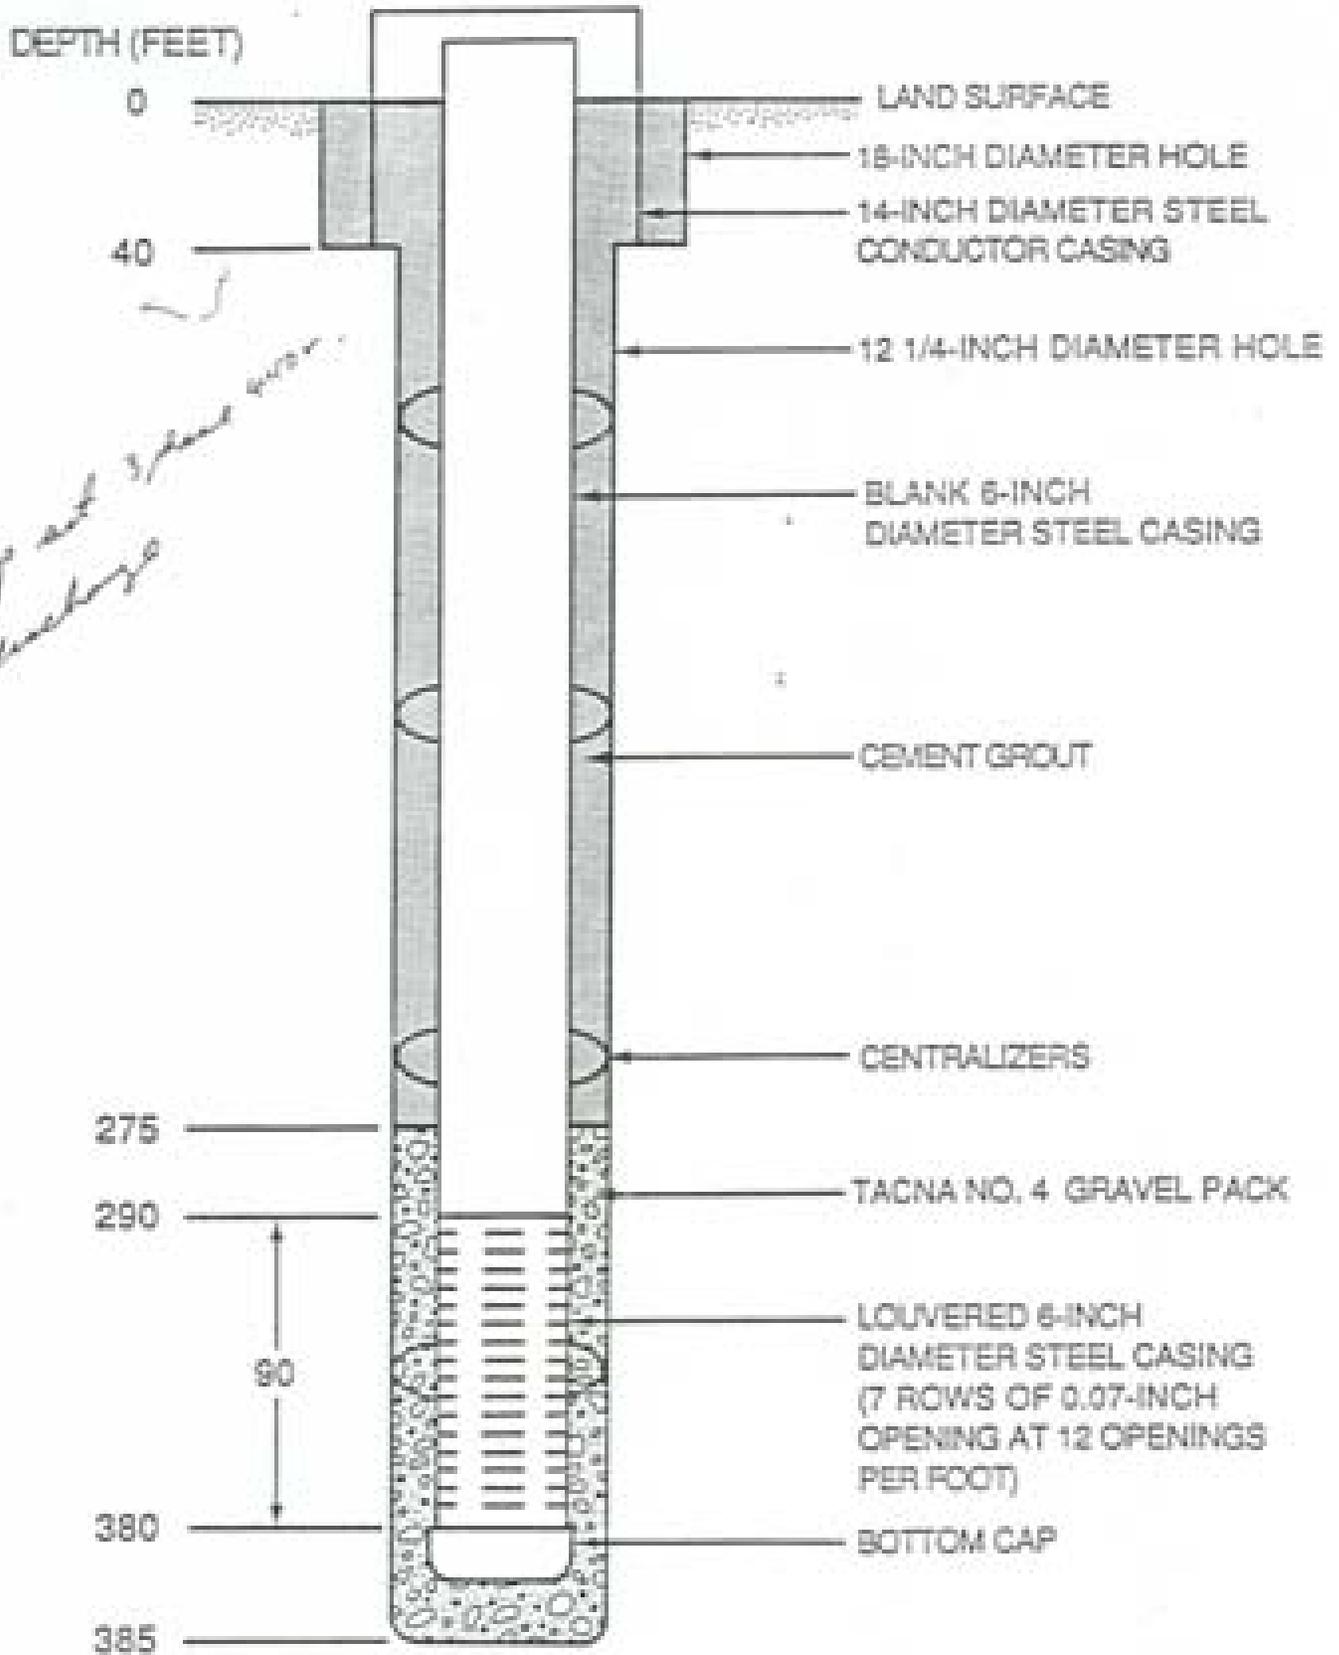
SCHMATIC DIAGRAM OF INTERMEDIATE MONITOR WELL SC-9

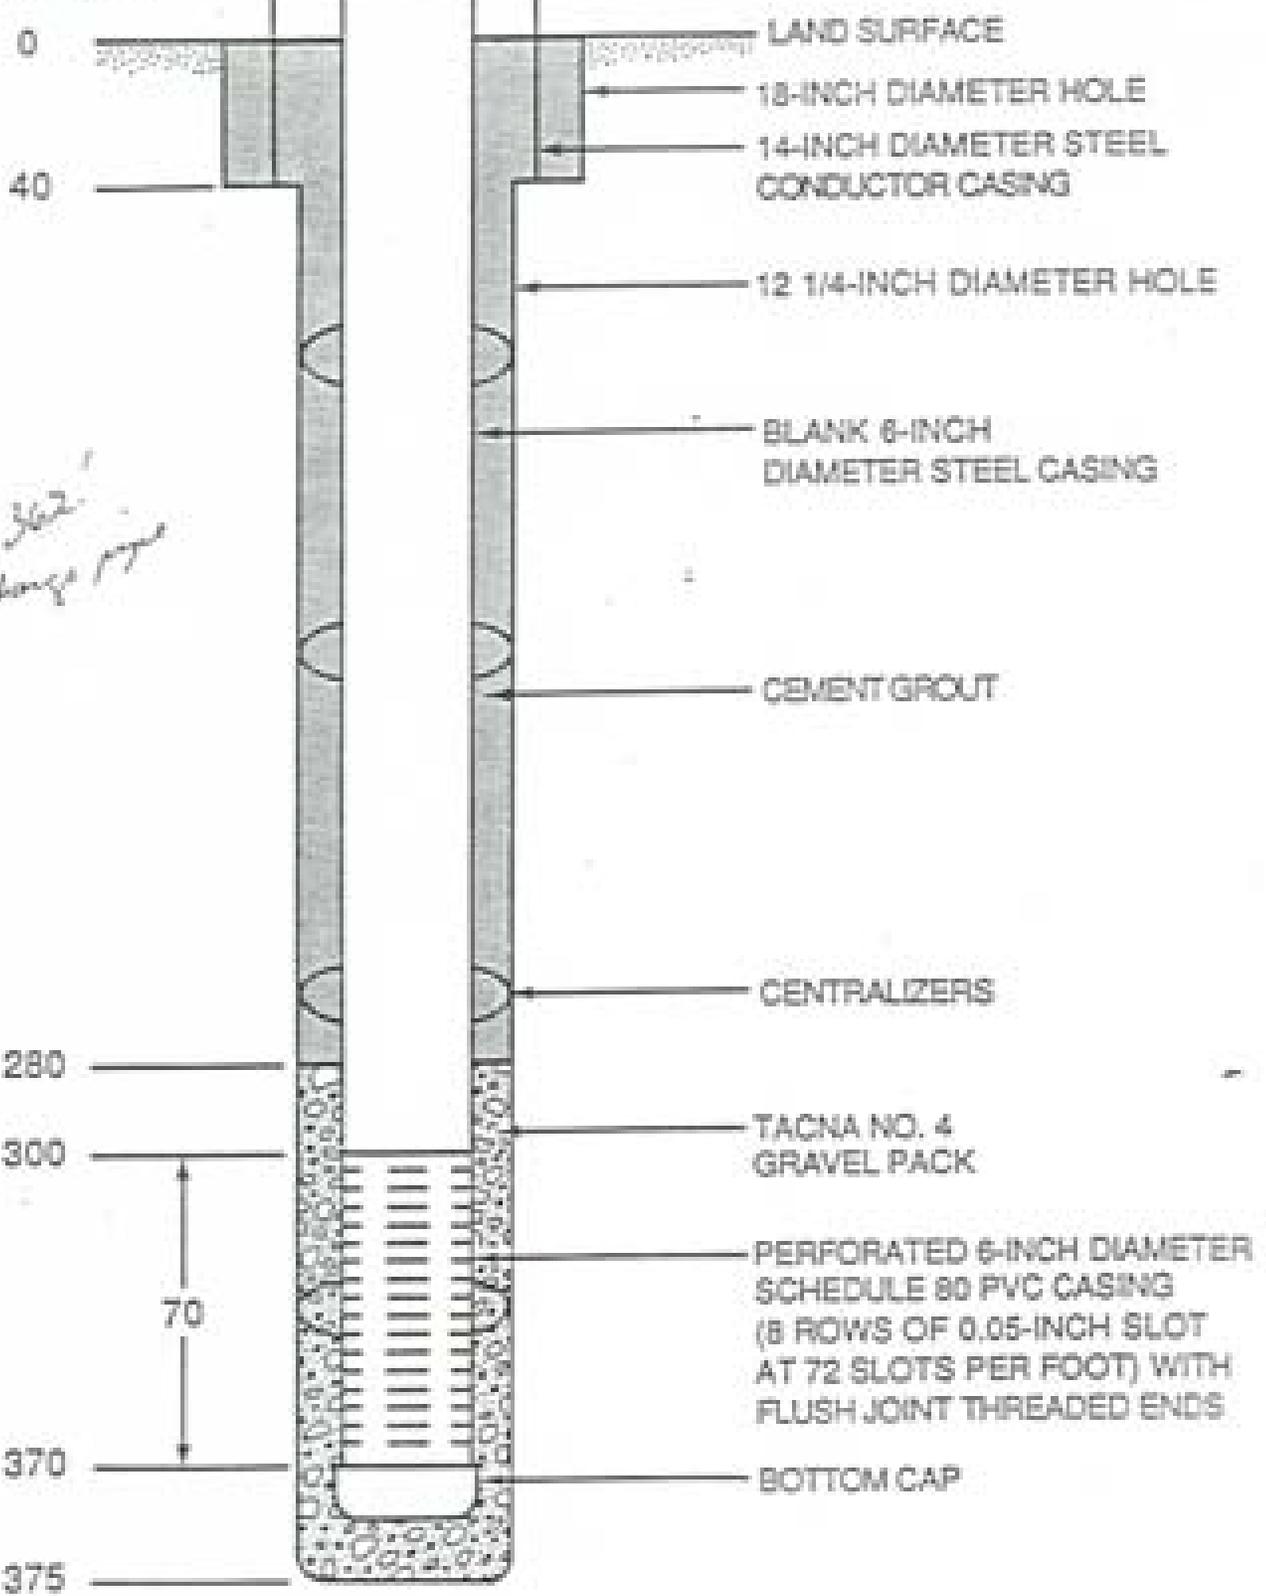
SCHMATIC DIAGRAM OF INTERMEDIATE MONITOR WELL SC-10
