Debris Flows and Floods in Southeastern Arizona from Extreme Precipitation in July 2006—Magnitude, Frequency, and Sediment Delivery

Open-file Report 2008-1274

By Robert H. Webb, Christopher S. Magirl, Peter G. Griffiths, and Diane E. Boyer

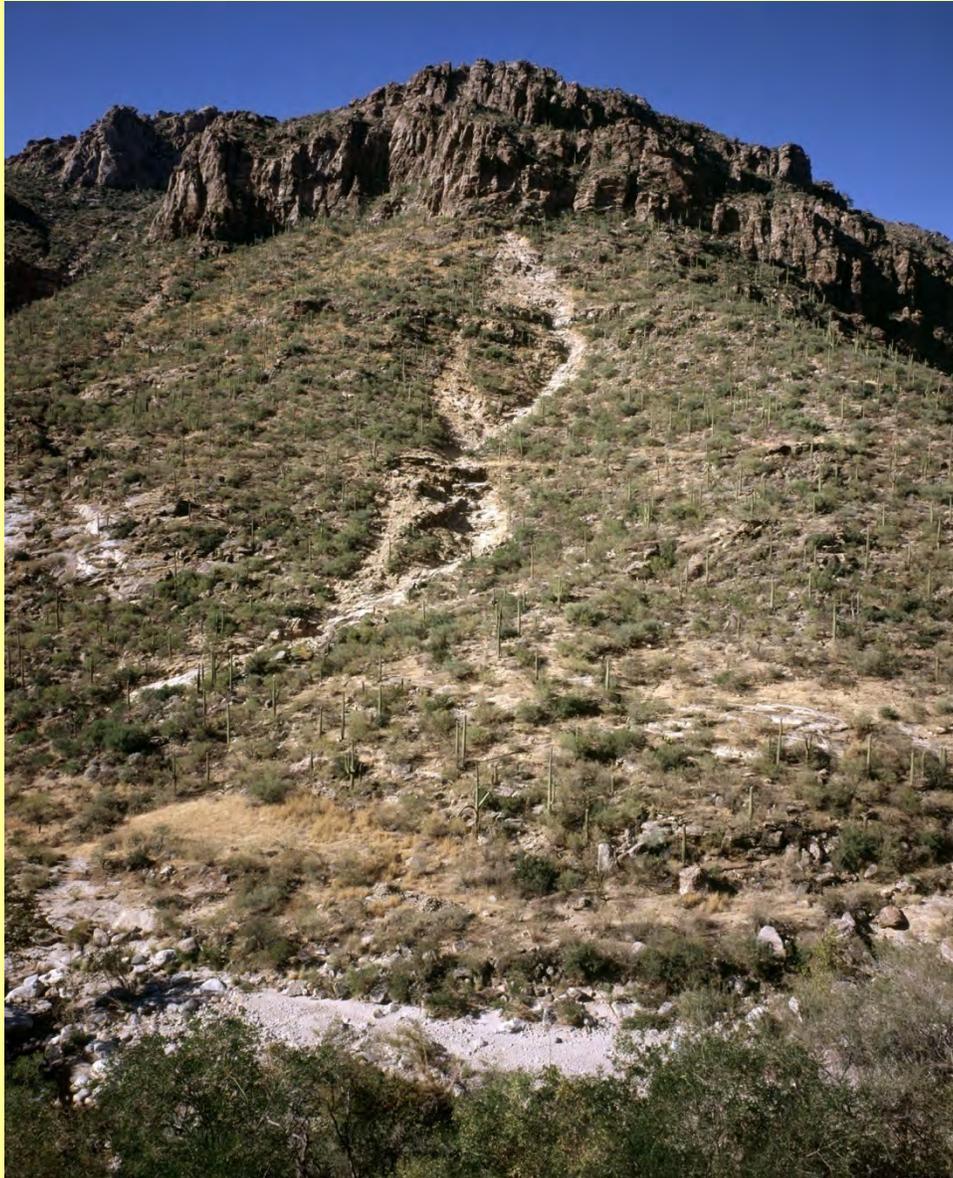
Cover Photograph. (November 21, 2006) Debris-flow initiation and transport zones on the western side of Sabino Canyon, southern Santa Catalina Mountains, as seen from the Sabino Canyon road close to its end. (R.H. Webb, Stake 3803x).

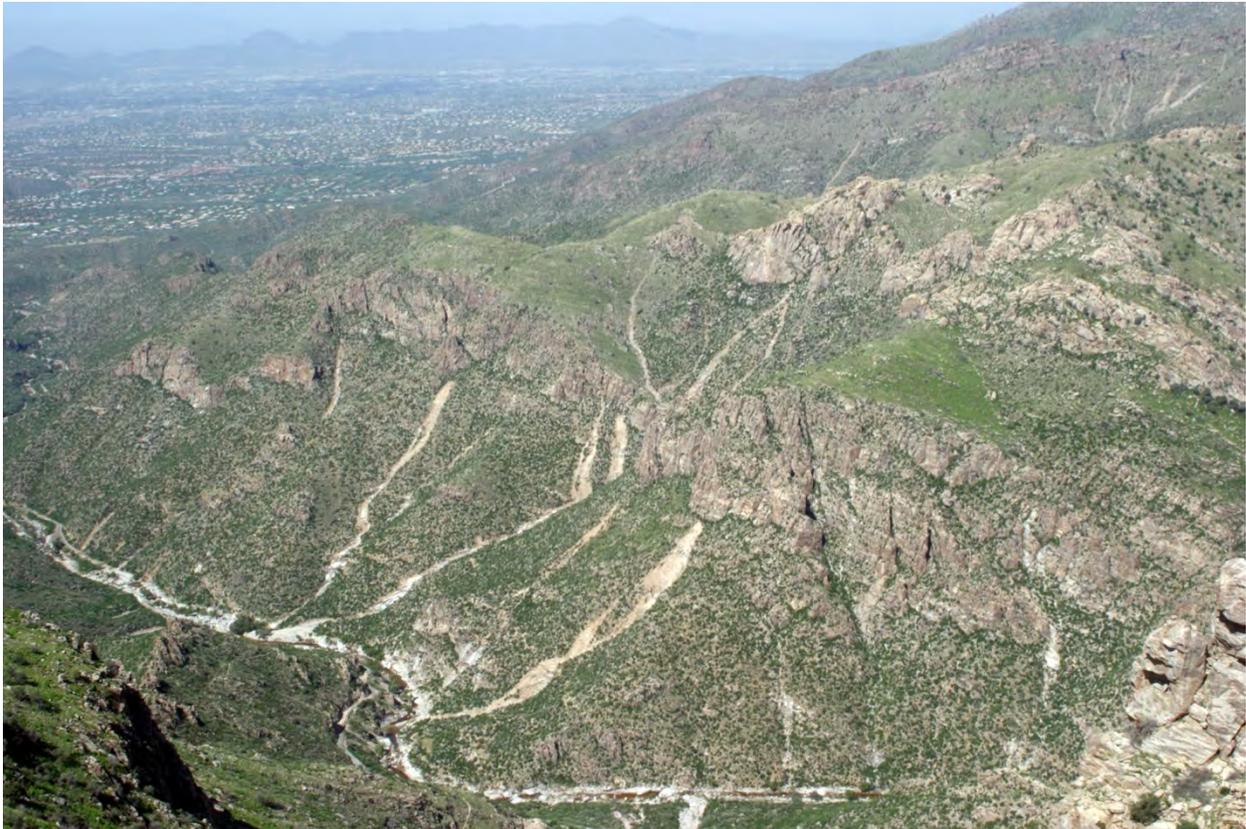
Figure 10. (August 18, 2006) This aerial photograph shows numerous slope failures, debris-flow deposits, and the channel of Sabino Creek in Sabino Canyon Recreation Area. The prominent slope failure at lower center is the same one shown on the cover of this report (R.H. Webb).

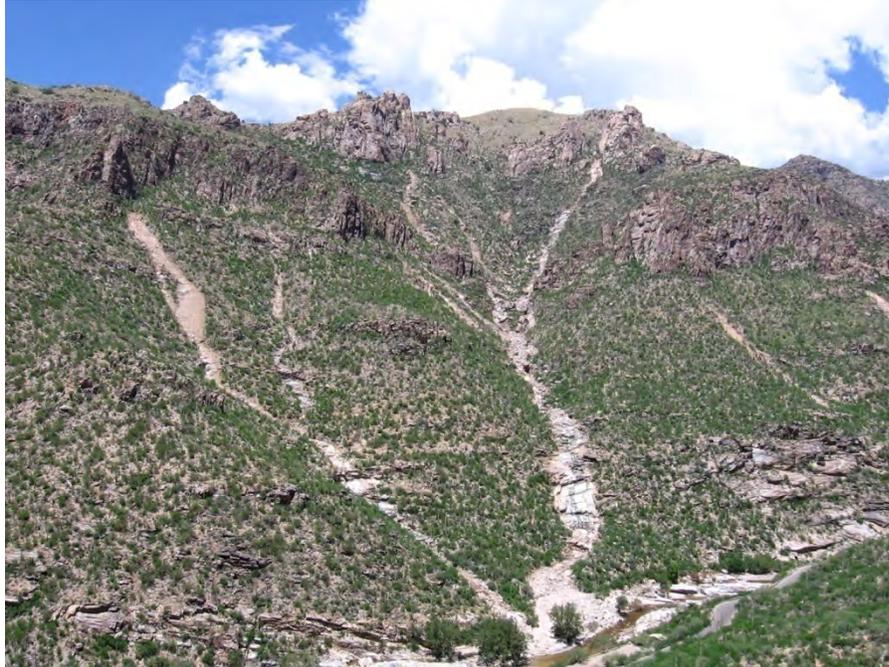
Figure 11. (August 8, 2006) Slope failures and debris-flow deposits along Sabino Creek in Sabino Canyon Recreation Area. A large chute that passed a debris flow, with its multiple contributing initiation points, appears in the center of the view. A total of 56 slope failures occurred in the Sabino Canyon Recreation Area, which encompasses most of lower Sabino Canyon (C.S. Magirl).

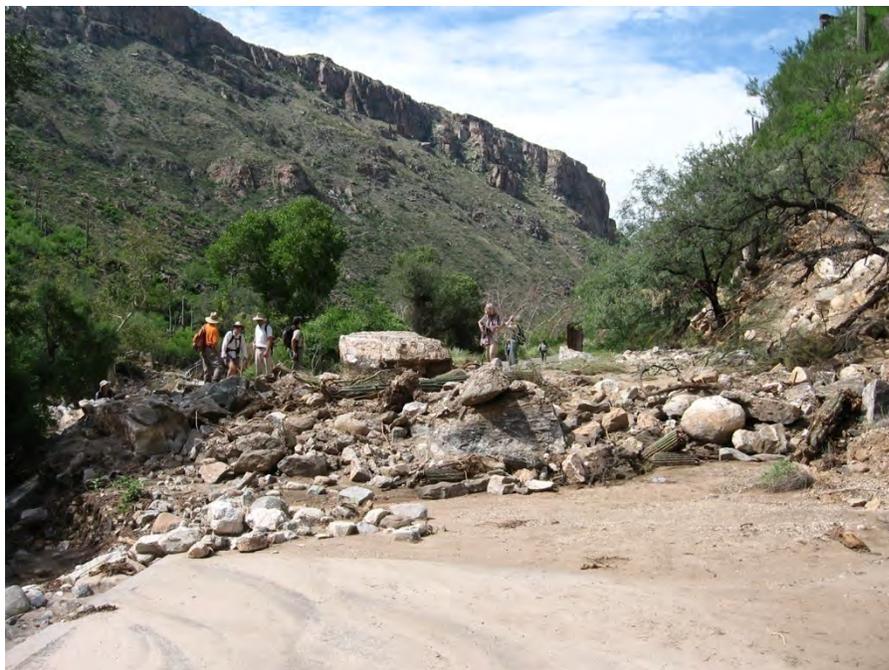
Figure 12. (August 11, 2006) Debris-flow deposits on the Sabino Canyon road in Sabino Canyon Recreation Area downstream from bridge 9. Debris-flow matrix, mostly fine gravel to clay-sized particles, appears in the right foreground (P.G. Griffiths).

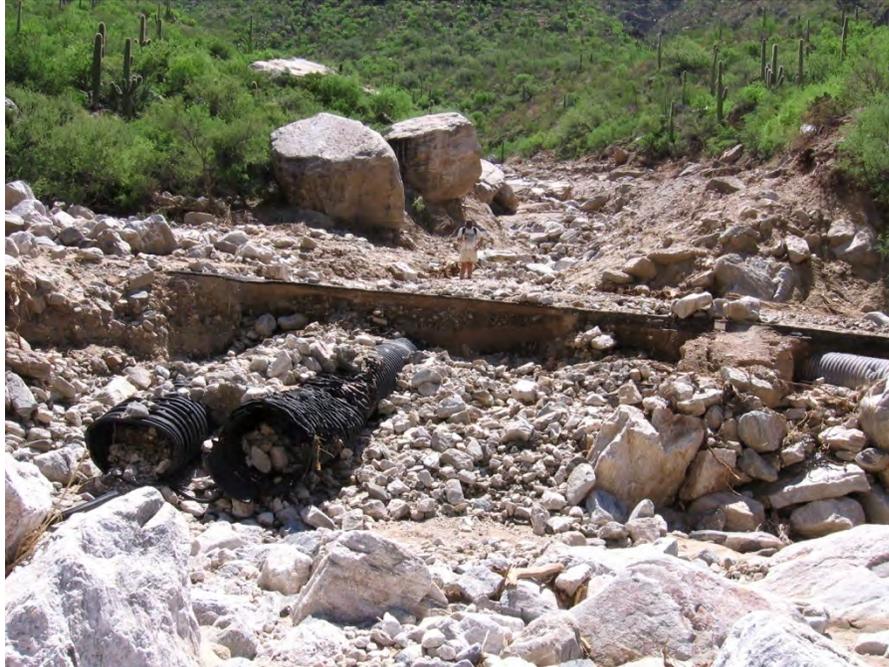
Figure 13. (August 8, 2006) The July 2006 debris flow, informally named “Ocho Grande,” covered and damaged the Sabino Canyon Road in Sabino Canyon Recreation Area. The debris flow filled the two culverts with coarse sediment and flowed into Sabino Creek, which flows from left to right in this view. Note the person standing on what is left of the roadway in the midground for scale. This debris flow had a superelevation stage of more than 20 ft on the right side of this view. Cosmogenic ^{10}Be dates obtained from the two large boulders on the left side of the channel (channel right) indicated that these boulders most likely were deposited during the latest Pleistocene; see appendix 1 for details and Youberg and others (2008) for full results (C.S. Magirl).

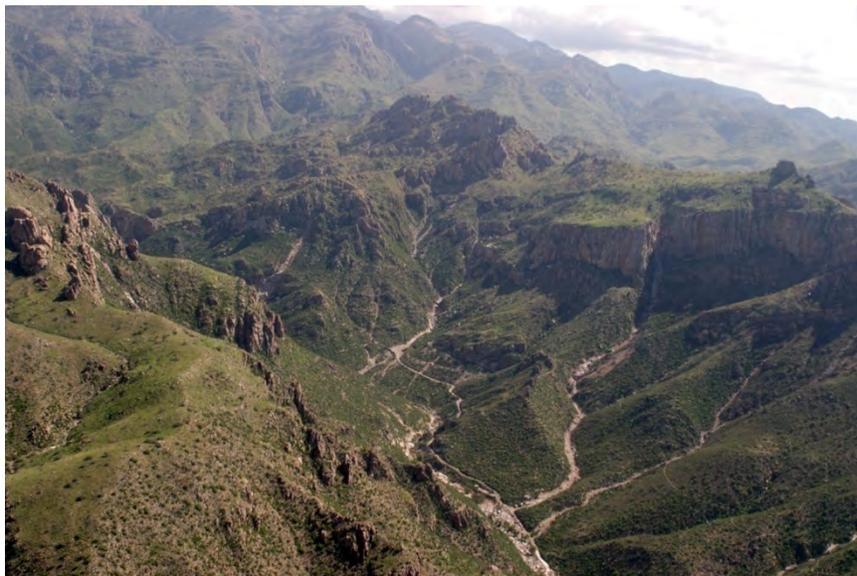
Figure 14. (August 18, 2006) This photograph of the eastern wall of Sabino Canyon shows the large debris flows of Ocho Grande (right center) and the debris flow that deposited coarse sediment over tram stop 9 (center) (R.H. Webb).

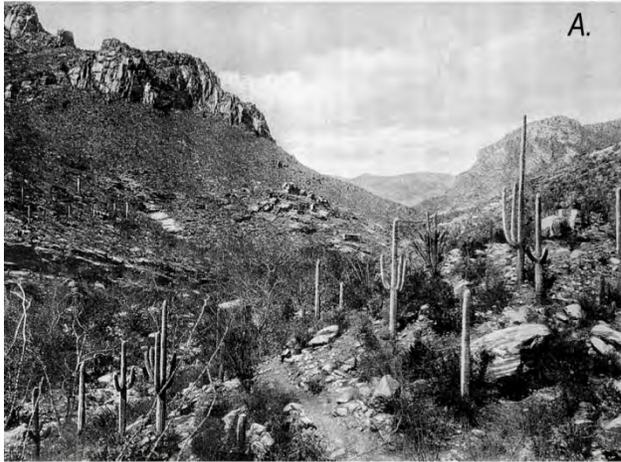
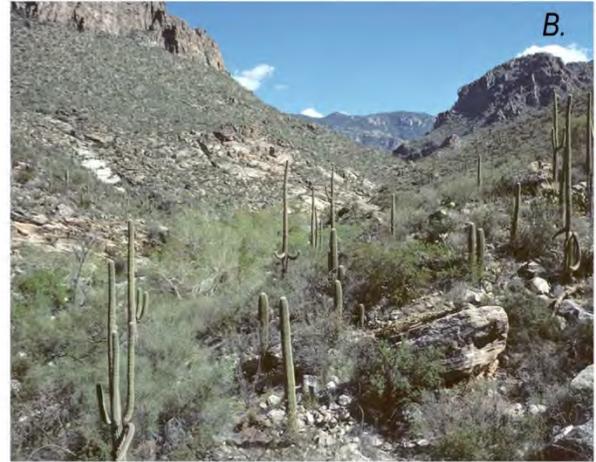
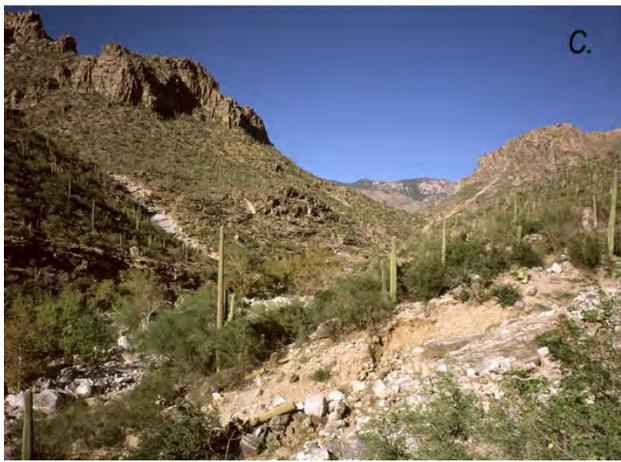
Figure 16. Repeat photographs of Sabino Canyon Recreation Area. *A*, (ca. 1909) This image, from a souvenir view book of Tucson-area photographs, shows an upstream view of Sabino Canyon with Mount Lemmon in the distance. The trail was the main canyon access; the road had not been built at this time. The dominant vegetation includes saguaro (*Carnegiea gigantea*), ocotillo (*Fouquieria splendens*), catclaw acacia (*Acacia greggii*), and babybonnet (*Coursetia glandulosa*) (R. Rasmussen, courtesy of James Klein). *B*, (April 3, 1990) This approximate match, taken nearly 80 years after the original was made, has a smaller field of view than the original. The trail, now known as the Historic Sabino Trail, fell into disuse in 1912 after construction of the Phoneline Trail, which is upslope to the right. The density of the vegetation has increased, particularly the cottonwoods (*Populus fremontii*) that line Sabino Creek on the left side of the view (D.W. Lazaroff, 523-20, courtesy of the photographer). *C*, (November 21, 2006) In July 2006, a debris flow bisected the foreground of the view, scouring vegetation and largely burying the large boulder visible in the lower right. Debris-flow transport zones are also visible at left midground and in the distance at right center (D.E. Boyer, Stake 4958).

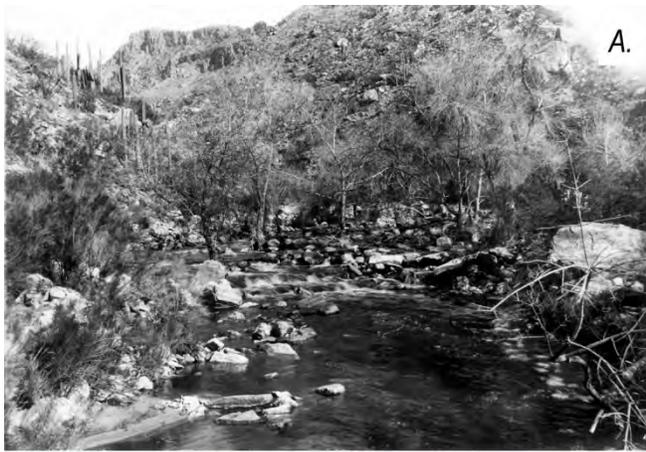
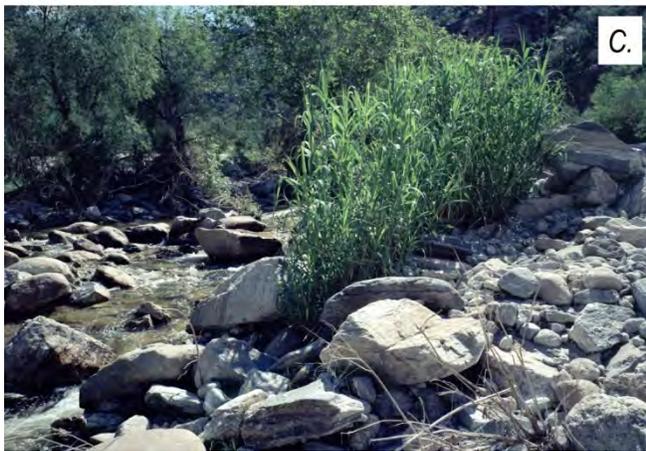
Figure 17. Repeat photographs of the channel of Sabino Creek downstream from the second bridge in Sabino Canyon Recreation Area. *A*, (February 1901) Samuel J. Holsinger shot some of the earliest known photographs of Sabino Canyon, including this image just downstream from where the second bridge is now located. The trees are mostly leafless (S.J. Holsinger, courtesy of James Klein). *B*, (September 26, 2003) Views *A* and *B* originally appeared in Webb and others (2007b, p. 282). In the 102 years since the original image was taken, the channel has changed considerably, and none of the original boulders can be recognized. The dominant trees are sycamore (*Platanus wrightii*) and Bonpland willow (*Salix bonplandiana*), along with some cottonwood (*Populus fremontii*) and coyote willow (*Salix exigua*). Non-native giant reed (*Arundo donax*) is also present. Driftwood suggests recent flood occurrence, and the sediments are laden with ash from the Aspen Fire (R.M. Turner). *C*, (September 1, 2006) Surprisingly little has changed in the view between 2003 and 2006 in spite of the debris flows upstream in Sabino Canyon and the record streamflow flood. Most of the boulders visible in 2003 are still in the same positions, although some have shifted slightly. The sycamores in the midground survived the recent flood, and the giant reeds in the foreground have grown (R.H. Webb, Stake 4693).

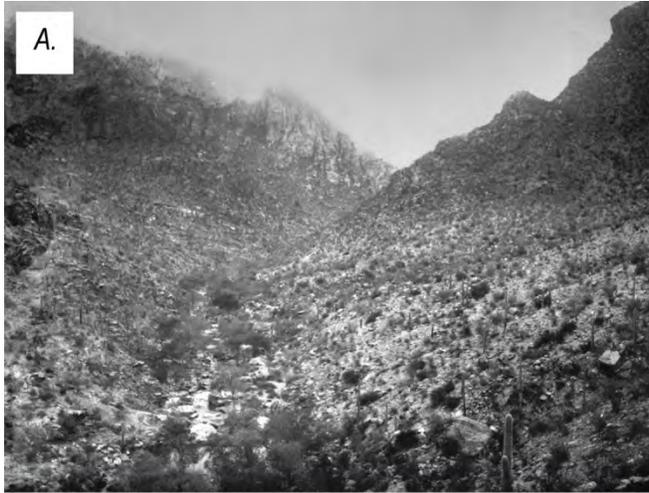
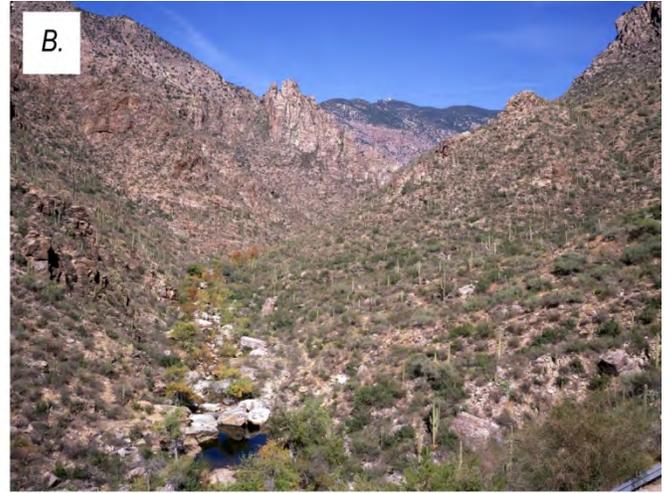
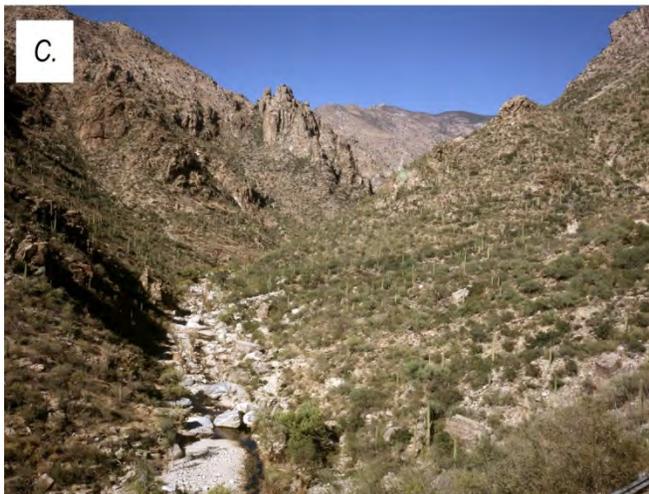
Figure 18. Upstream views of Sabino Creek near the end of the Sabino Road in Sabino Canyon Recreation Area. *A*, (March 1902) This view, one of the earliest photographs of upper Sabino Canyon, looks almost due north from a point that is now between tram stops eight and nine. The channel is thickly lined with vegetation, and many small pools are present. The background mountains are not completely visible, due in part to the poor quality of the photograph (D. Griffiths, 83-FB-902, courtesy of the National Archives). *B*, (November 19, 1998) Many of the large boulders in the channel appear to be in the same locations 96 years after the original image was taken, although the sediments have shifted. Most of the channel vegetation appears to have changed, and mountains clearly appear in the background (D. Oldershaw, Stake 3803). *C*, (November 21, 2006) This image was made eight years after the previous match and four months after the debris flows of July 31, 2006. The channel vegetation has been freshly scoured. Many of the large boulders are still visible in the same locations, but there has been considerable sediment deposition, filling in some of the pools visible in the 1998 view. Some slope failures are visible in the upper right corner of the view (R.H. Webb, Stake 3803).

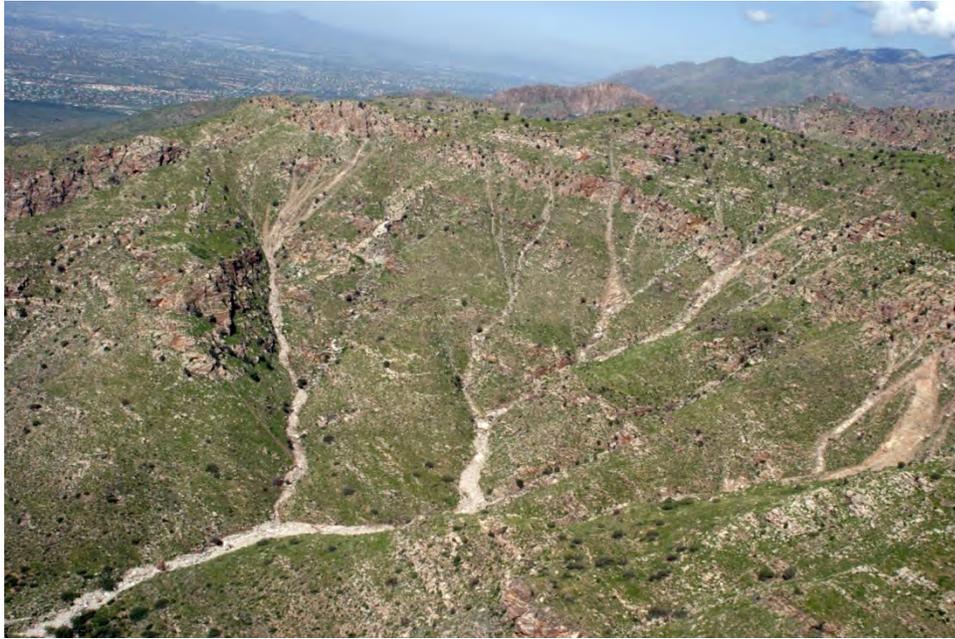
Figure 24. (August 18, 2006) Aerial photograph showing numerous slope failures on the west slope (east-facing slope) of a tributary of Soldier Creek. A total of 56 slope failures were mapped in the Soldier Creek watershed. This slope appears in the repeat photography pair shown in Figure 25 (R.H. Webb).

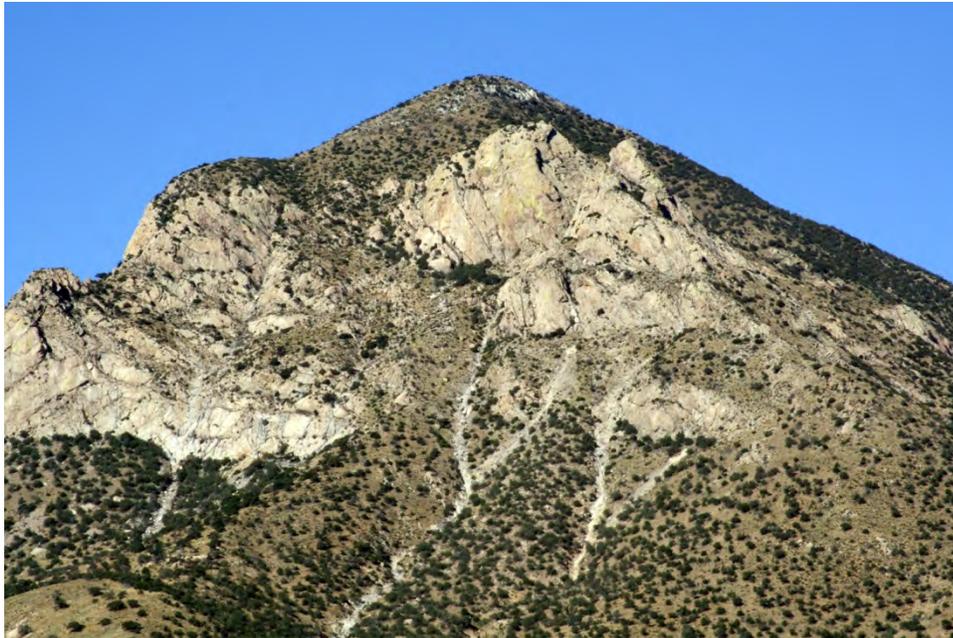
Figure 28. (February 2007) Slope failures at the southern end of the Huachuca Mountains, Coronado National Memorial. This view shows several failures beneath granite outcrops from an area not recently burned on the east face of Montezuma Peak (R.H. Webb).

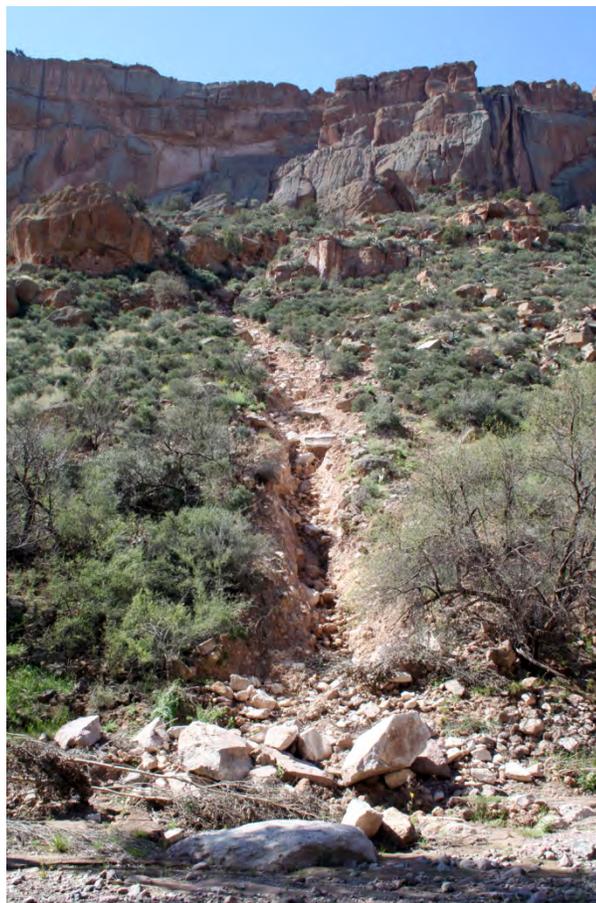
Figure 31. (March 28, 2007) A representative debris-flow deposit in Aravaipa Canyon from the 2006 event. This debris flow occurred across from the mouth of Horse Canyon at an elevation of 3,000 feet and had a volume estimated to be about 370 yd³ (D.E. Boyer).

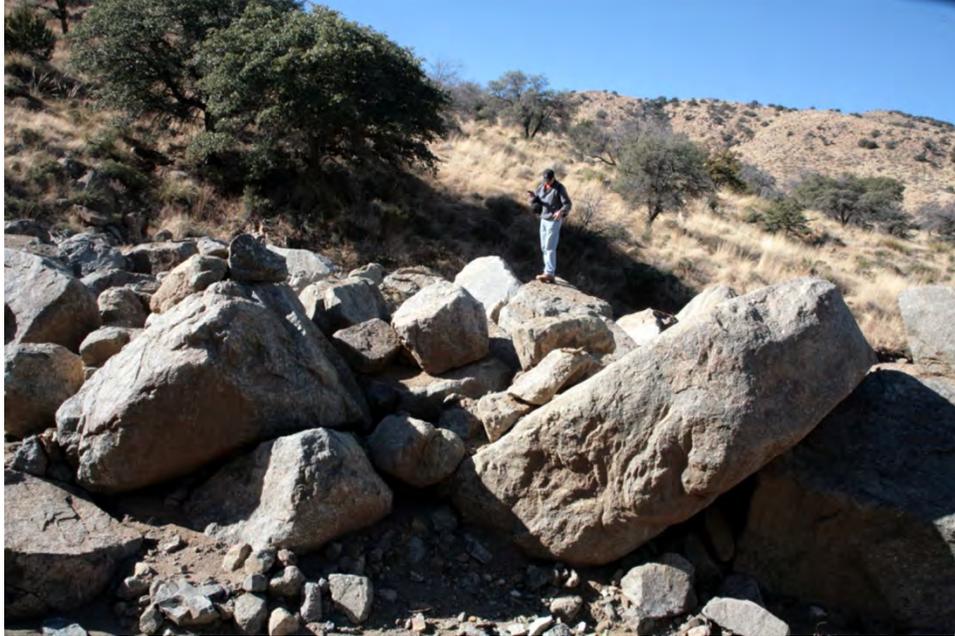
Figure 33. (January 16, 2007) Large boulders now clog the channel of an unnamed wash, informally called Bab Wash, that drains the northeastern side of Bowie Mountain, southeastern Arizona. This area used to be a grassy channel that allowed passage of law-enforcement vehicles before July 2006 (R.H. Webb).

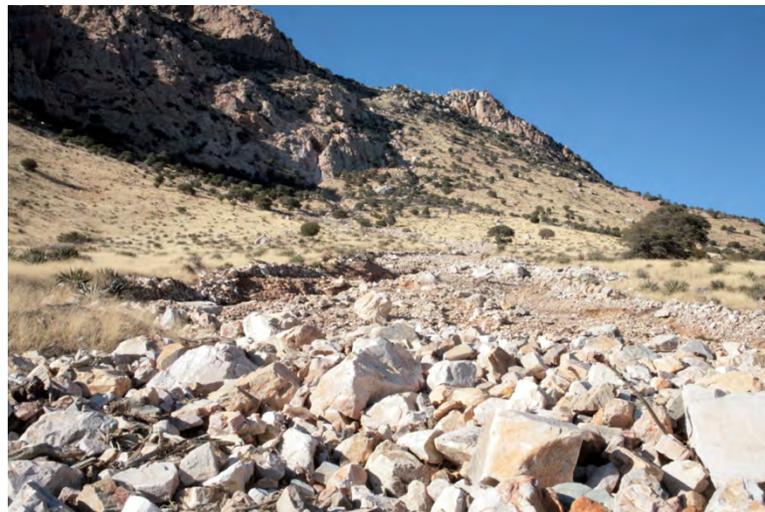
Figure 34. (January 16, 2007) Debris-flow deposits (left foreground) and erosion in an unnamed tributary to Bear Spring Wash, a drainage from the southeastern side of Bowie Mountain, southeastern Arizona. On exiting the cliffs in the left background, the debris flow cut across several channels, forming a new drainage network on the southeastern flank of Bowie Mountain (R.H. Webb).

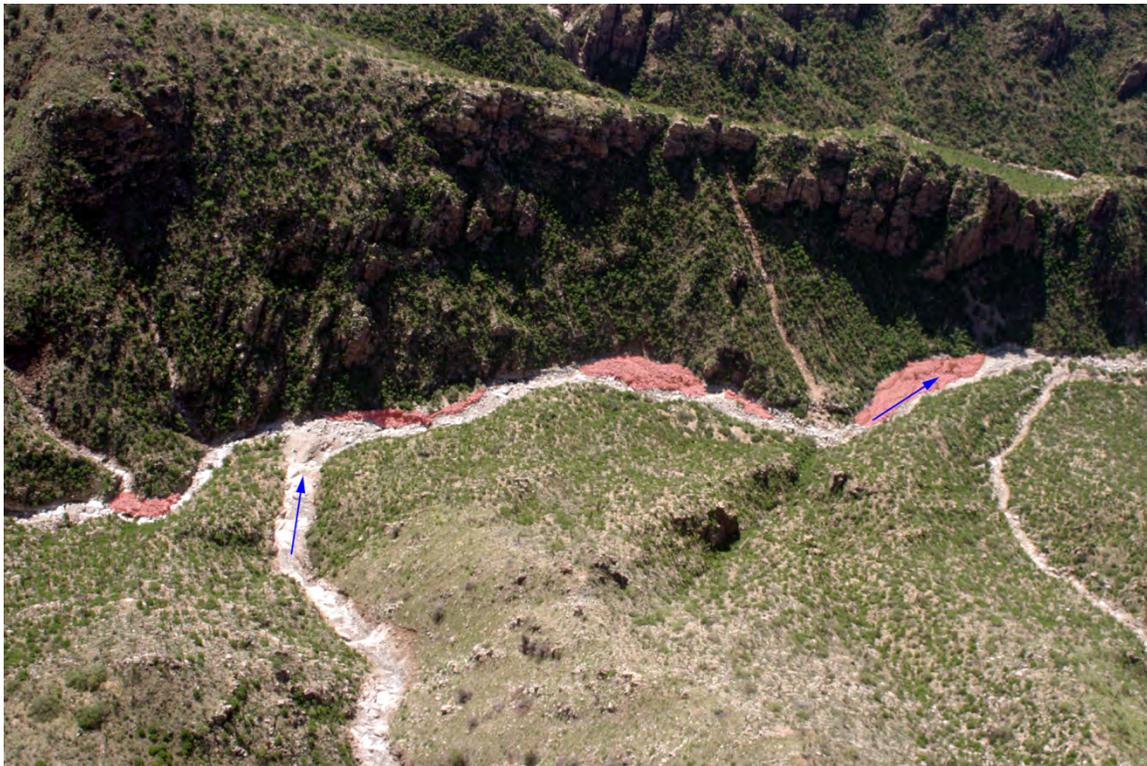
Figure 39. (August 18, 2006) Aerial photograph showing debris-flow levees (shaded in red) and channel sediments deposited on July 31, 2006, in Rattlesnake Canyon, southern Santa Catalina Mountains (R.H. Webb).

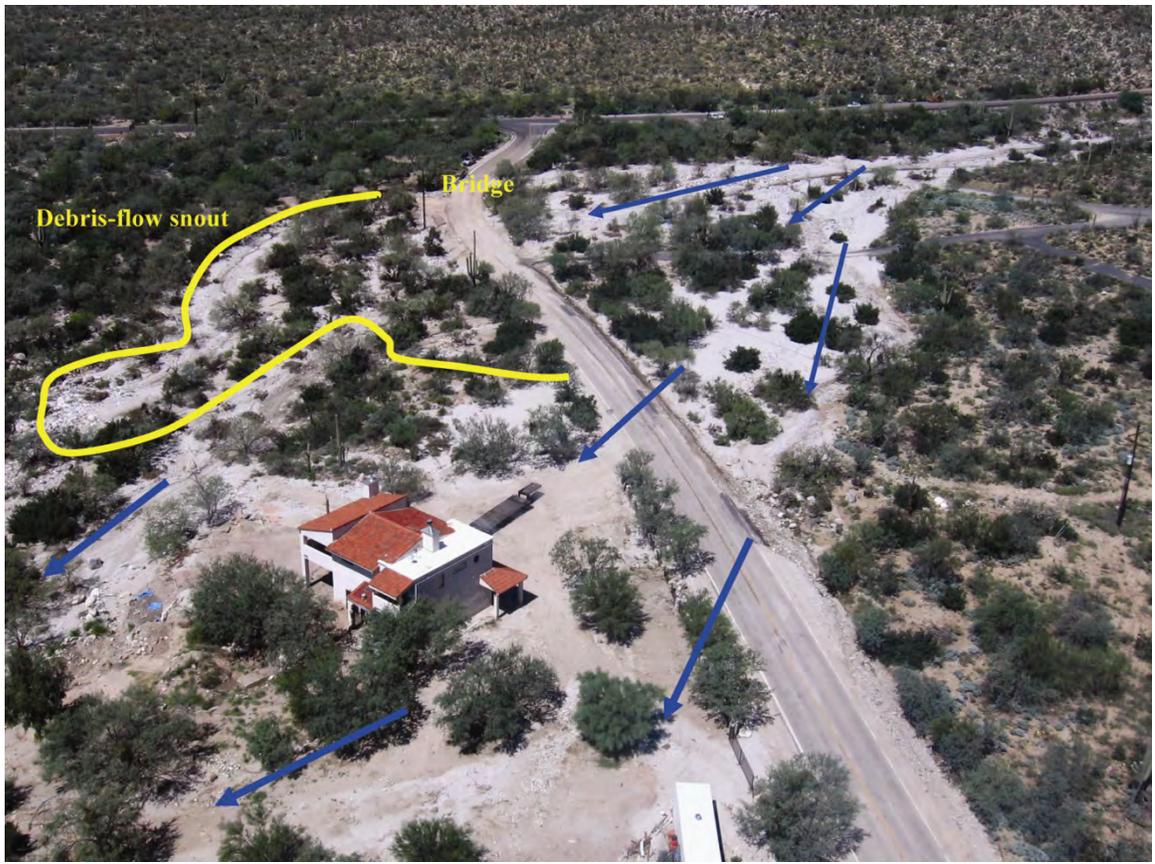
Figure 44. (September 13, 2006) This oblique aerial photograph of the snout of the Soldier Canyon debris flow shows that debris-flow deposits filled the culvert at the bend in the Mount Lemmon Short Road (upper center), and streamflow deposits related to the debris flow surrounded the house at lower left (C.S. Magirl).

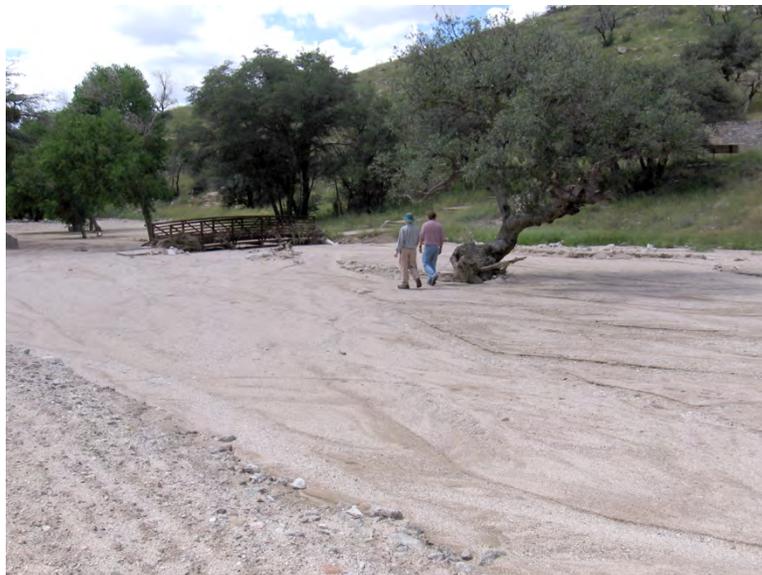
Figure 51. (September 14, 2006) Deposition in the headwaters of Soldier Creek caused by the combination of the 2003 Aspen Fire and the 2006 debris flows in the watershed filled the channel, eliminating the usefulness of the pedestrian bridge (left center) in the Gordon Hirabayashi Picnic Area (C.S. Magirl).

This unconsolidated sediment potentially poses a hazard to fixed-conveyance floodplain structures in Rillito Creek. However, our analyses suggest that deposition in the channel would be modest, even in the unlikely event that all the sediment displaced in the 2006 slope failures were to arrive in the channel simultaneously. It should be noted that sediment from the 2006 debris flows are not the only source of additional sediment from the Santa Catalina Mountains; denudation of hillslopes during the Aspen Fire in 2003 also contributed to increased sedimentation of fine particles, much of which is still stored in stream channels in the canyons and available for entrainment by future floods (fig. 51).
