FPUP # P16FC00668
DSD # P16BP07639

ELEVATION CERTIFICATE

SECTION A – PROPERTY INFORMATION		FOR INSURANCE COMPANY USE
A1. Building Owner's Name Pattee Family Trust		Policy Number:
A2. Building Street Address (including Apt., Unit, Suite, and/or Bldg. No.) or P.O. Route and Box No. 11553 East Tanque Verde Road		Company NAIC Number:
City Tucson	State Arizona	ZIP Code 85749-8273

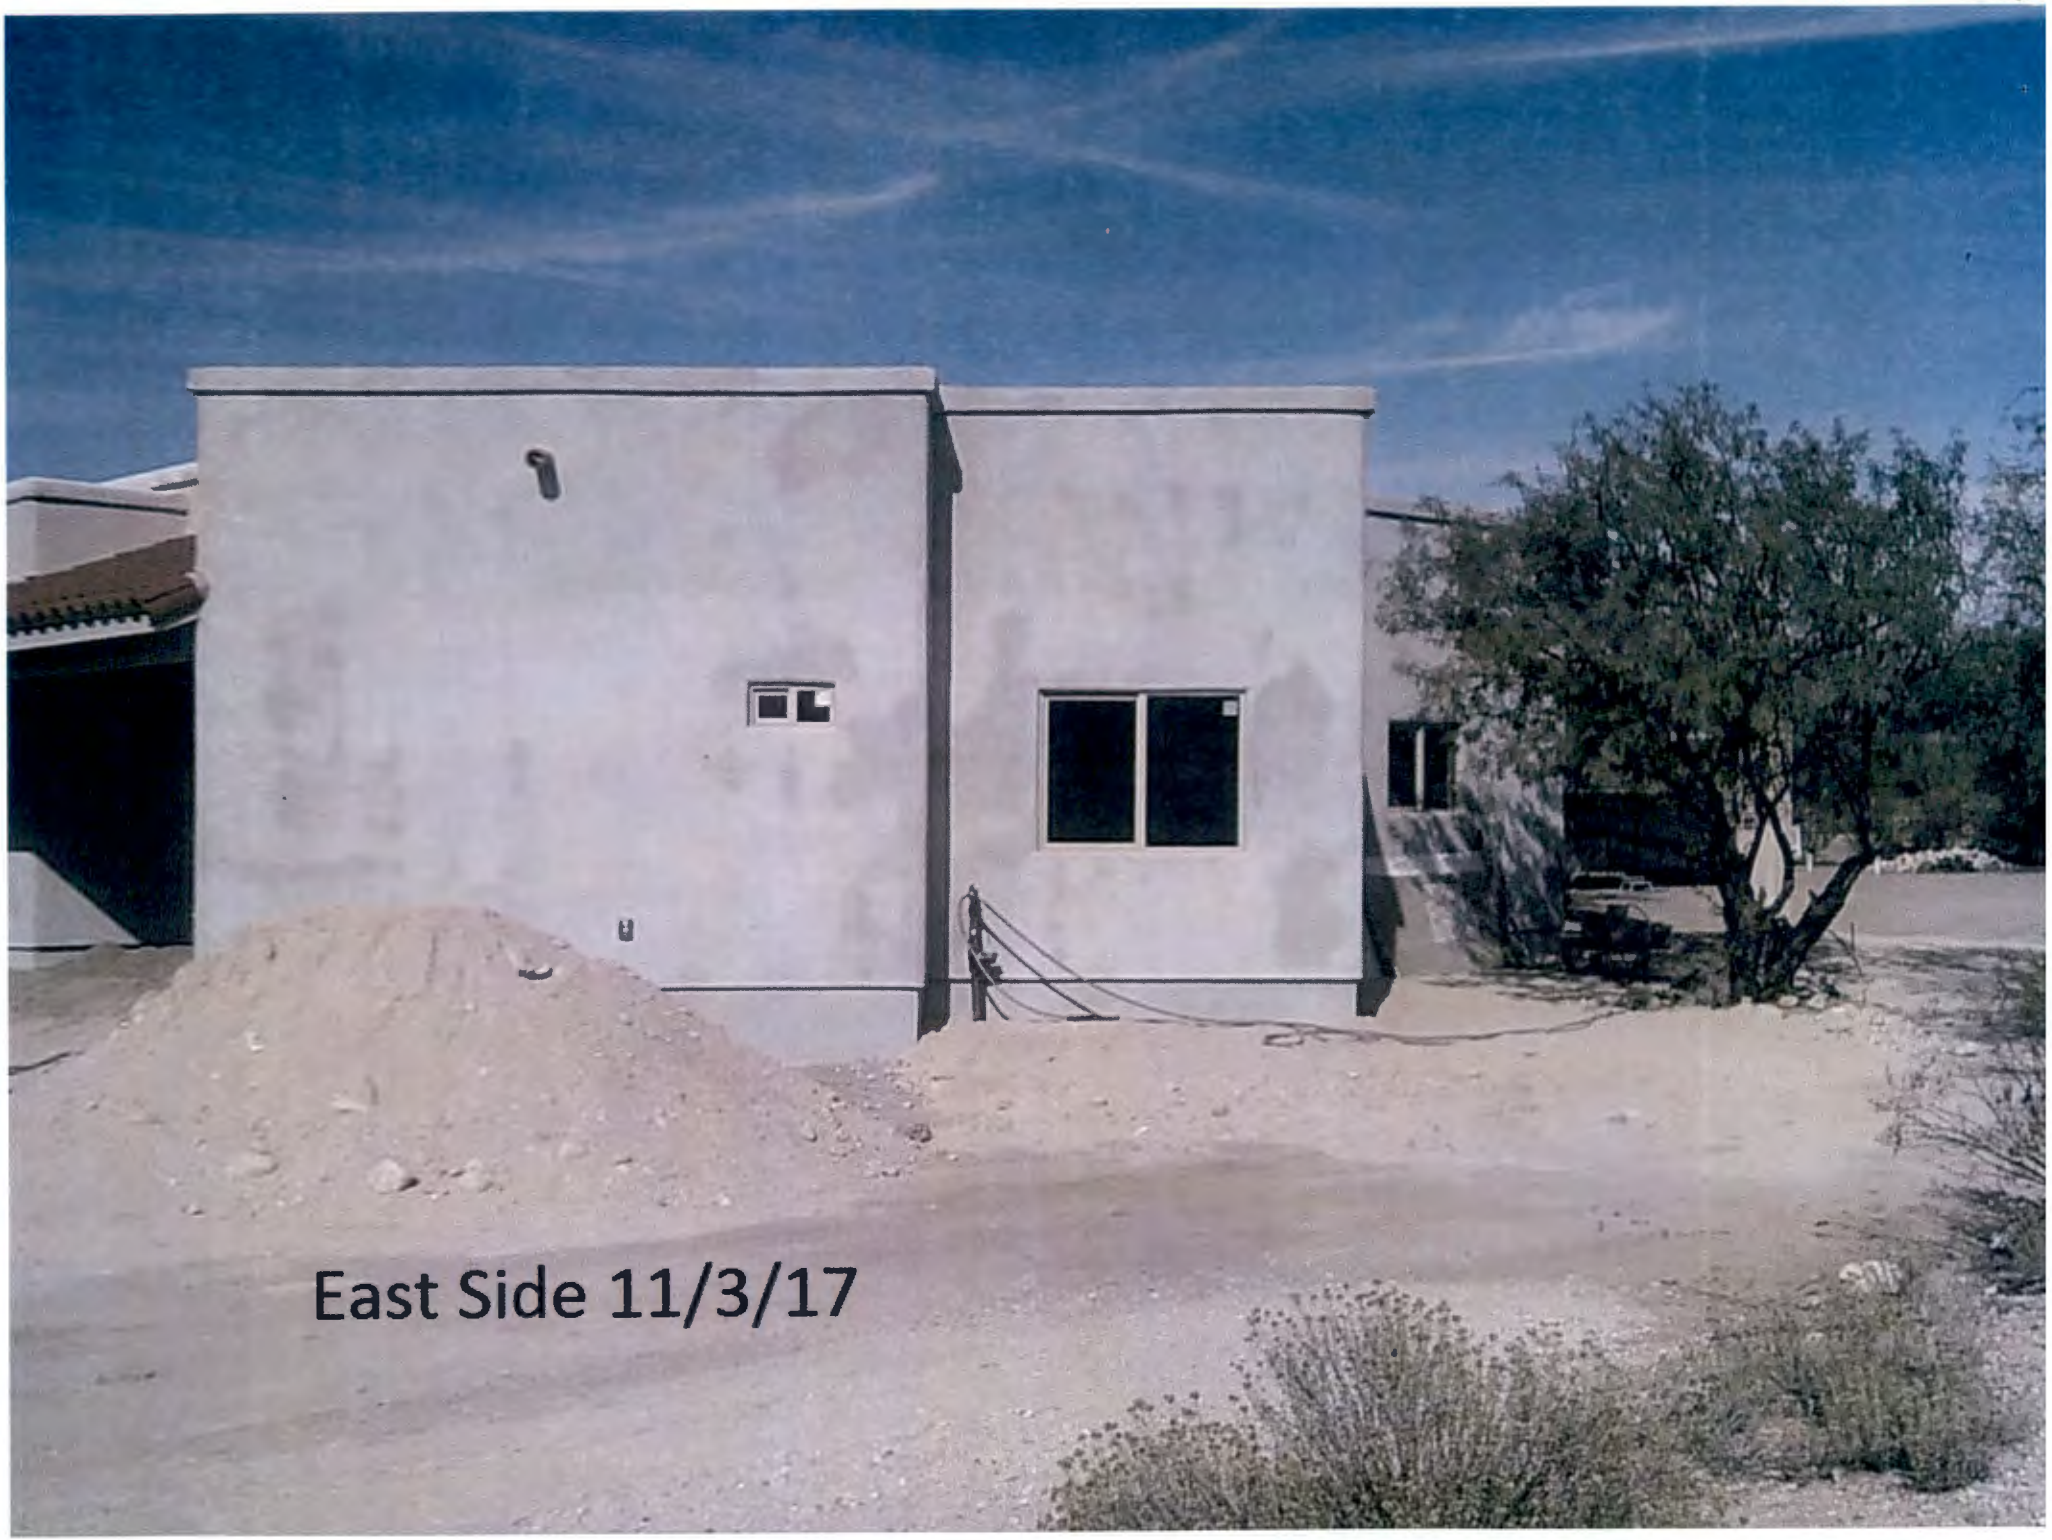
West Side 11/3/17

North Side 11/3/17
