**Santa Cruz River, Paseo de las Iglesias
Pima County, Arizona
Draft Feasibility Report**

**APPENDIX F
GEOTECHNICAL**

APPENDIX F
GEOTECHNICAL EVALUATION
FEASIBILITY REPORT
FOR
PASEO DE LAS IGLESIAS, FEASIBILITY STUDY
PIMA COUNTY, ARIZONA

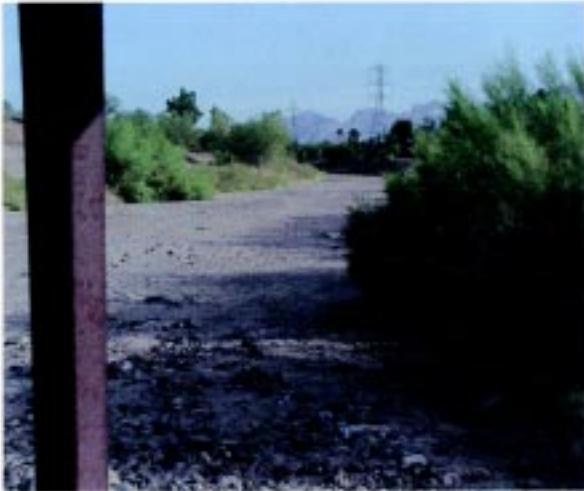
#1: Santa Cruz channel just S. of Congress

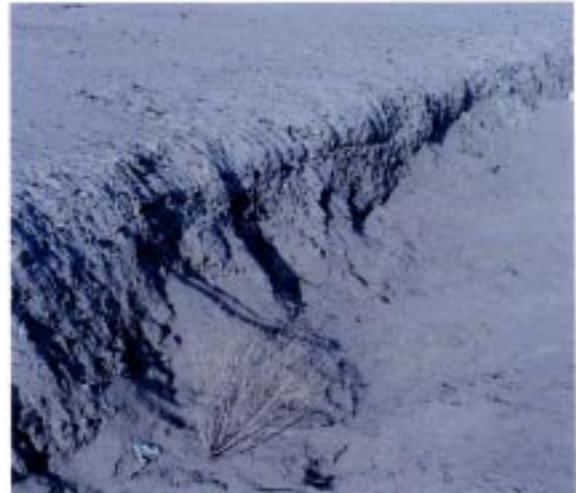
#2: Grade control structure S. of Congress
in the main channel

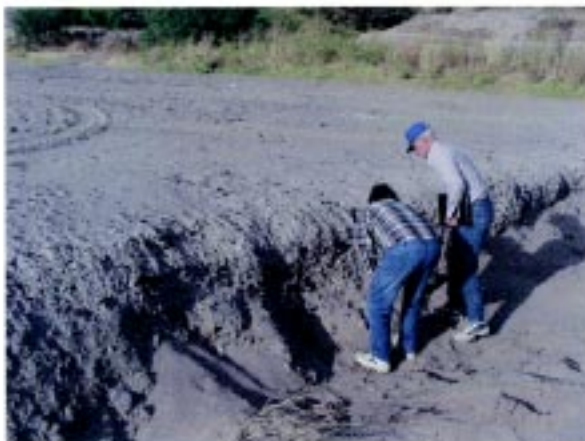
#3: Grade control structure S of Congress
in the main channel

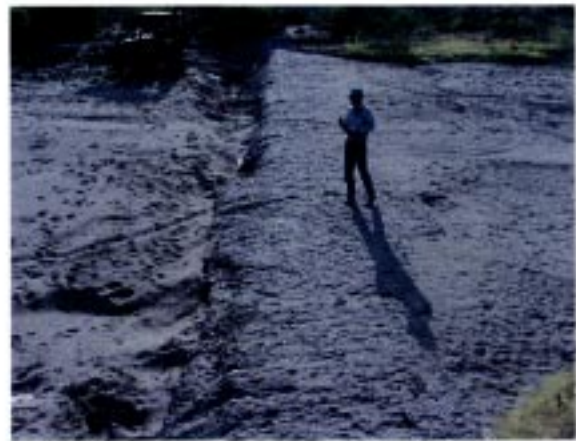
#4: Grade control structure S of Congress
in the main channel

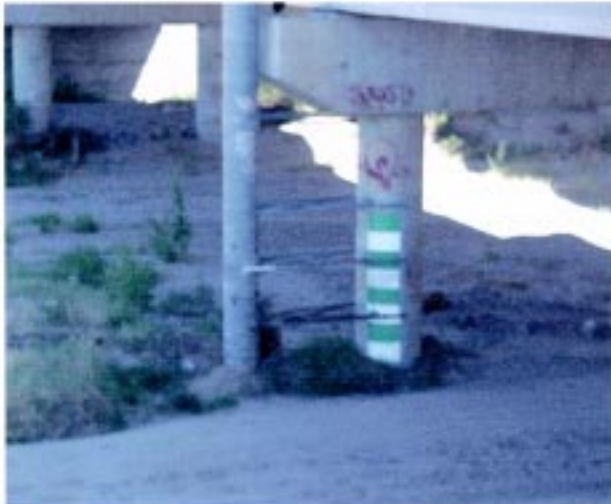
#20: Valencia Bridge

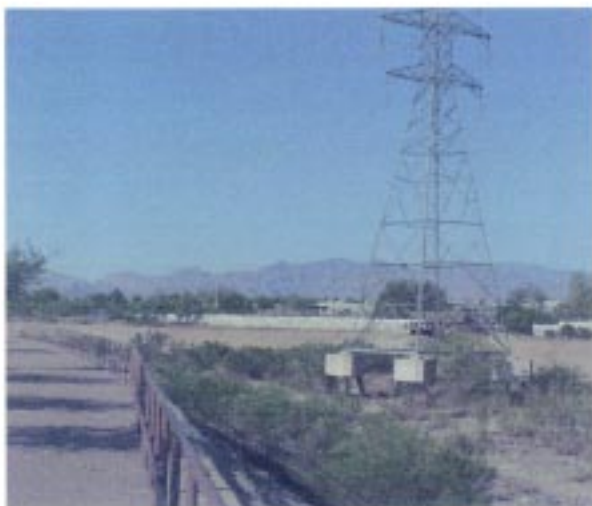
#22: Power pole base in Santa Cruz channel

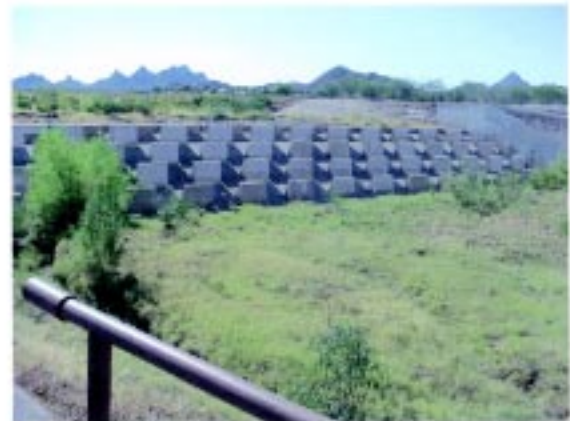
#27: Energy dissipation structure @ W. Branch just upstream of Santa Cruz River

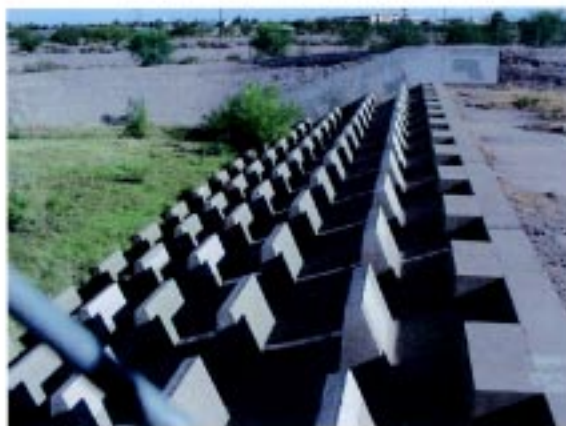
#28: Energy dissipators @ West Branch and Santa Cruz intersection (view to S)

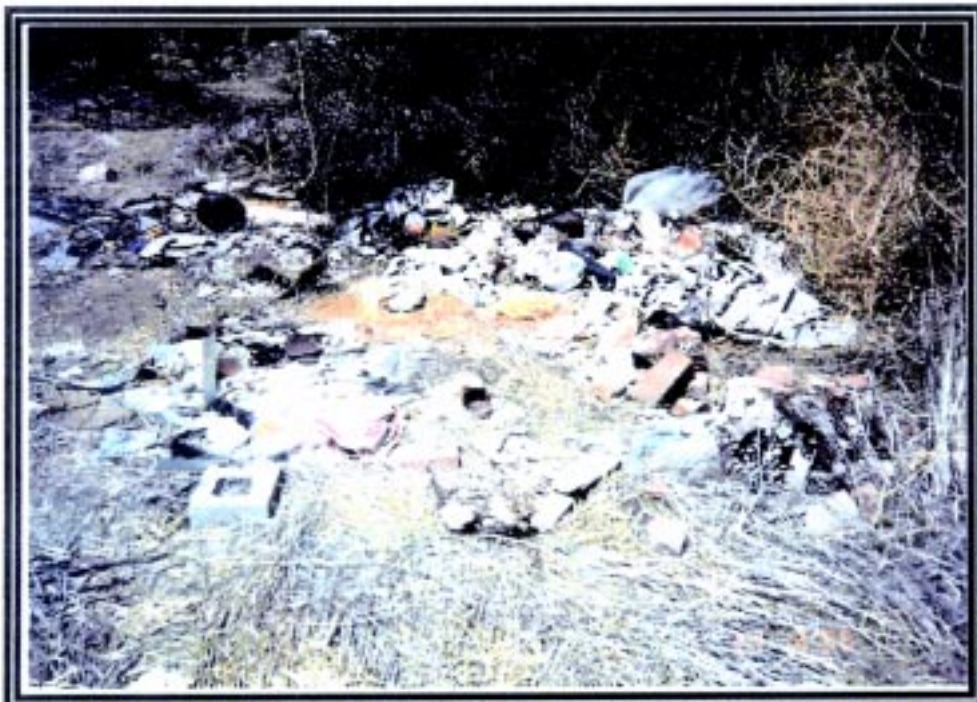
Field Description: This site consisted of a minor wildcat dump on a vacant lot with shallow drainages running approximately southeast-northwest and desert broom along with other vegetation. Waste seen on the surface included dirt piles, asphalt, rubber tires, office dividers, a few empty 55-gallon drums, one-gallon cans, carpet, concrete debris, paper, metal screening, aluminum foil, a plastic oil bottle, rusted cans, glass, plastic, cloth, brick, mattress springs, and a refrigerator. Photograph #3 shows an area of concentrated dumping in the center of the site. The waste on the rest of the site was more scattered. Access was available from Kroeger Lane. The surrounding land uses included vacant land to the west (Site 12), and residential areas to the east, south, and north.

Photograph 3. Wildcat dump in center of vacant lot at Site 13, view toward the northeast.

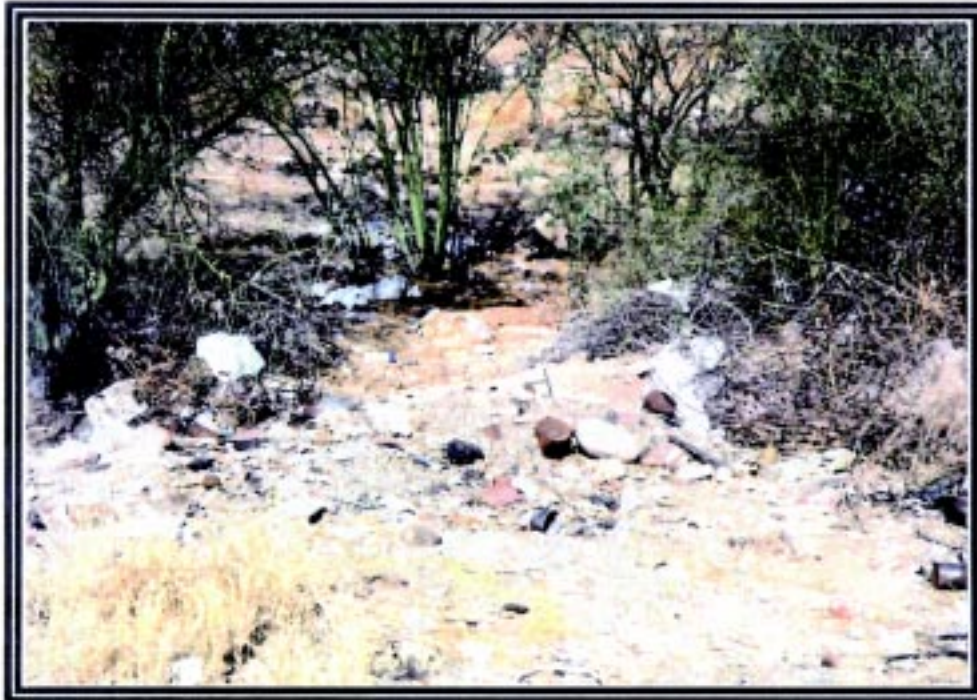
Photograph 2. Wildcat dump on surface of "A" Mountain Landfill at Site 11, view toward the southeast.

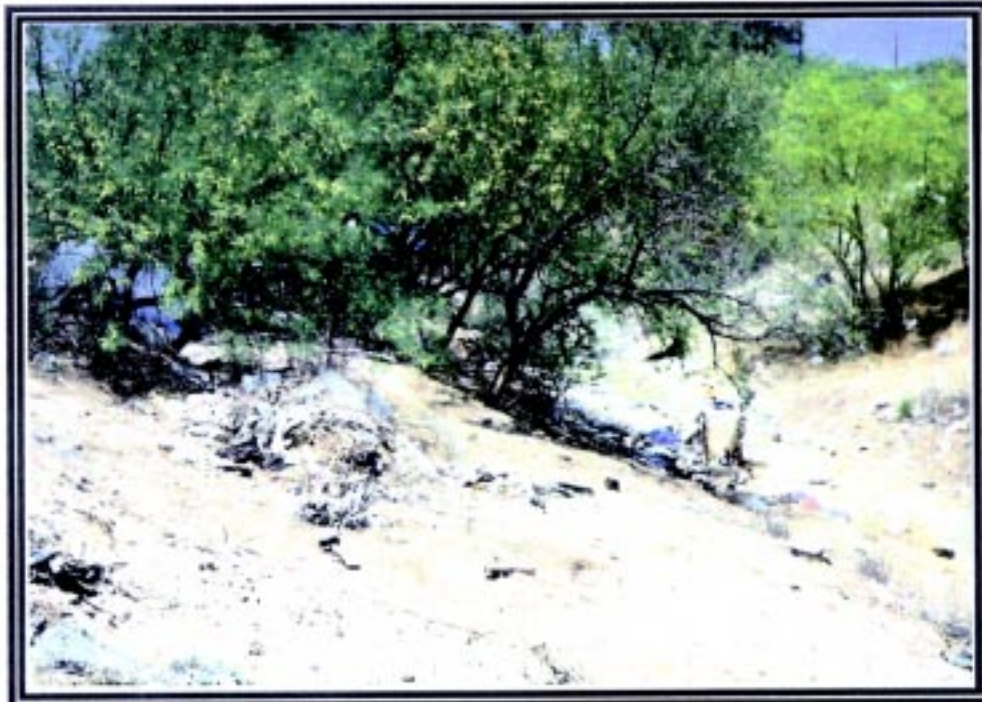
Field Description: This site consisted of a disturbed, vacant lot with a minor wildcat dump in a well-vegetated (mesquite and other trees and shrubs) drainage running north-south on the eastern edge of the site. The waste seen on the site included dirt piles, cardboard, cloth, old chairs, paper, plastic bags and bottles, glass, asphalt, cloth, and concrete debris. The waste was concentrated in, or near, the drainage. Photograph #4 shows an area along the western bank of the drainage that represented the concentration of surface material within the drainage. There were also a large number of plastic bags and paper products that were probably blown onto the site. Access was available from Kroeger Lane. The surrounding land uses included residential areas to the west and north, commercial areas (hotels) to the east, and 22nd Street and vacant land to the south. The litter may have originated from open, poorly maintained dumpsters located east of the site. Several homeless encampments were also seen on the site.

Photograph 4. Wildcat dump in drainage at Site 14, view toward the north.

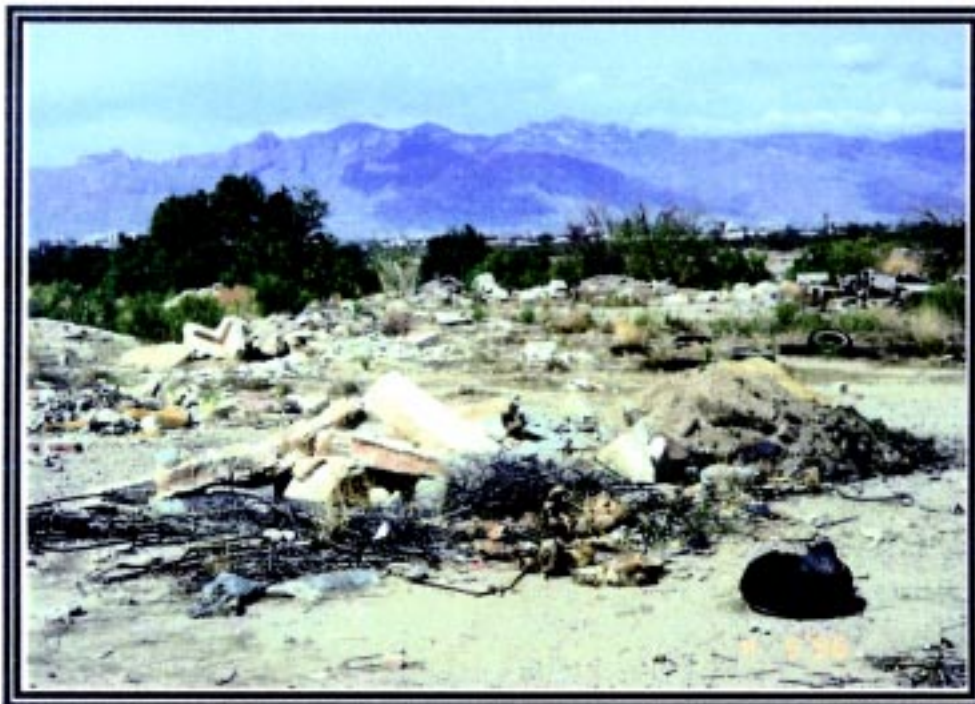
Field Description: This site consisted of a minor wildcat dump on a vacant lot, approximately 1/4 mile long and 200 feet wide, located on the west bank of the Santa Cruz River with desert broom and grasses. The waste seen on the site included piles of concrete debris, metal, rubber tires, glass, brick, oil filters, dirt and a washing machine. Photograph #6 shows an area of concentrated dumping, in the foreground, located in the center of the site. The waste on the rest of the site was more scattered, such as the waste in the background of the photograph. Access was available from dirt paths off Cottonwood Lane. The surrounding land uses included the river with no bank protection on the east, a gravel pit to the north, and residential areas to the west and south.

Photograph 6. Wildcat dump at Site 23, view toward the north.

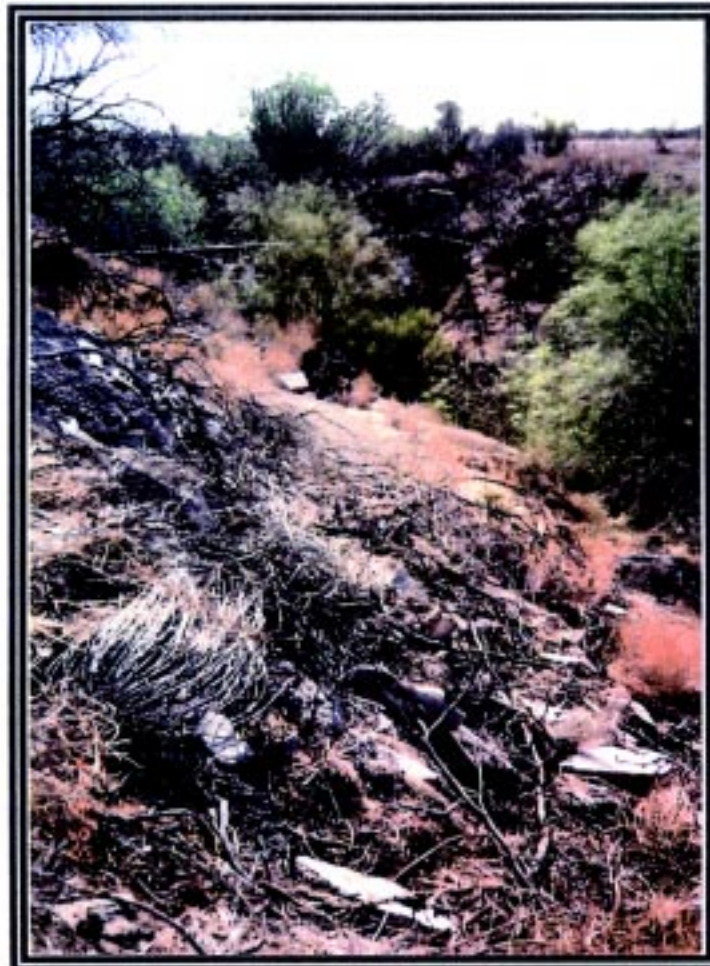
Field Description: This site consisted of a minor wildcat dump in a drainage east of the Santa Cruz River. The waste seen on the site included piles of green waste, concrete debris, bricks, cans, bottles, and empty 55-gallon drums. Photograph #7 shows an area of concentrated dumping along the northern bank of the drainage. The waste on the rest of the site was more scattered. Access was available from the empty lot located south of Michigan Street on the northern side of the drainage. The surrounding land uses included vacant land, residential land, and a Tucson Water well to the north (#SS-12); residential land to the east; vacant land to the south; and recreational park to the west.

Photograph 7. Wildcat dump in drainage at Site 27, view toward the east.

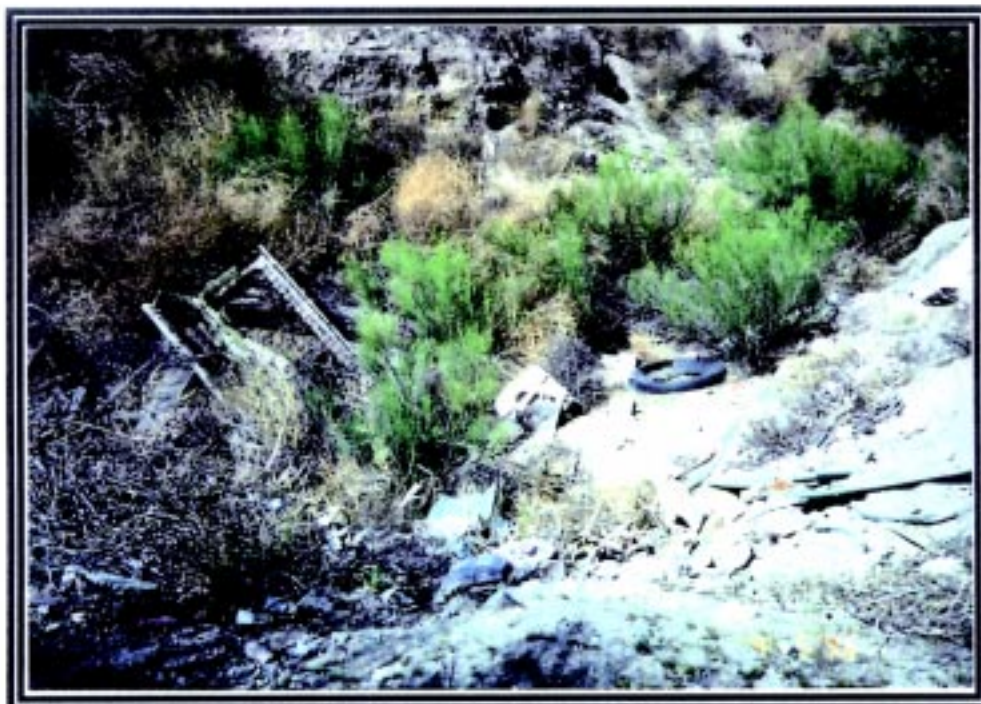
Field Description: This site consisted of a major wildcat dump along the edge of a vacant lot. It encompassed two drainages and the intervening section of river bank on the east side of the Santa Cruz River. The disposal area was located a few hundred feet west of Calle Santa Cruz and was hidden from the road by trees and bushes. The dump appeared to have been primarily on the surface, not buried. The drainage on the southern edge of the site contained piles of wood, brick, carpet, towels, tiles, metal, clothing, asphalt, rubber tires, and shoes. Brick, concrete debris, miscellaneous scrap metal, and wood piles were identified along approximately 200 feet of the river bank down to the river bed. Photograph #8 shows an area of dumping in the southern drainage that indicates the density of waste in that drainage. Photograph #9 shows the representative concentration of waste on top of the wildcat dump. The drainage north of the site was clean, except for a buried tire and concrete debris with rebar protruding from it. Access was available from Calle Santa Cruz into the vacant lot and recent tire tracks were observed in a large cleared area east of the bank. The surrounding land uses included vacant lots to the north and south, the river with no bank protection to the west, and a commercial and industrial area to the east.

Photograph 8. Drainage at southern edge of wildcat dump at Site 34, view toward the southwest.

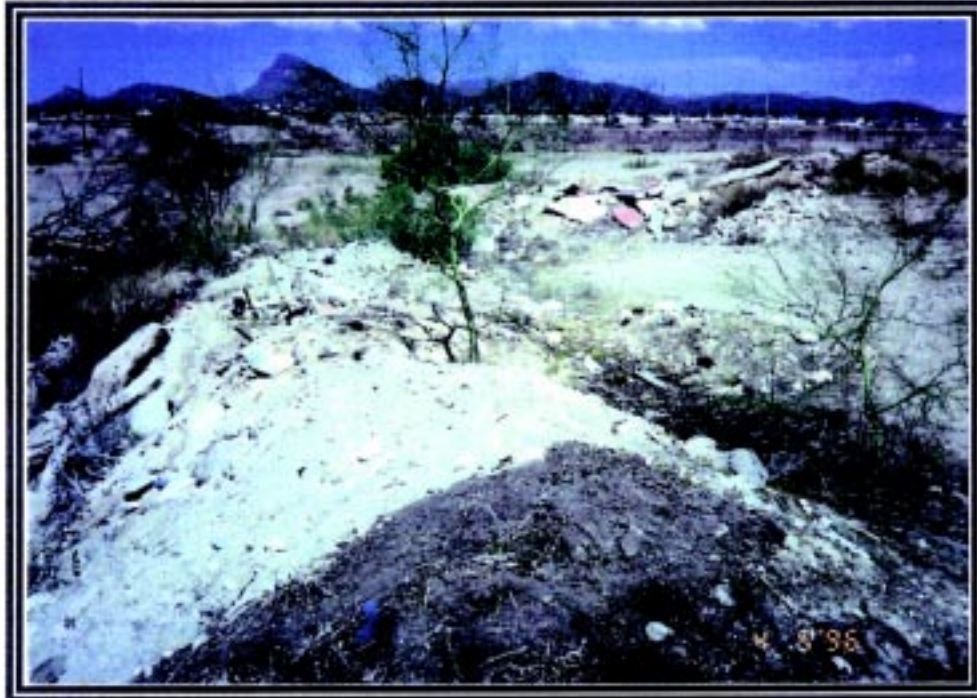
Photograph 9. Piles of dirt and concrete debris along the western perimeter of a wildcat dump directly east of Santa Cruz River at Site 34, view toward the west-northwest.

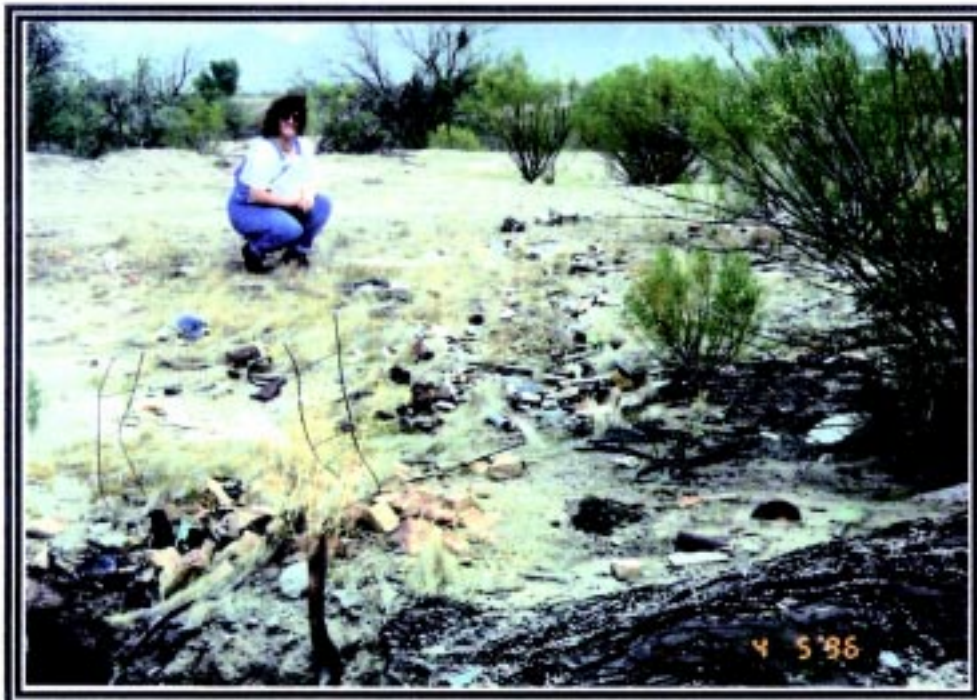
Field Description: This site consisted of a vacant lot, measuring approximately 1/3 mile long by 250 feet wide, containing three waste disposal areas that constitute a major wildcat dump. At the southern end of the site, PAG observed a pile of carpet, wood, metal pipes, tiles, cardboard, and rubber. Farther to the north, tarps, cardboard, motor oil cans, carpet, WD40 spray cans, rubber tires, anti-freeze, and scrap metal were identified. At the northern end of the site, an old, partially-buried wildcat dump was seen beside, and within, a tributary drainage of the Santa Cruz River. The waste was identified in an area measuring approximately 200 feet-by-100 feet, and consisted of rusted cans, old shoes, glass, wood, concrete and asphalt debris, rubber tires, plastic, rubber, bedsprings, cloth, and aluminum foil. Photograph #10 shows an area with a concentrated amount of waste in the center of the site. Natural runoff processes may have contributed to the burial of the trash. Access to these sites was available from Valencia Road, via dirt trails large enough for vehicles. The surrounding land uses included a residential area, a hospital, and a minor drainage to the west, the river with bank protection to the east, and vacant lots to the north and south.

Photograph 10. Wildcat dump at Site 37, view toward the northwest.

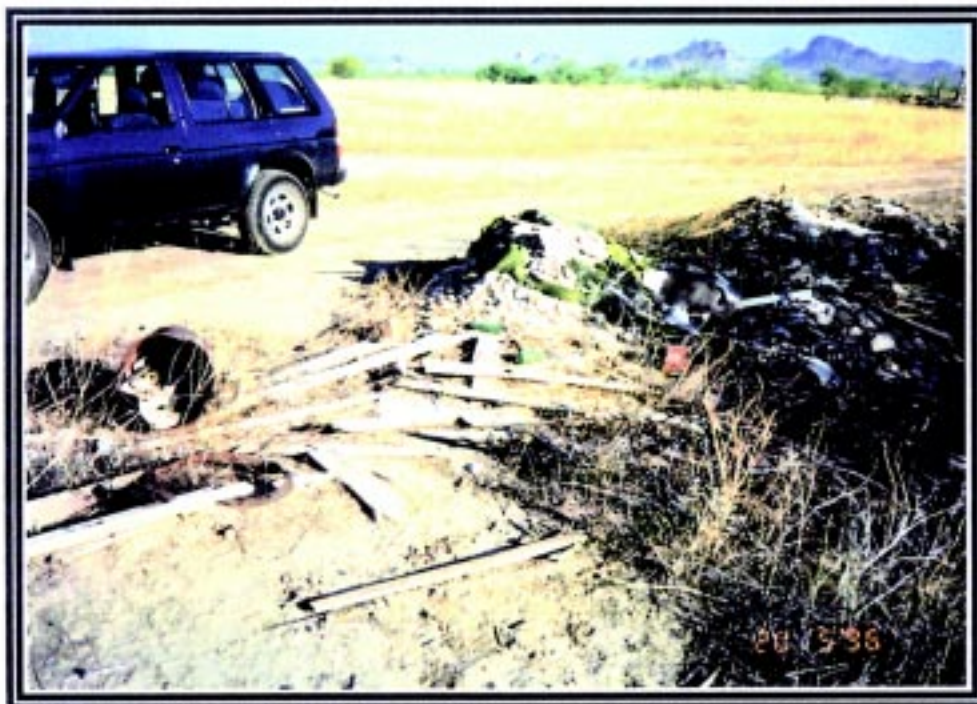
Field Description: This site contained a major wildcat dump within a drainage and a 300-foot section (approximate) of the river bank. Most of the drainage was essentially clean. The site was located directly west of the Santa Cruz River approximately one mile north of

San Xavier Loop Road, and had mesquite and palo verde trees and grasses. The material seen on the site included piles of asphalt, bricks, scrap metal strips, roofing materials, a paint can, rubber tires, an old car, old corrugated pipes, glass, an old water heater, old stoves, carpet, concrete debris, metal cans, wire, a 5-gallon can of roof cement, an empty 55-gallon metal drum, and wood. Photograph #11 shows an area on the eastern edge of the site containing more concentrated waste than the rest of the wildcat dump. Access was available from Oidak Wo:g. The surrounding land uses included abandoned farmland to the north, west, and south, and the Santa Cruz River with minor bank protection to the east.

Photograph 11. Wildcat dump at Site 48, view toward the southwest.

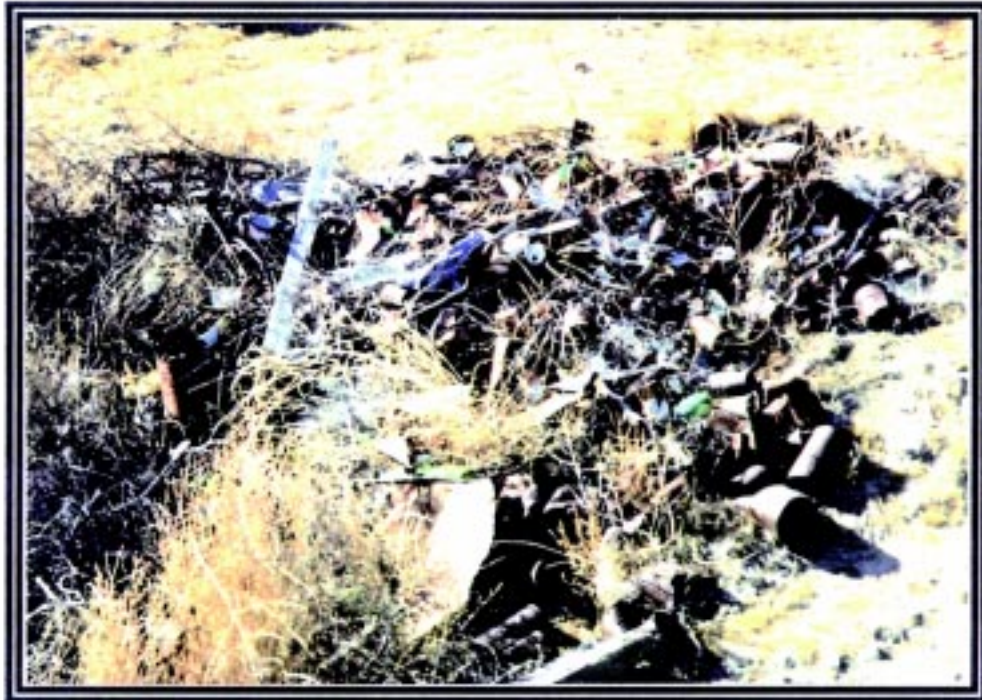
Field Description: The site consisted of a minor wildcat dump on a portion of the river bank east of I-19 and along the west bank of the Santa Cruz River. The waste seen at this site included glass bottles, plastic cups, 12-pack beer boxes, aluminum beer cans, wire, oil filters and cans, as well as partially buried metal cans, rubber and rubber tires. Photograph #12 shows waste in the center of the site that is more concentrated than the waste on the rest of the site. Access was available from the eastern terminus of Campus Drive. The surrounding land uses included abandoned farmland to the west, natural desert to the north and south, and the Santa Cruz River with no bank protection to the east.

Photograph 12. Wildcat dump at Site 52, view toward the southeast.

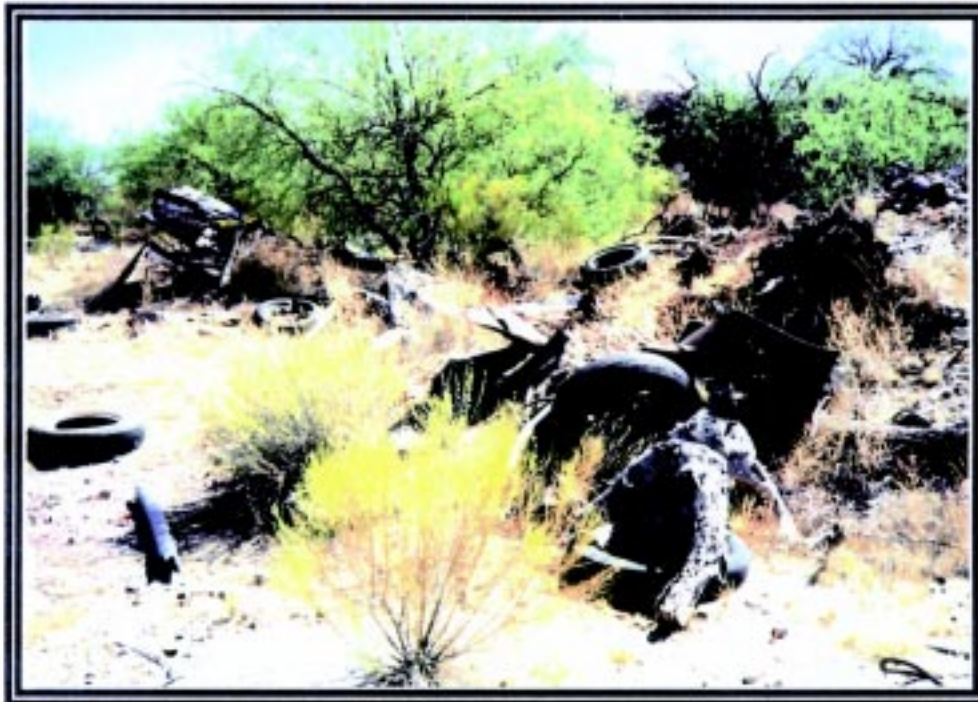
Field Description: The site consisted of a major wildcat dump on a portion of the river bank along the east side of the Santa Cruz River with mesquite and palo verde trees, desert broom, and grasses. The waste seen on the site included mainly intact and partially-buried old cars possibly dating from the 1940's; there were also piles of wire, wood, metal cans, metal springs, rubber tires, a muffler, rebar, dirt, glass, oil filters, concrete blocks, a car bench seat, and a vehicle gas tank. Photograph #14 shows piles of waste on the eastern edge of the site that were representative of the waste on the rest of the site. Access was available from two dirt roads directly west of I-19 and directly north of San Xavier Loop Road. The surrounding land uses included the Santa Cruz River with riprap bank protection to the west, north, and south, and vacant land and I-19 to the east.

Photograph 14. Wildcat dump at Site 57, view toward the northeast.
