**TECHNICAL DATA NOTEBOOK  
FOR**

**Camino Real Wash,  
Pima County, AZ**

**Contract #25-59-C-13522-0507**

**Prepared For:  
Pima County Regional Flood Control District  
97 E. Congress, 3<sup>rd</sup> Floor  
Tucson, AZ 85701**

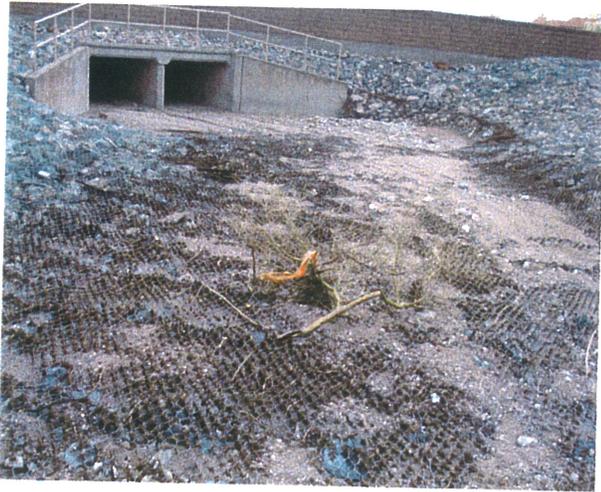
East Upstream Inlet (Looking Downstream)

On July 28, 2007 a severe storm hit the Camino Real Wash Watershed. While the Camino Real Wash watershed is not gauged, adjacent watershed gages indicated that 2.52" of rain fell (2 inches of that occurred in a two hour period). The following pictures show the aftermath of the storm and substantiate that sedimentation is not a problem as the improvements have sufficient capacity to convey the sediment supply.

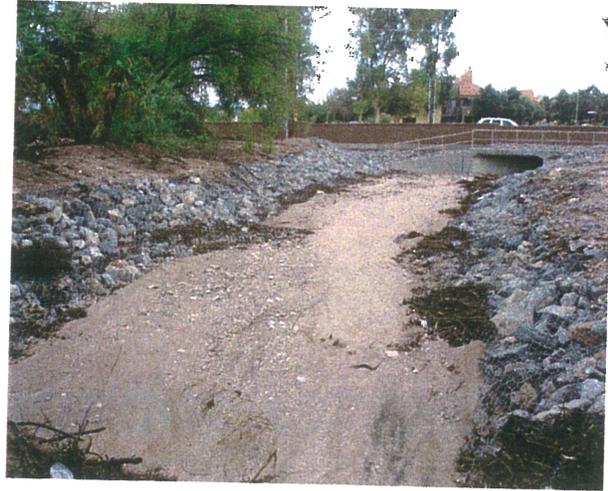
West Upstream Inlet (Looking Downstream)

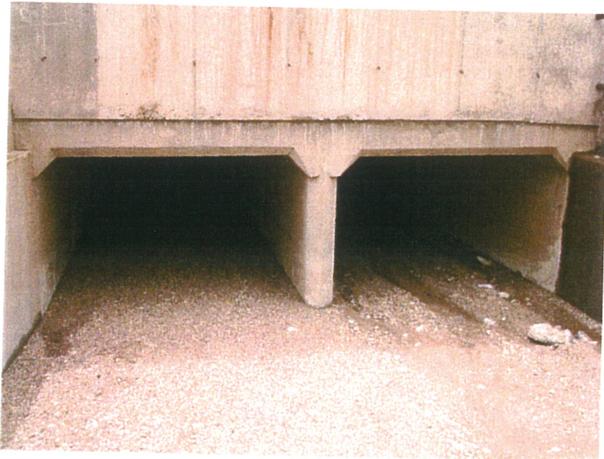
East Upstream Outlet (Looking Upstream)

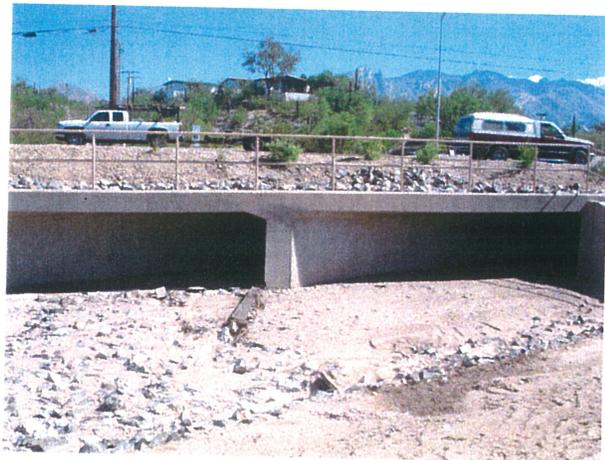
West Upstream Outlet (Looking Upstream)

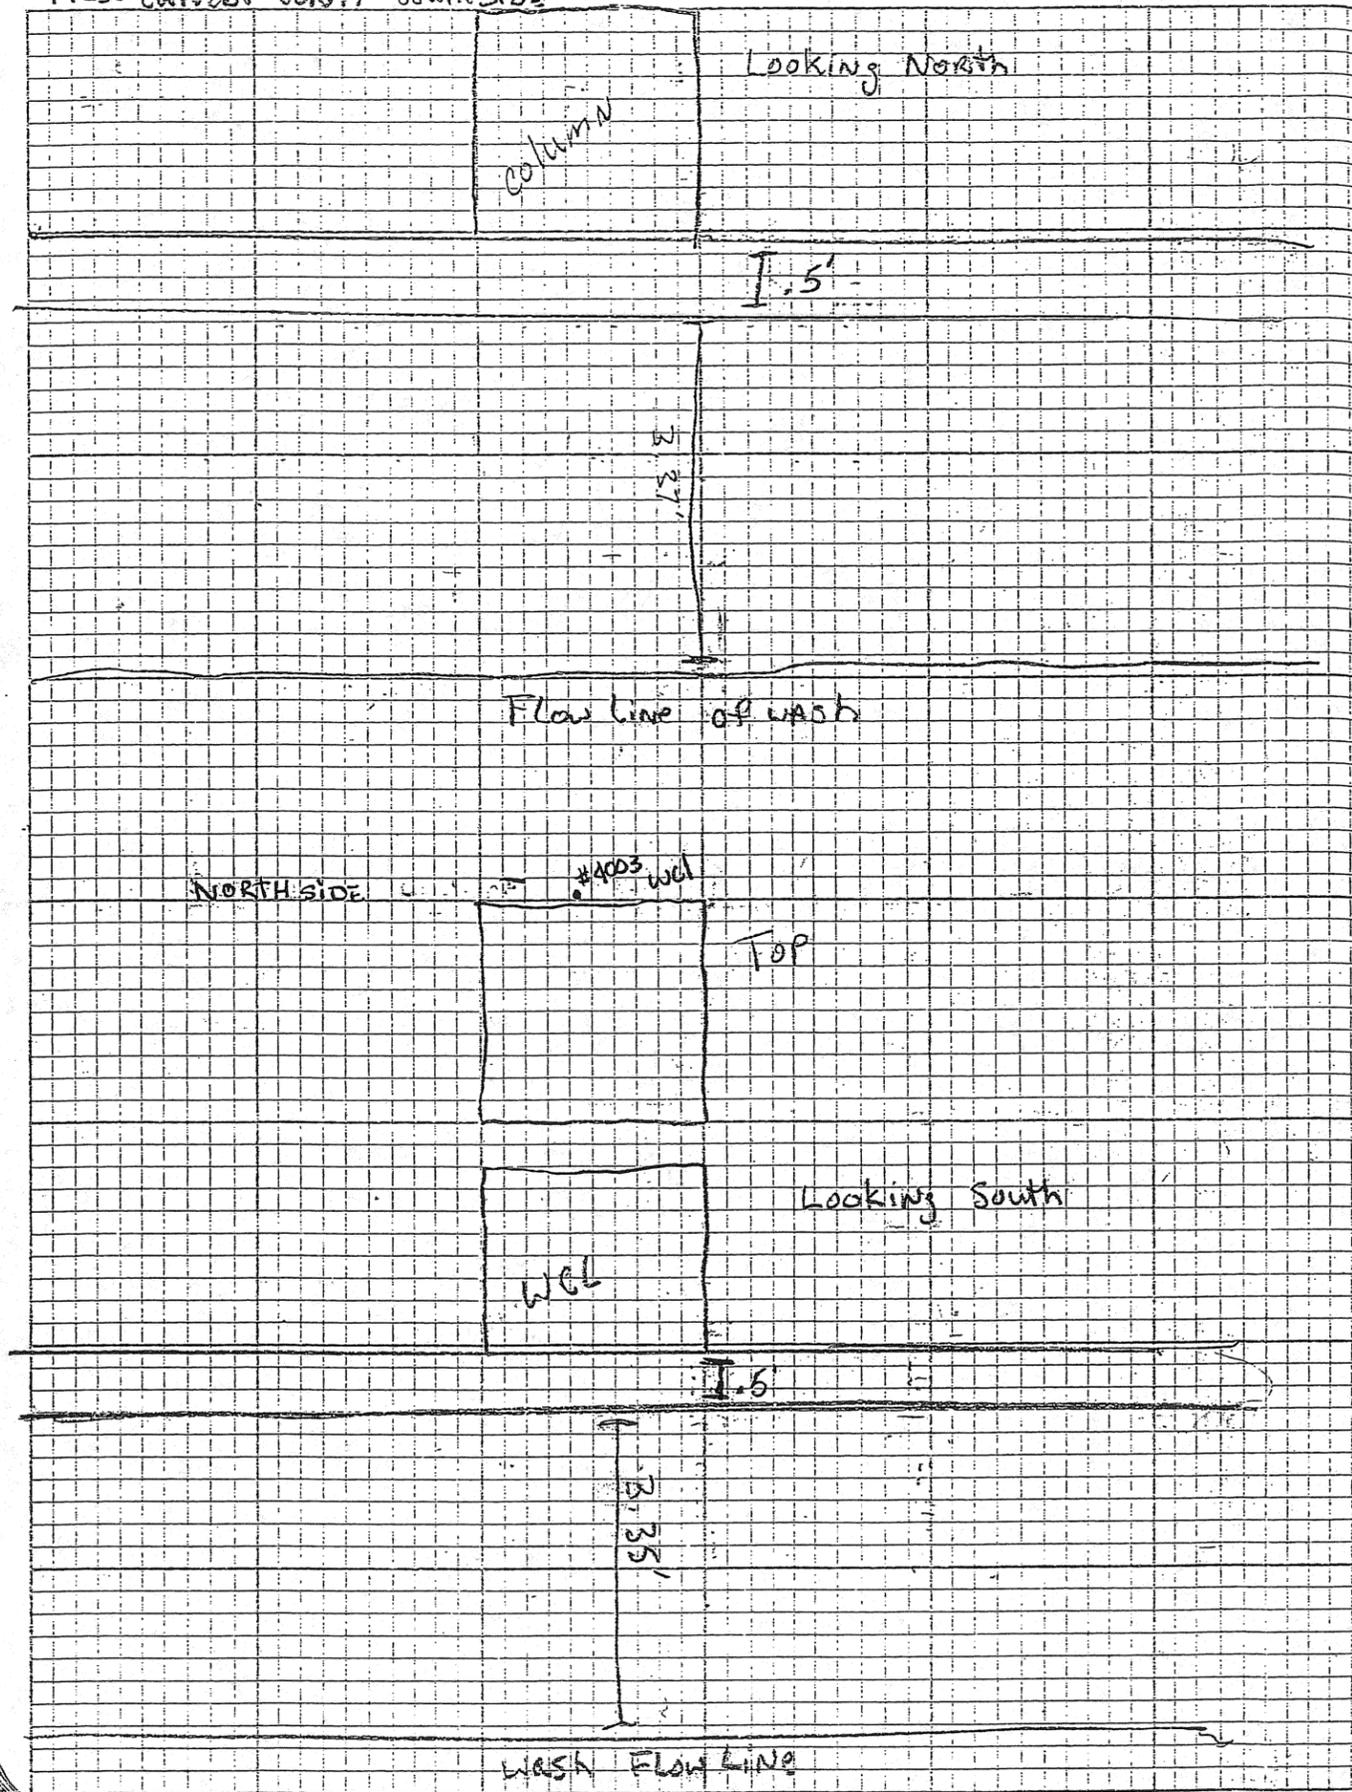
Second Culvert south side

Top View

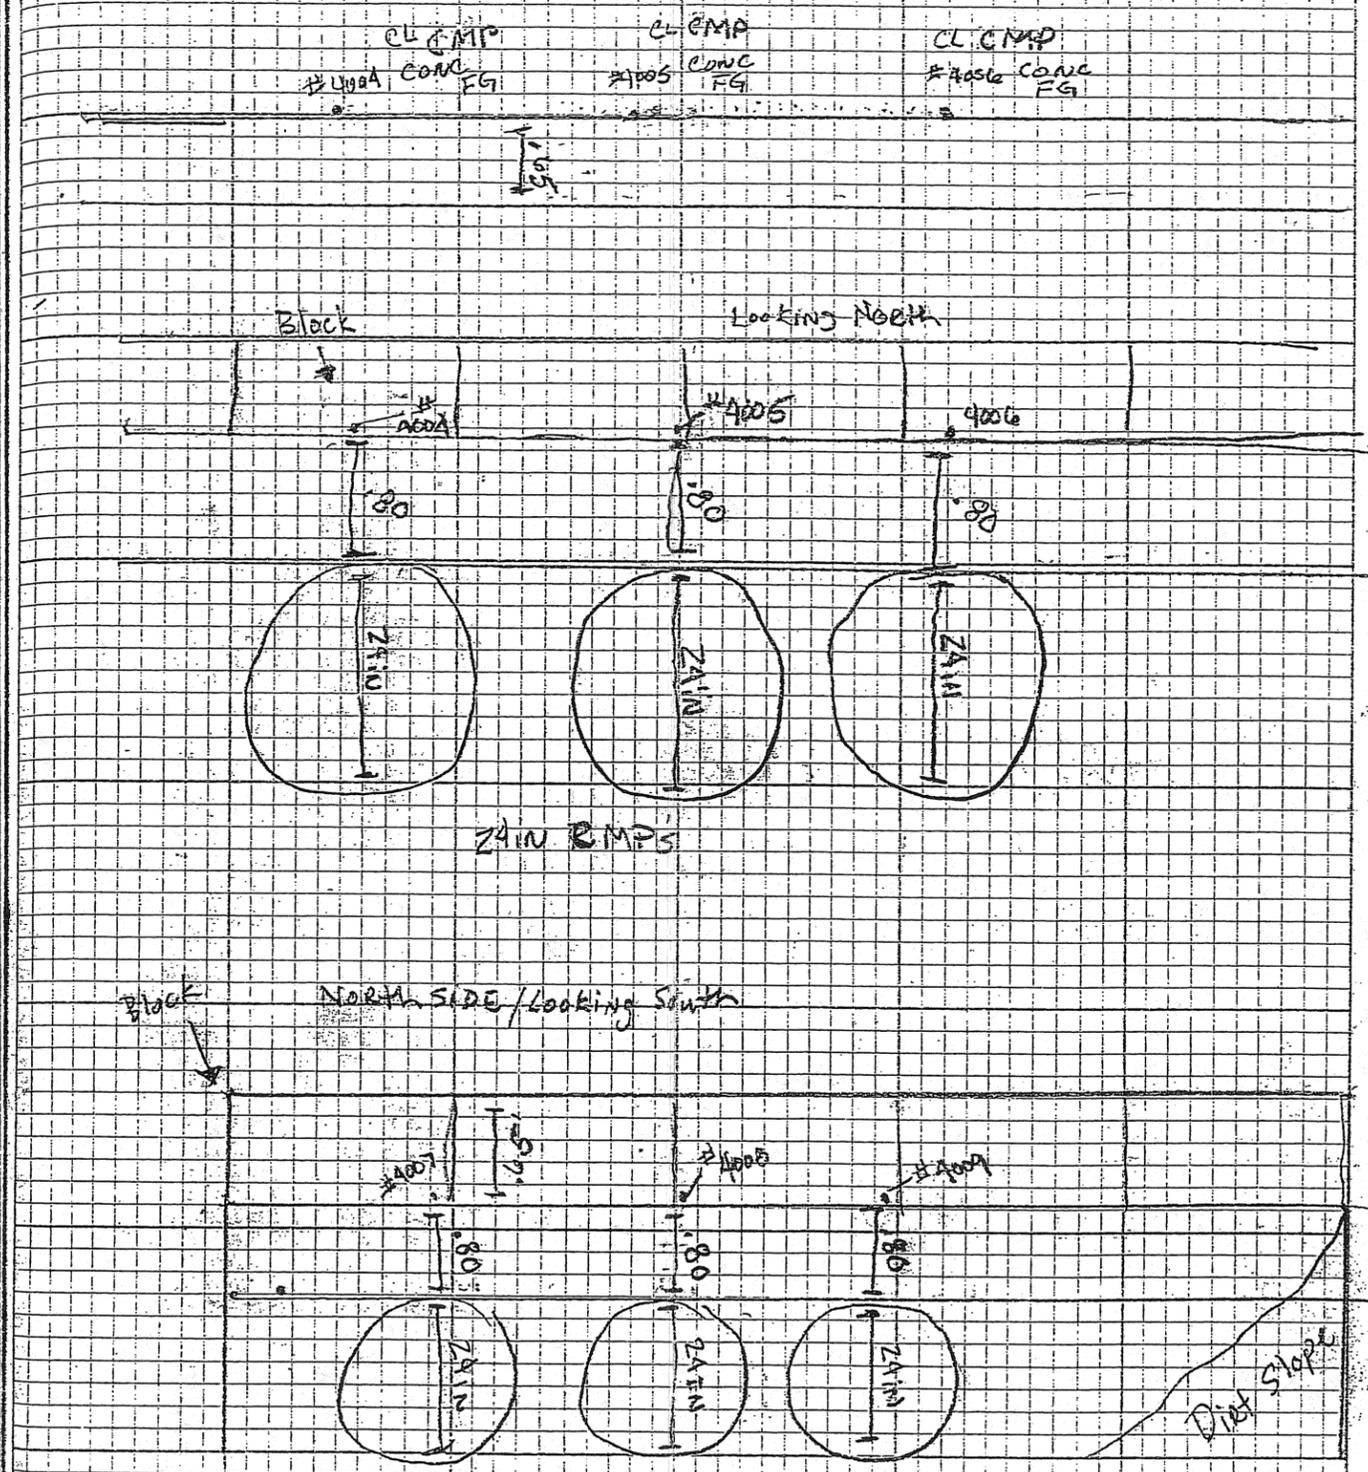
Third culvert southside

Looking North

Block

Gravelled

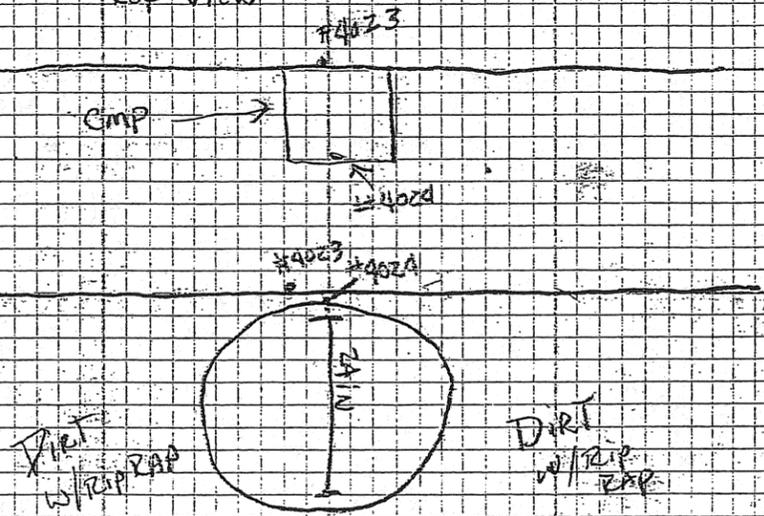
CMP Starts @ North side steps 1/2 way under driveway and connects to steel pipe

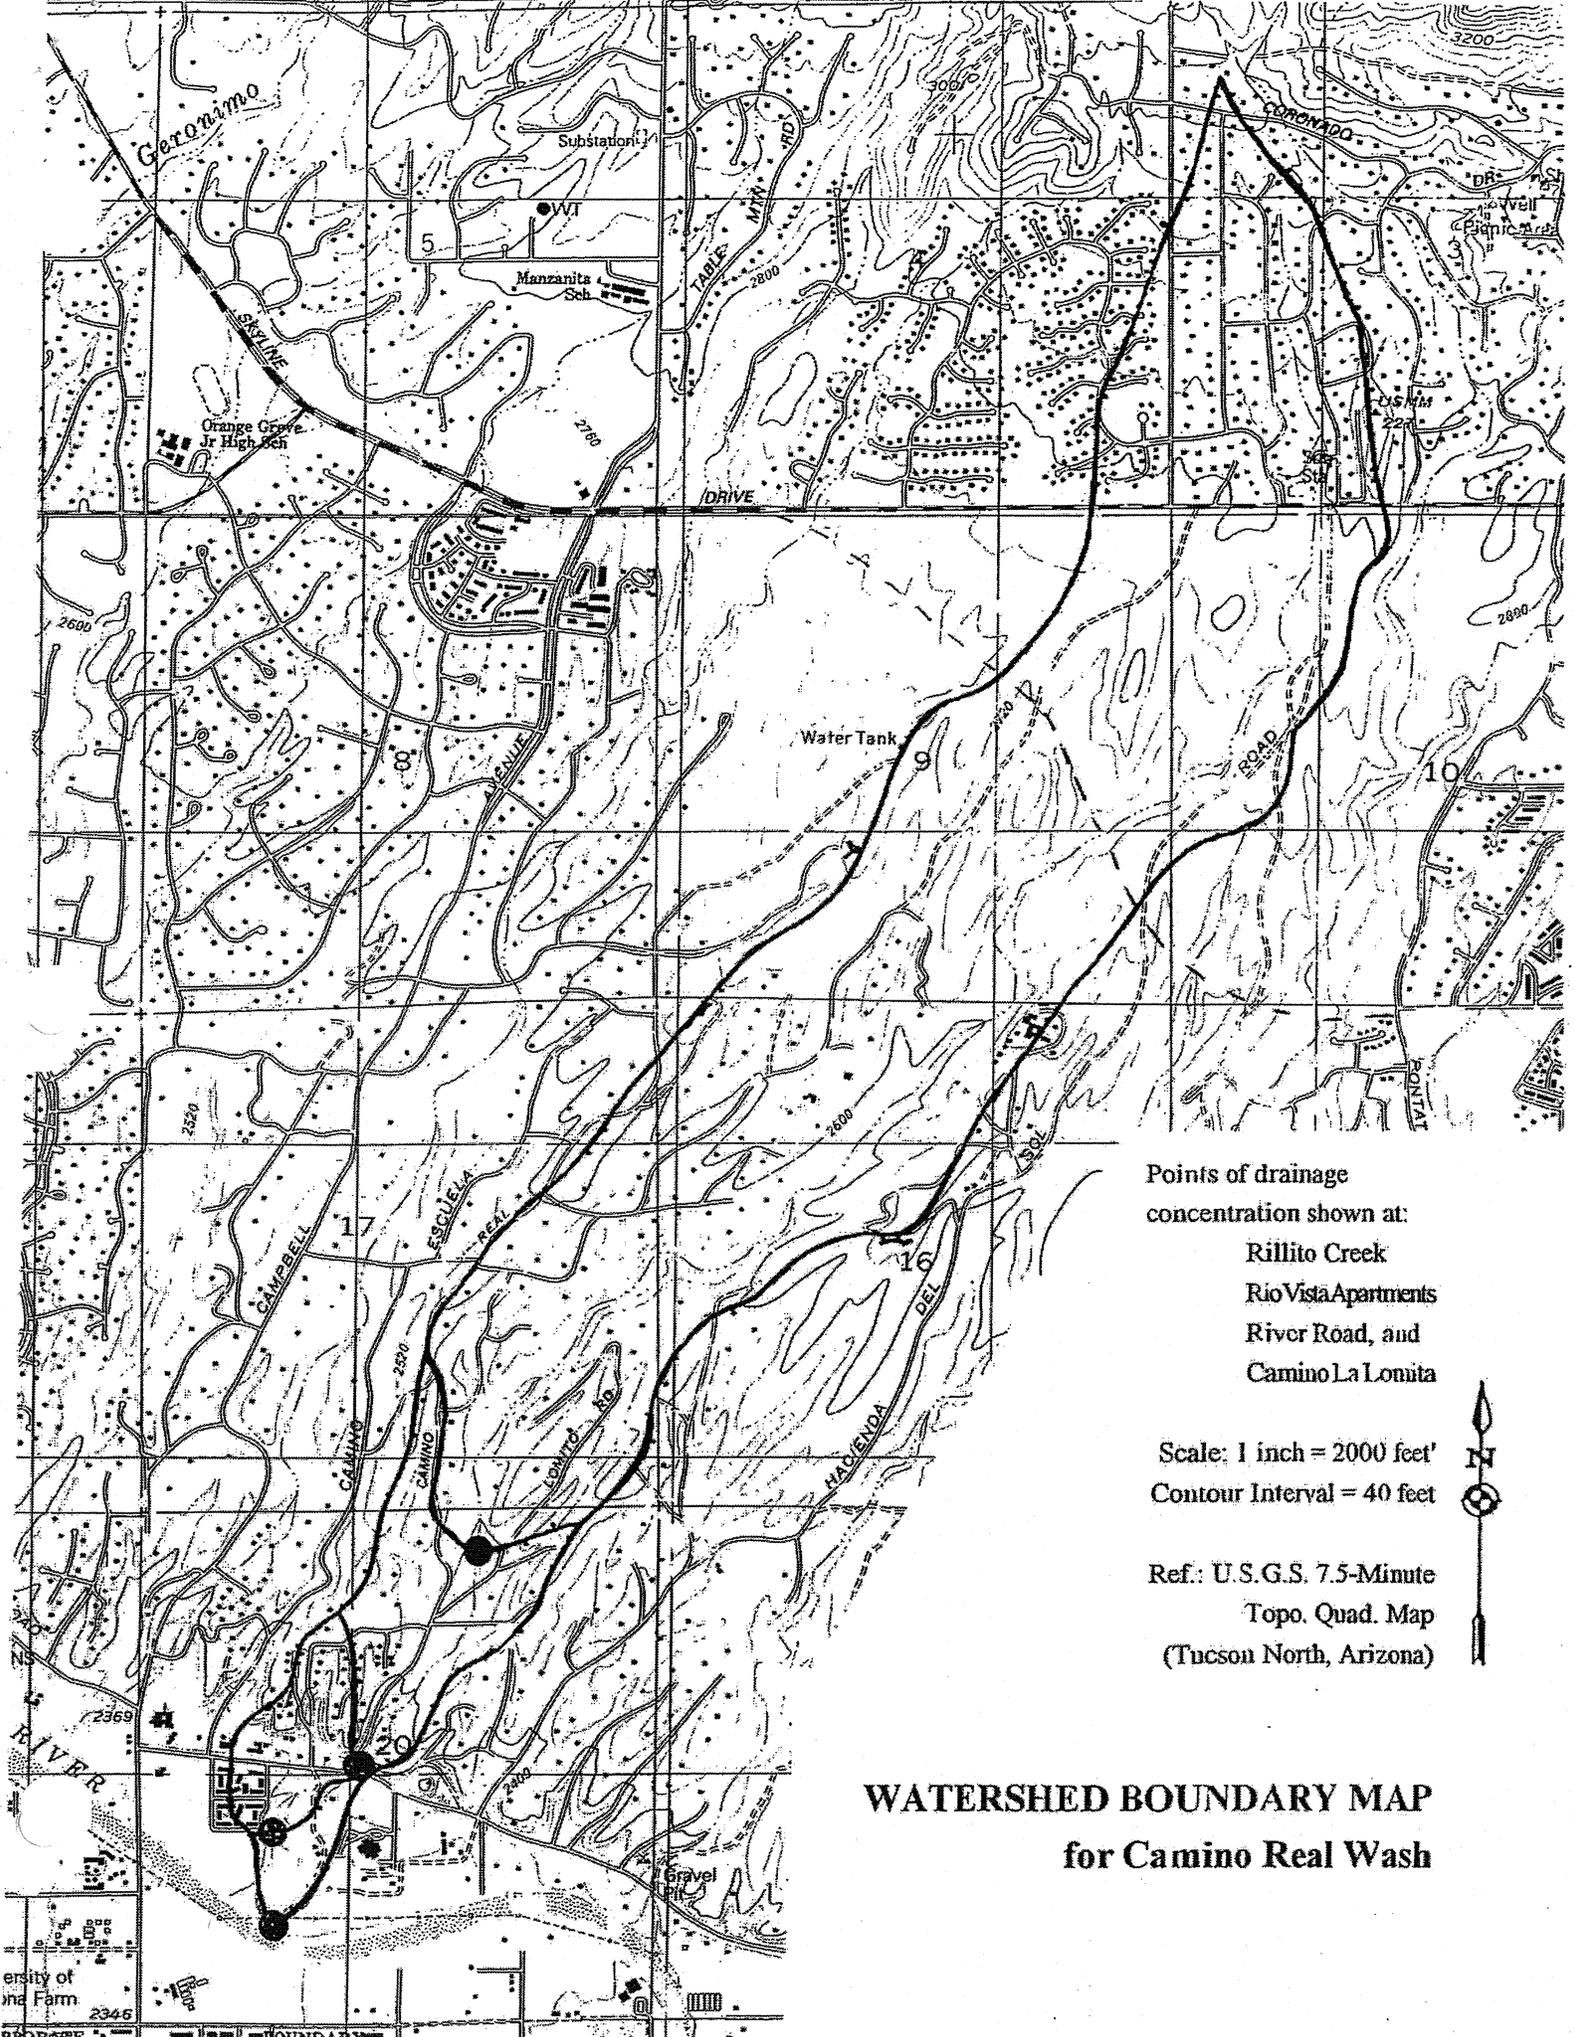
Points of drainage  
concentration shown at:  
Rillito Creek  
Rio Vista Apartments  
River Road, and  
Camino La Lonita

Scale: 1 inch = 2000 feet'  
Contour Interval = 40 feet

Weighted Runoff Coef. (Cw): 0.637  
 Time of Concentration: 55.0 min  
 Rainfall Intensity (i) @ Tc: 2.75 in/hr  
 Runoff Supply Rate (q) @ Tc: 1.75 in/hr  
**PEAK DISCHARGE:** 1,955.8 cfs

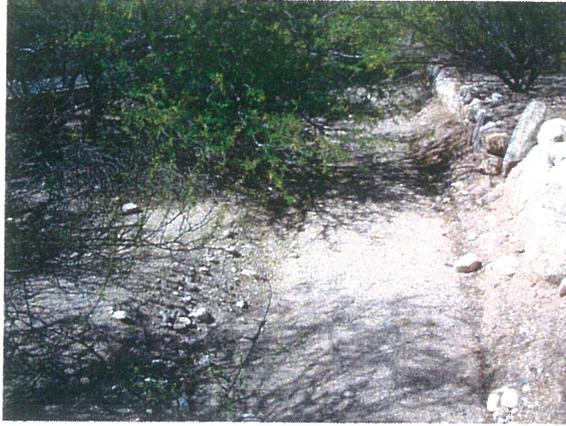
Exhibit 1: Camino Real West Channel  
Looking Upstream

Manning’s Roughness coefficients were estimated using the Table 8.1: Manning’s Roughness Coefficients in the ‘Standards Manual for Drainage Design and Floodplain Management In Tucson, Arizona’ December, 1989 (Revised July, 1998). The method to determine Manning’s Roughness was observation and analysis of aerial photos provided by Pima County, along with field visits to verify findings. Photos were taken to show field conditions of the Camino Real Wash. For all cross-sections that were established in the CLOMR by Castro Engineering, the Manning’s roughness value was maintained.

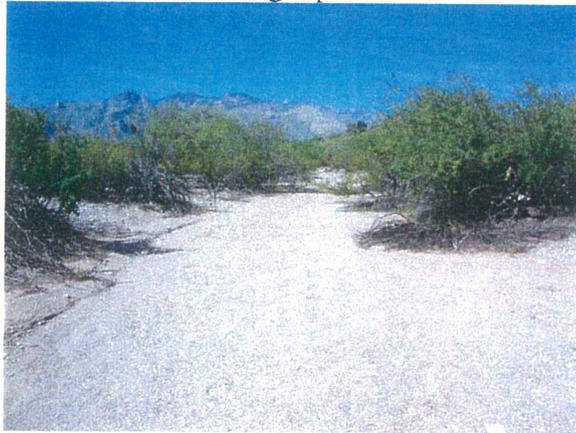
Exhibit 2: Camino Real Upstream Reach  
Looking Upstream

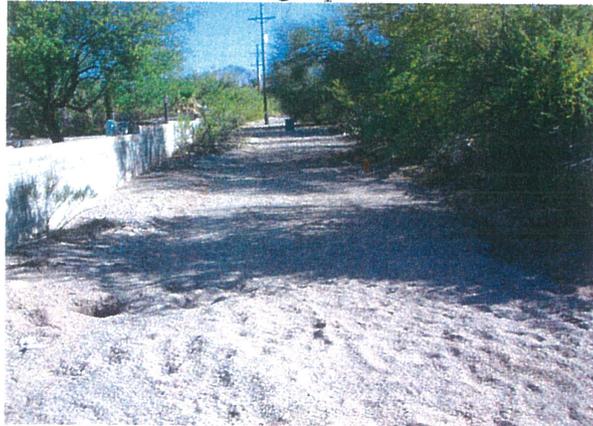
Exhibit 3: Camino Real East Channel  
Looking Upstream

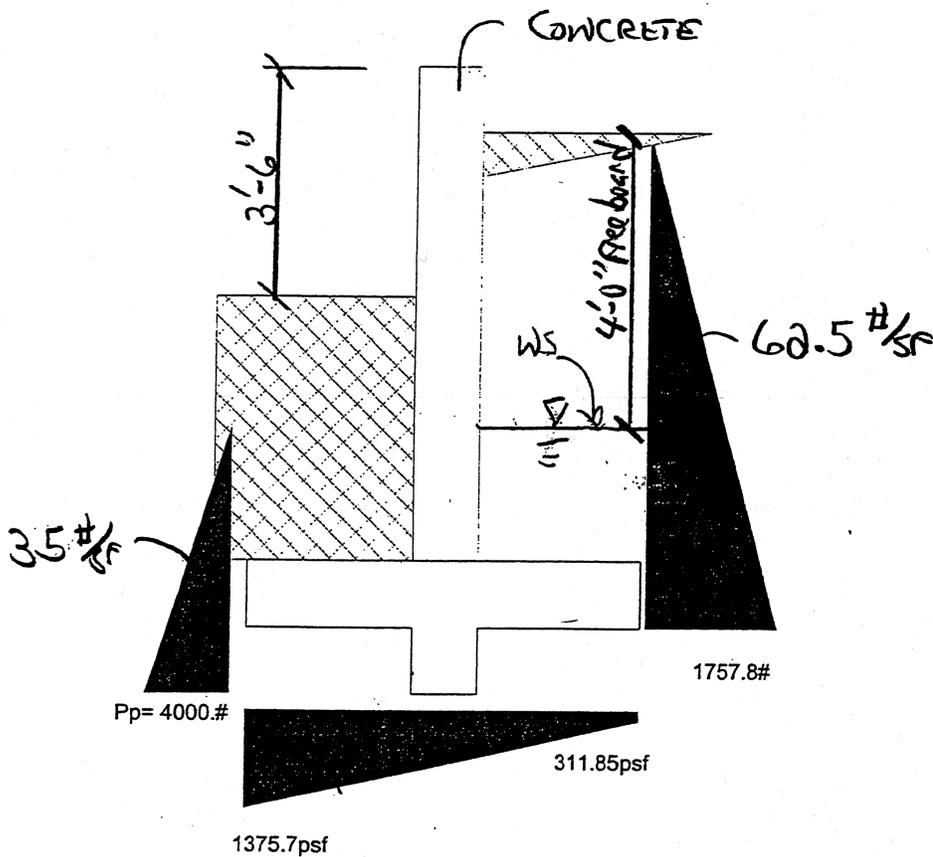
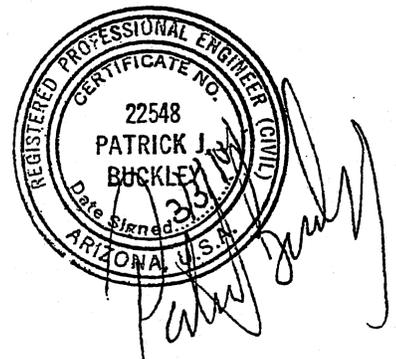
RIVER ROAD FLOOD WALL  
CAMINO REAL WASH

WALL DESIGN: 4' WATER (FLOW) ABOVE PROPOSED WATER SURFACE (W.S.)

CONCRETE DESIGN

In order to meet NFIP guidelines as listed at 44 CFR §65.10, Terracon Consultants, did an analysis to ensure that Embankment Protection, Embankment and Foundation Stability, and Settlement were all acceptable per FEMA requirements. Per the letters dated March 17, and April 3, 2008, found in Appendix E.4, it was established that the embankments were expected to be resistant to erosion. It was also found that due to the short duration of the 100-year flood, and a low water surface elevation differential in a flood condition, that minimal seepage potential is expected. And based upon the field results and laboratory tests the expected total settlement is not to exceed one-inch. We have verified, based upon the As-built data that even with the maximum settlement of one-inch the floodwalls still provided adequate freeboard.

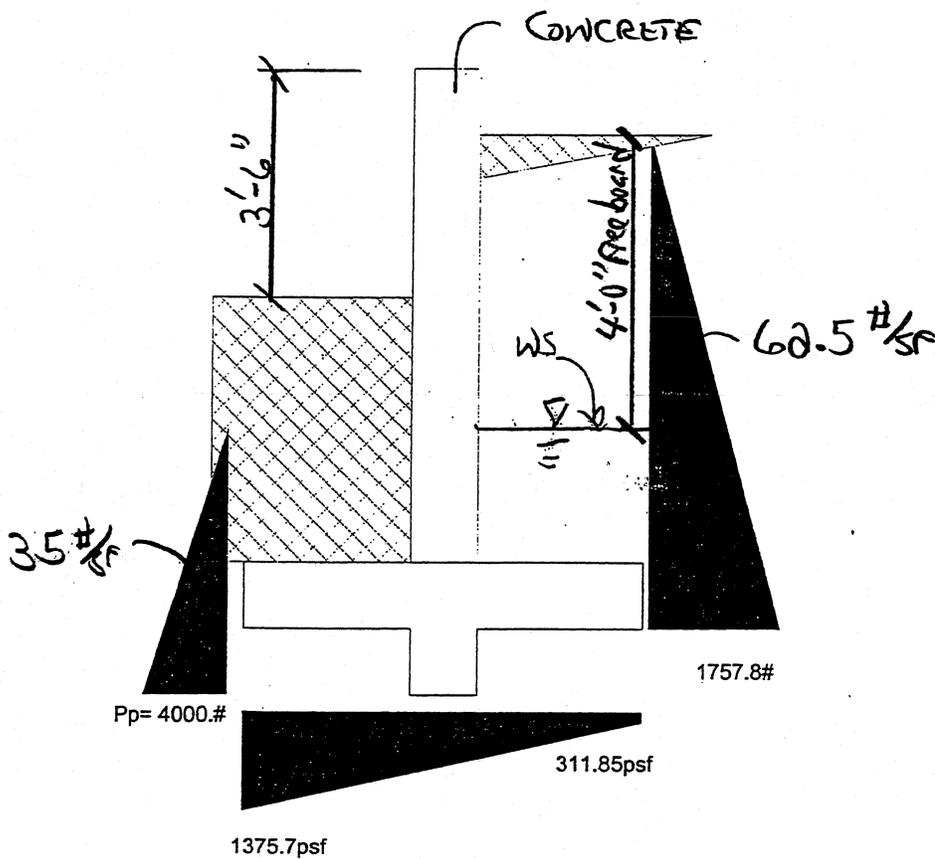
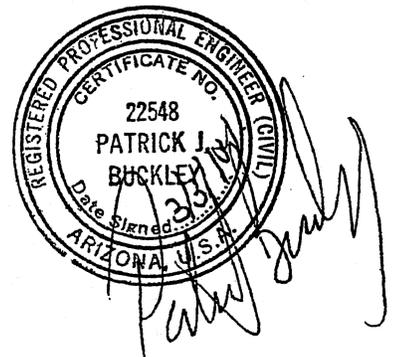
RIVER ROAD FLOOD WALL  
CAMINO REAL WASH

DESIGN OF WALL: TOP OF WALL 3'-6" OF ROADSIDE GRADE.  
WALL DESIGN: 4' WATER (FLOOD) ABOVE PROPOSED WATER SURFACE (W.S.)  
CONCRETE DESIGN

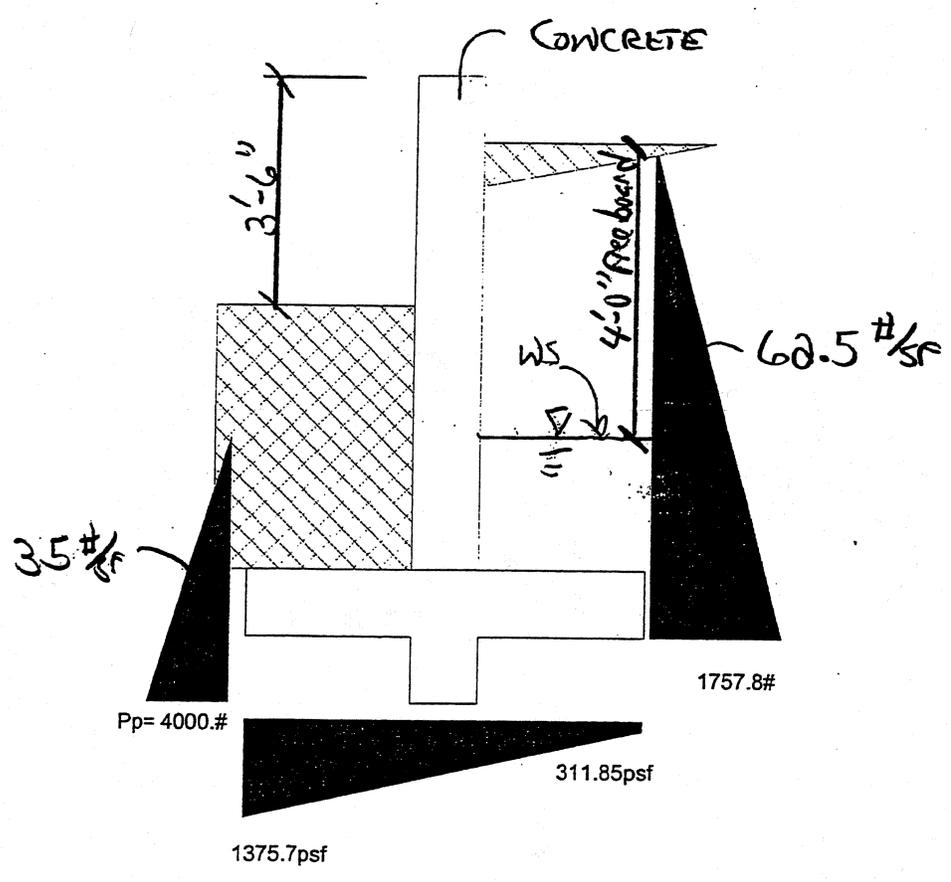
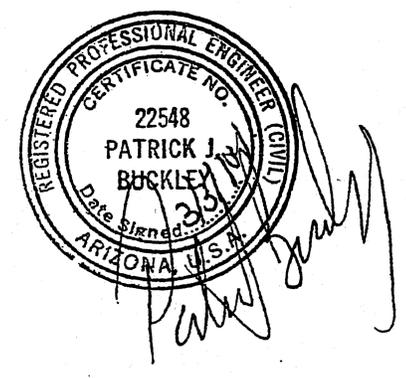
RIVER ROAD FLOOD WALL  
CAMINO REAL WASH

DESIGN OF WALL: TOP OF WALL 3'-6" OF ROADSIDE GROOVE.  
WALL DESIGN: 4' WATER (FLOOD) ABOVE PROPOSED WATER SURFACE (W.S.)  
CONCRETE DESIGN

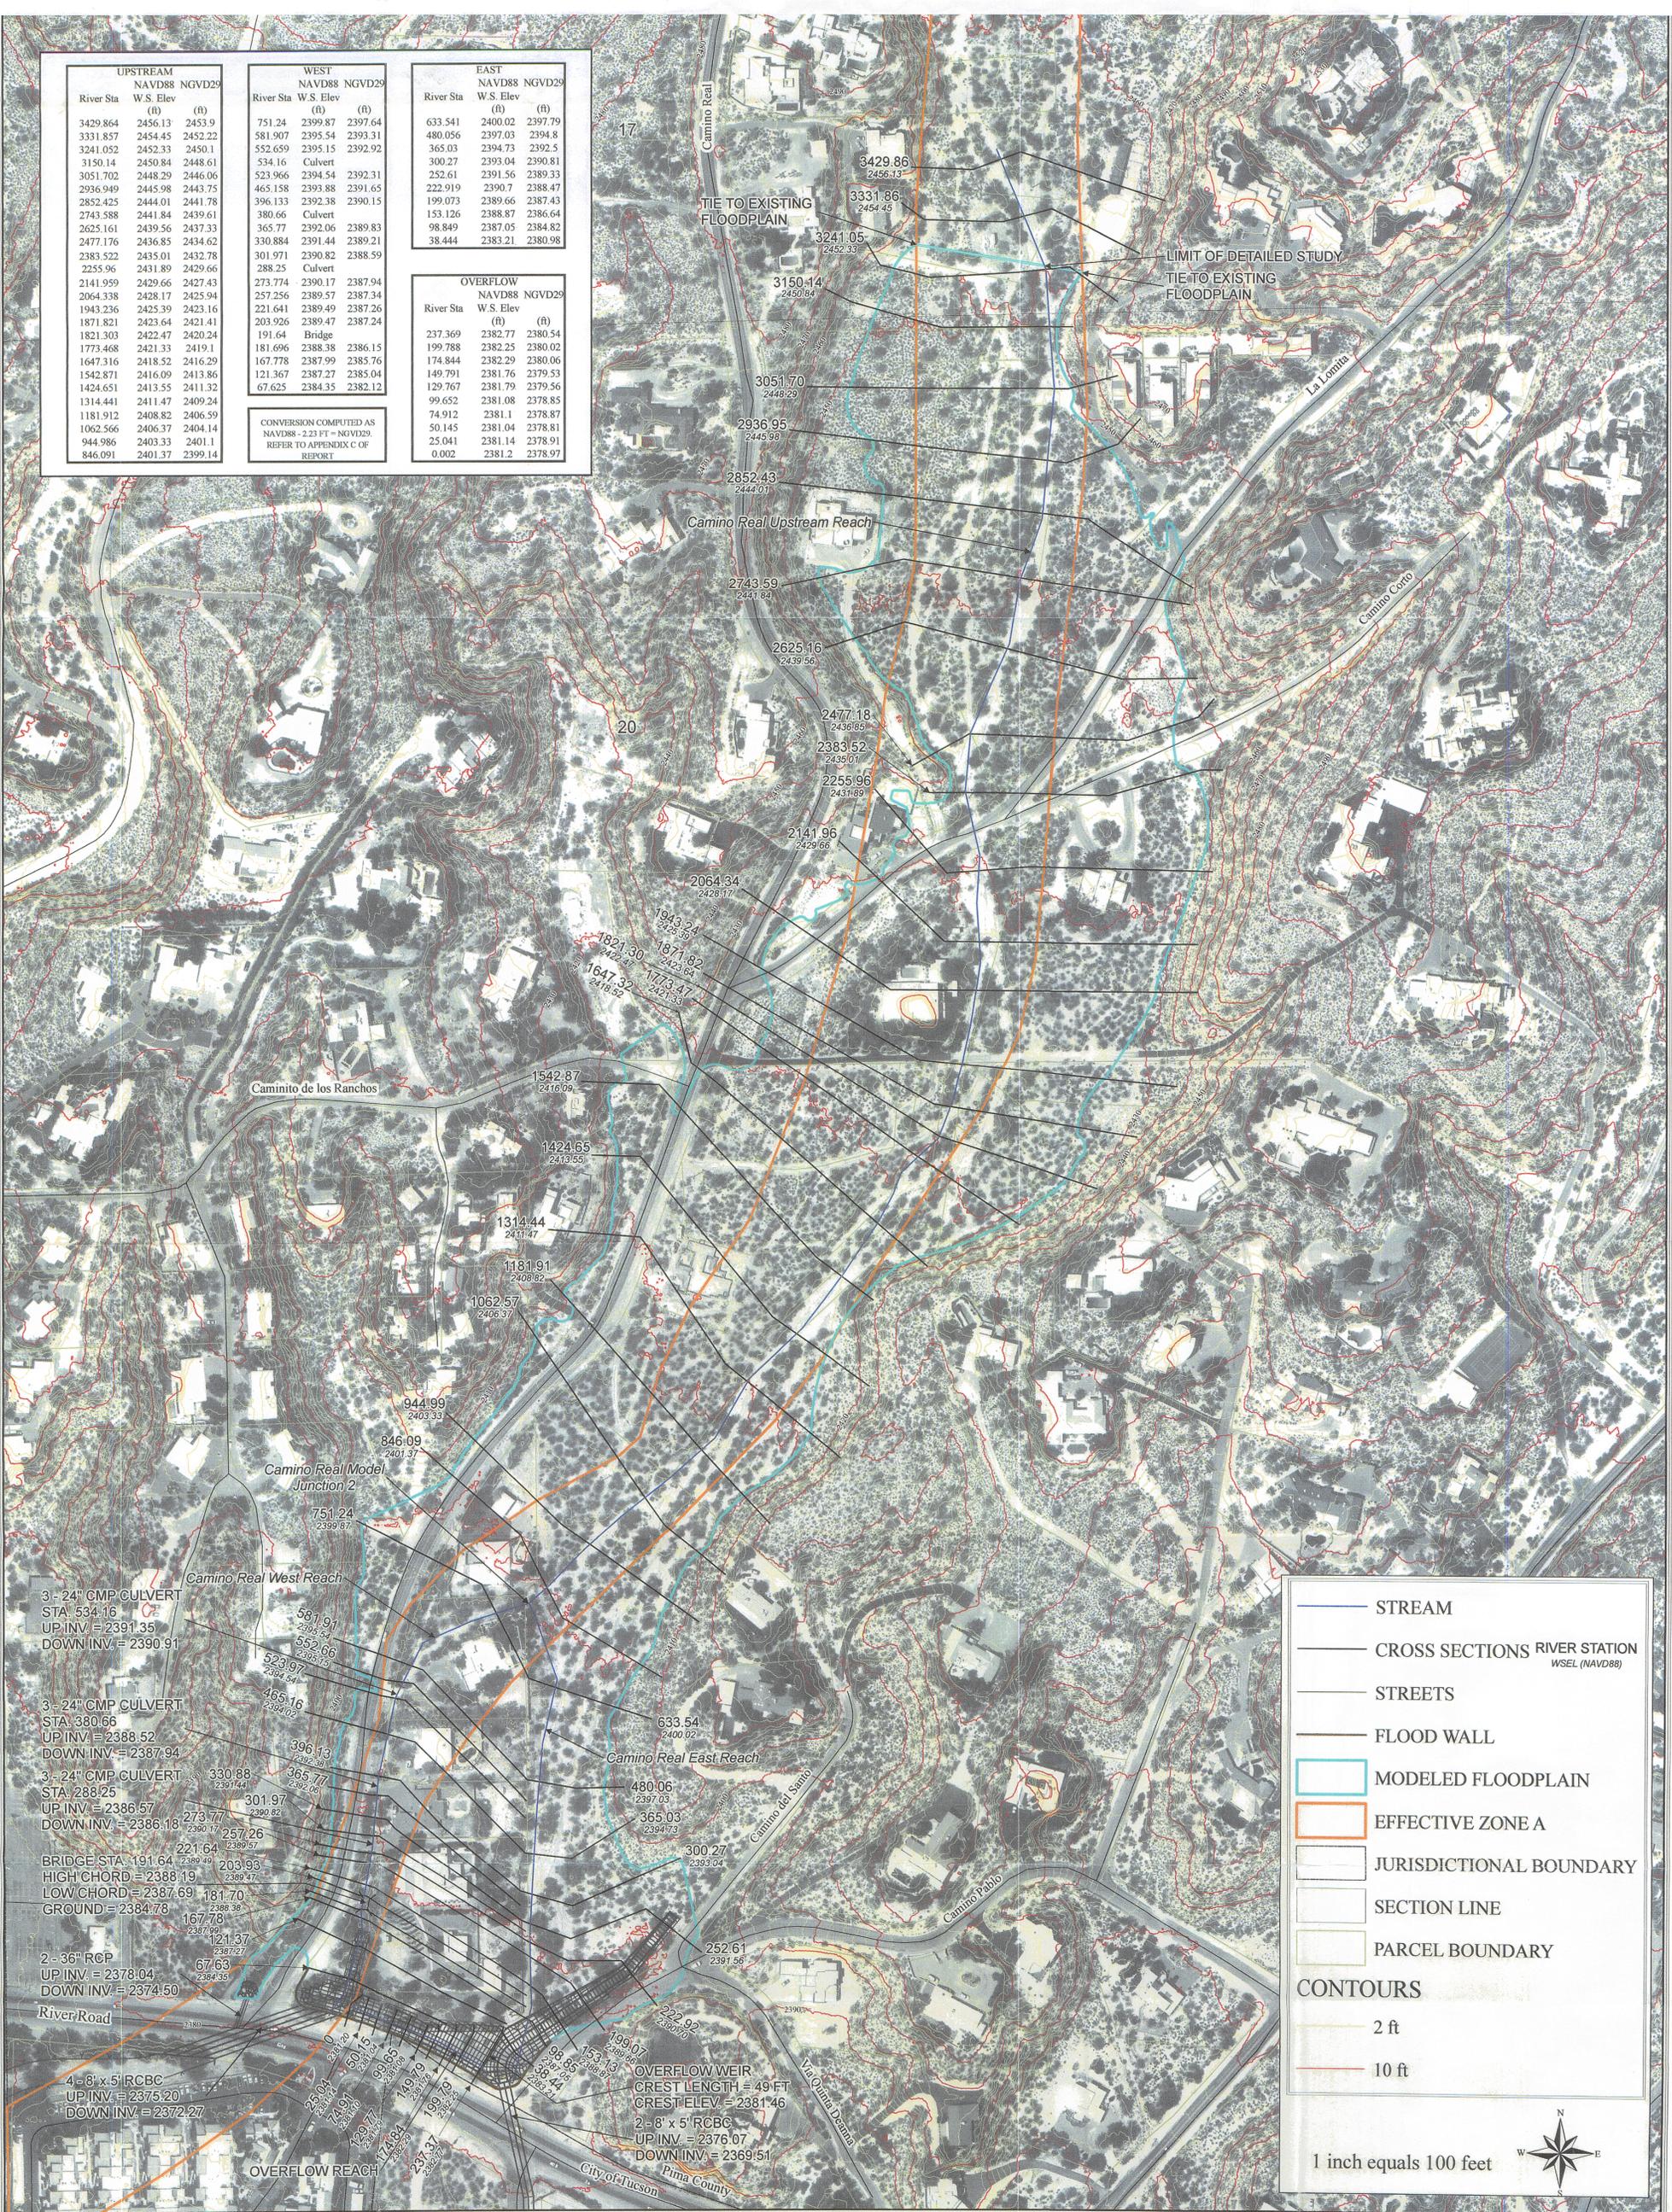
## CAMINO REAL LOMR HYDRAULIC STUDY: FIGURE 2 - UPSTREAM REACH

**NOTES**  
 Project view is within FIRM Panel 04019C1645K  
 Located in: T. 13 S, R. 14 E, Sections 17 & 20  
 No LOMR or LOMA are in this view  
 Vertical Datum NAVD88

Work maps are provided to display the stream alignments, cross-sections, structures, floodplain delineations, topography, and aerial photos. The work maps are separated into the Upstream Reach, Figure 2, and the Downstream Reach, Figure 3. See Exhibit Maps for figures.

- **FIGURE 2**, CAMINO REAL WORKMAP NORTH OF RIVER ROAD
- **FIGURE 3**, CAMINO REAL WORKMAP SOUTH OF RIVER ROAD

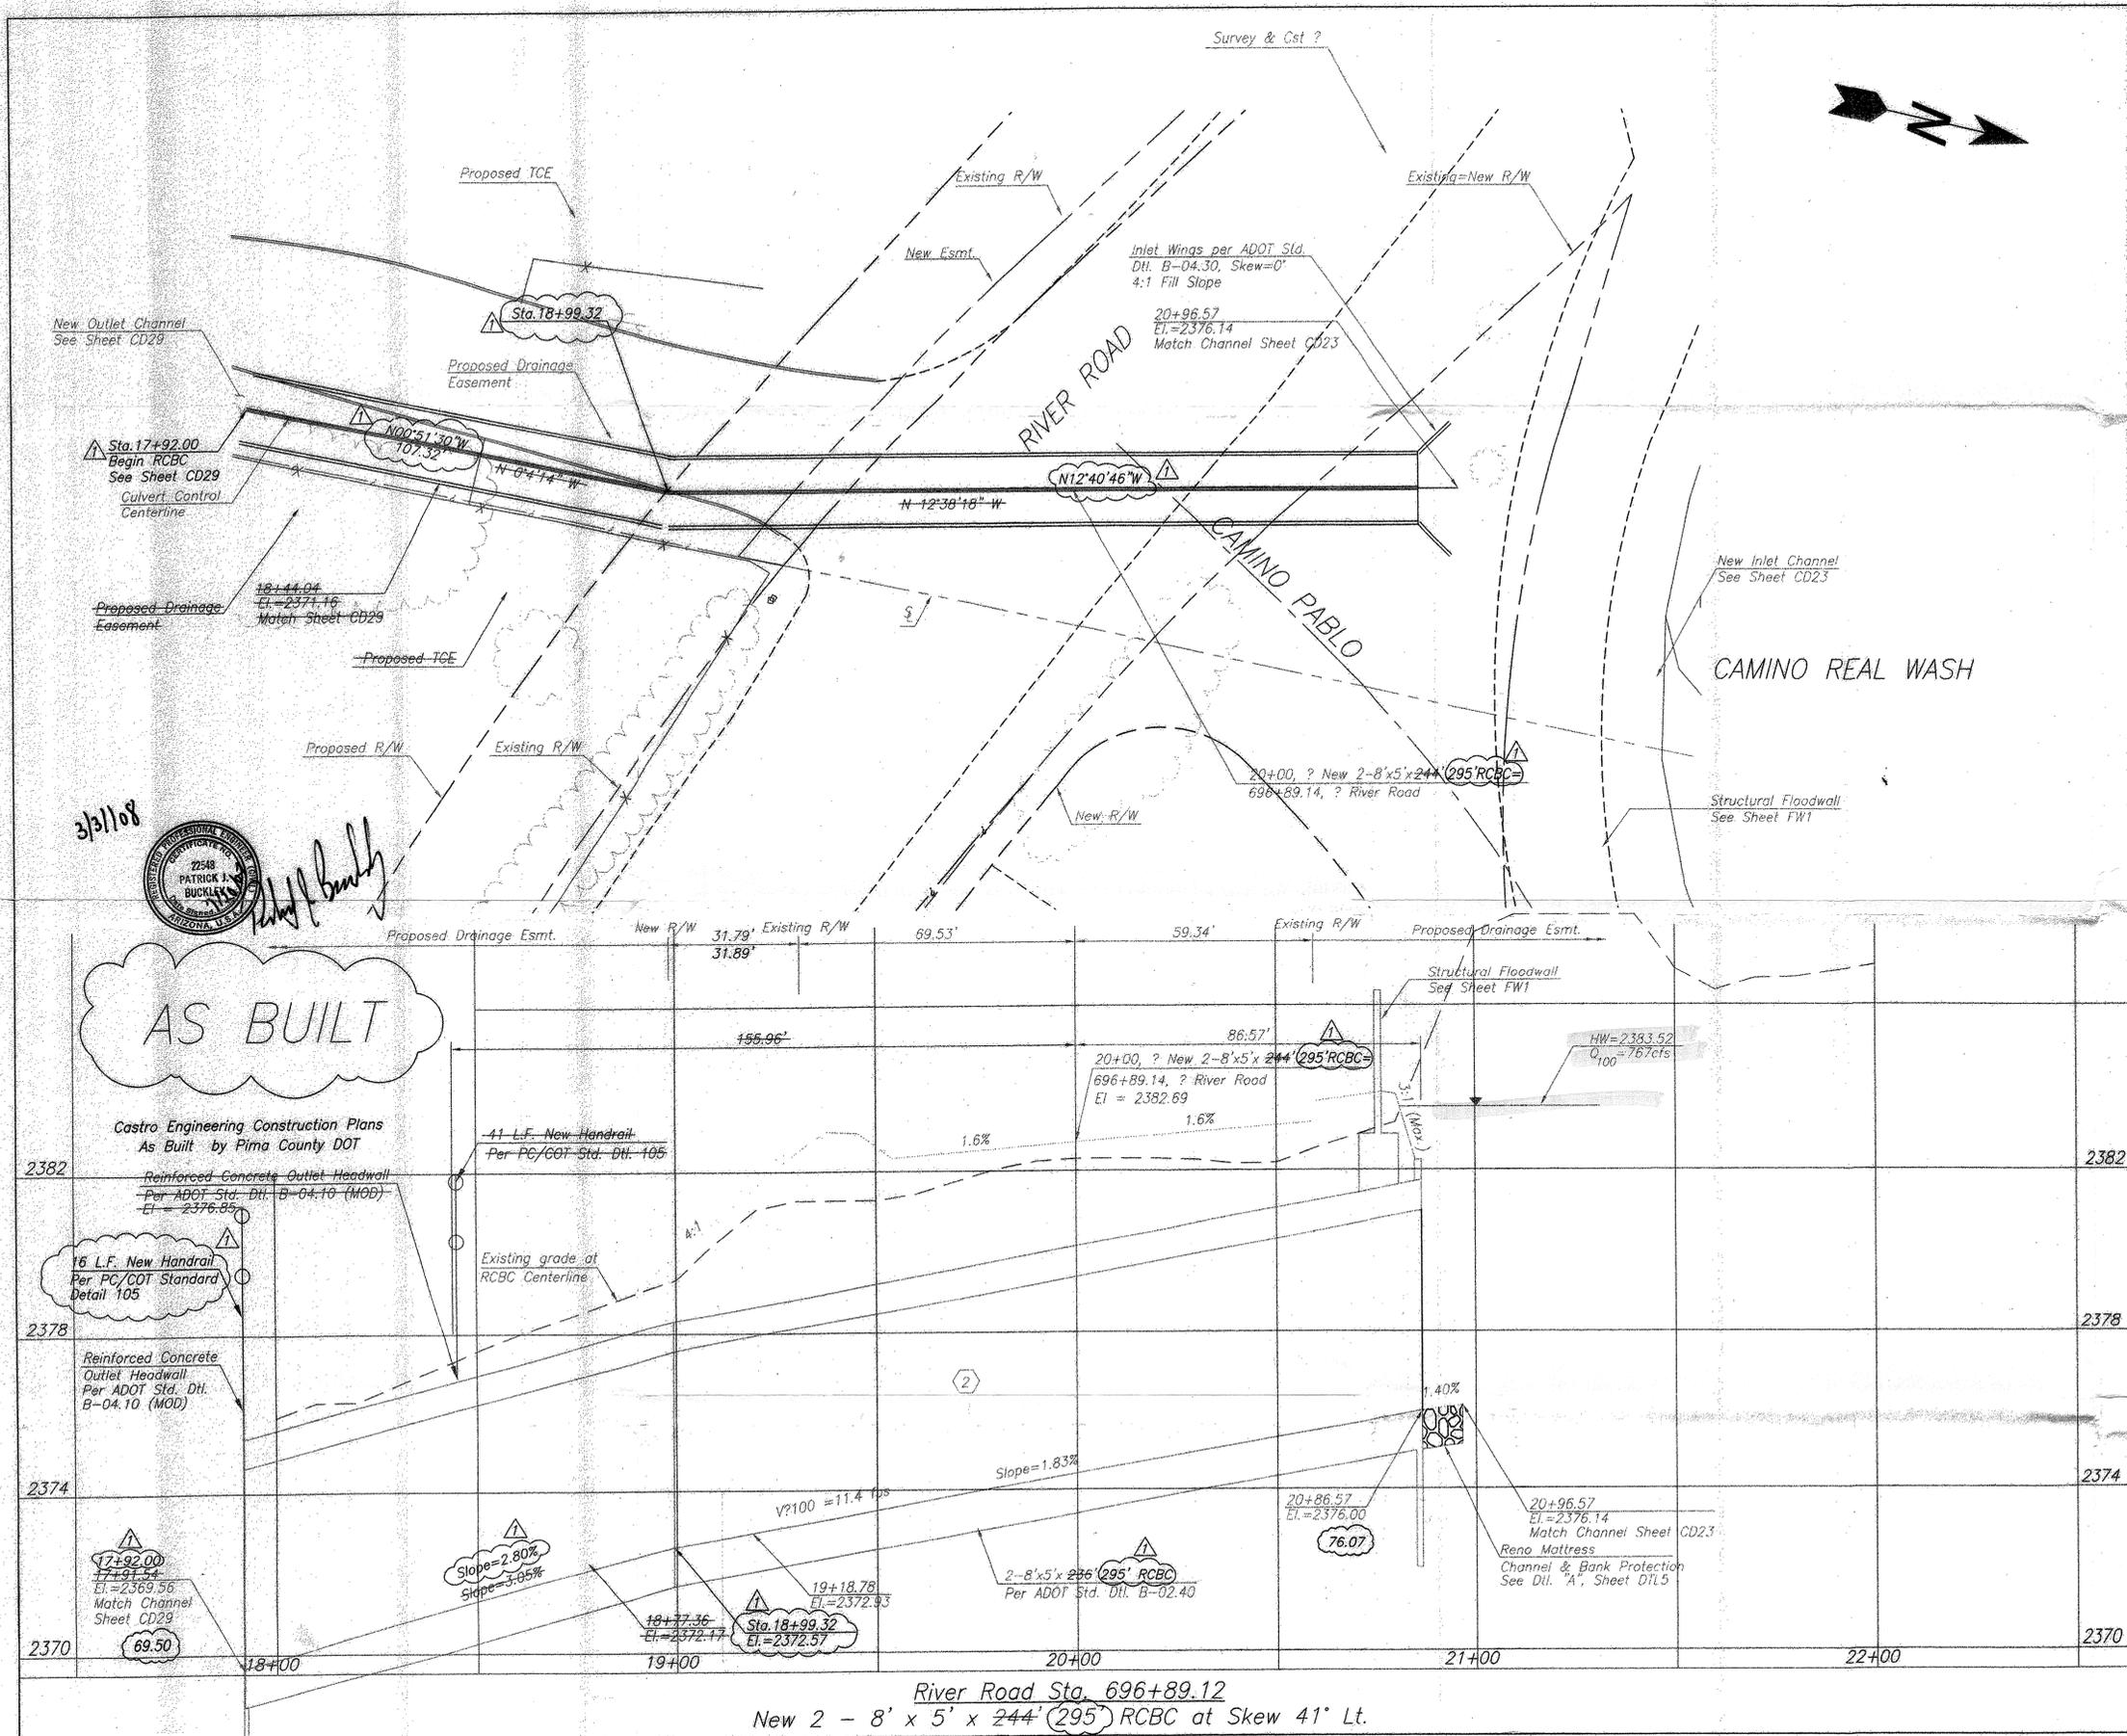
Pima County Department of Transportation  
 RIVER ROAD  
 CAMPBELL AVE TO ALVERNON WAY  
 CROSS DRAINAGE PLAN & PROFILE  
 STA. 696+89  
 W.O. 4TRCA

**EARTHWORK QUANTITIES**  
 Structural Excavation: 1892 CY  
 Pipe Excavation: N/A  
 Drainage Excavation: N/A  
 Structural Backfill: 40 CY  
 Pipe Backfill: N/A  
 Trench Backfill: 492 CY

**REVISED QUANTITIES**  
 1. (2)-8'x5' RCBC Length: (+)51 LF  
 -Revised from 244' to 295'  
 2. Handrail Length: (-)25 LF  
 -Revised from 41' to 16'

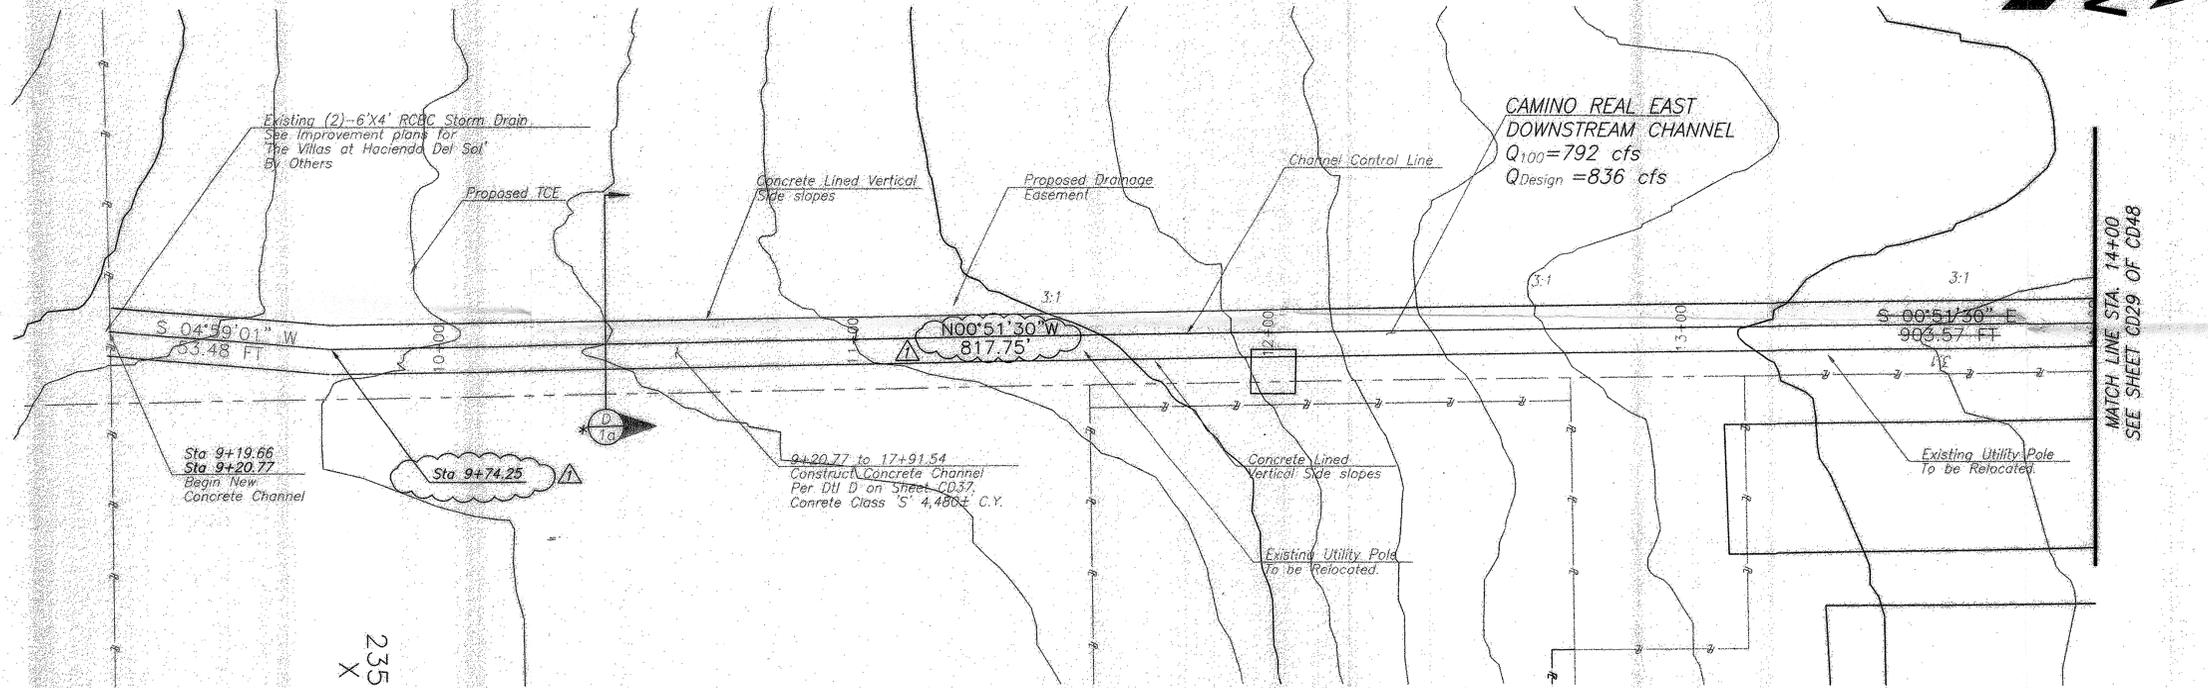
Castro Eng. Job No. PC07059  
Scales: Horiz. 1" = 10'  
Vert. N/A  
Sheet CD27of CD 48  
Page 138 of 366

RIVER ROAD  
CAMPBELL AVE. TO ALVERNON WAY  
CHANNEL IMPROVEMENT PLANS  
CHANNEL REAL WEST CHANNEL  
CAMINO W.O. 4TRCA
