**TECHNICAL DATA NOTEBOOK  
FOR**

**Camino Real Wash,  
Pima County, AZ**

**Contract #25-59-C-13522-0507**

**Prepared For:  
Pima County Regional Flood Control District  
97 E. Congress, 3<sup>rd</sup> Floor  
Tucson, AZ 85701**

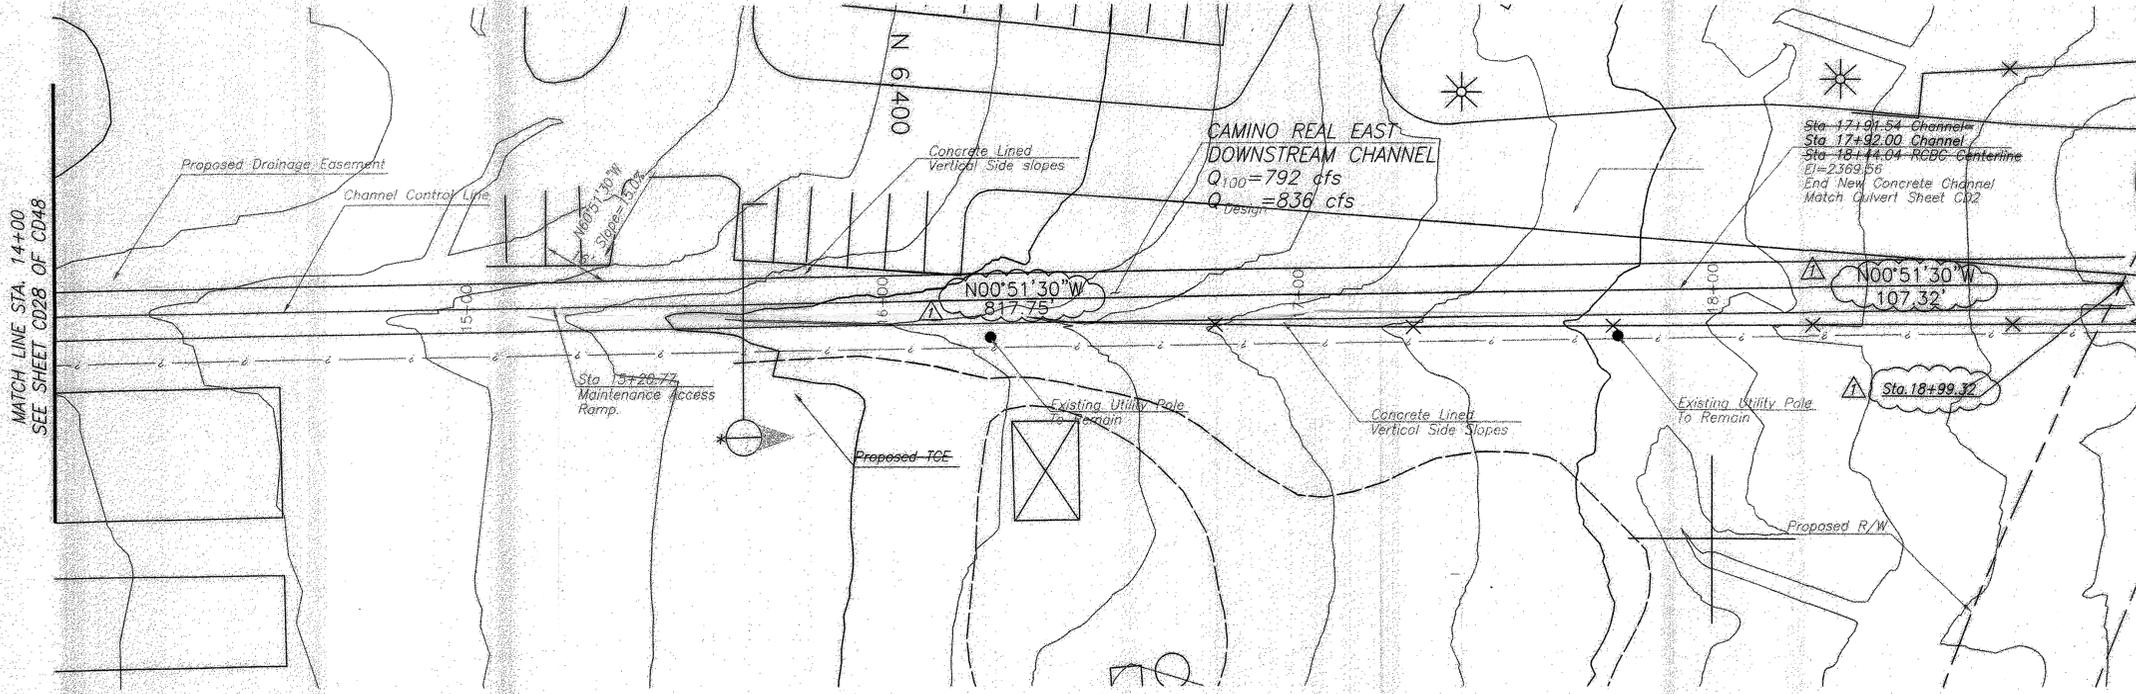
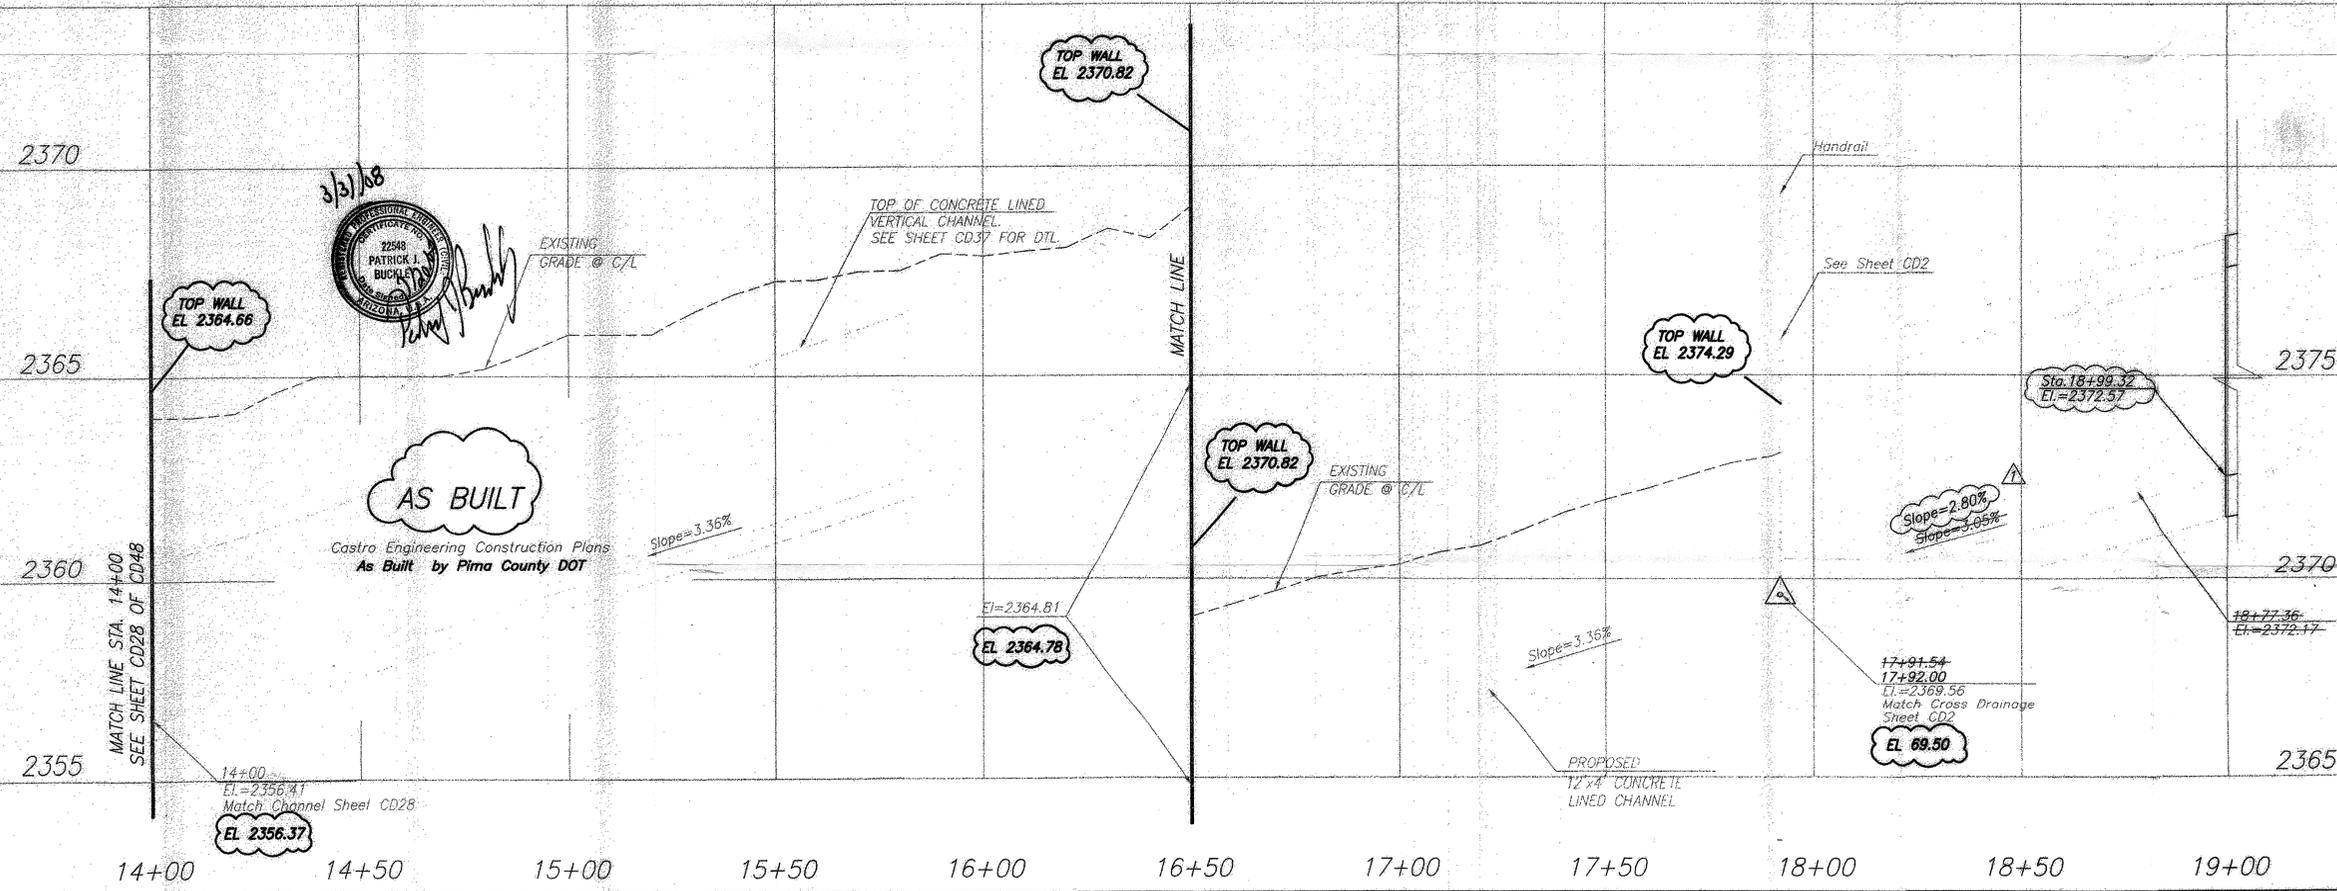
RIVER ROAD  
CAMPBELL AVE. TO ALVERNON WAY  
CHANNEL IMPROVEMENT PLANS  
CAMINO REAL EAST CHANNEL  
M.C. 4TRCA

MATCH LINE STA. 14+00  
SEE SHEET CD28 OF CD48

\*See Sheet CD37  
for Cross Section

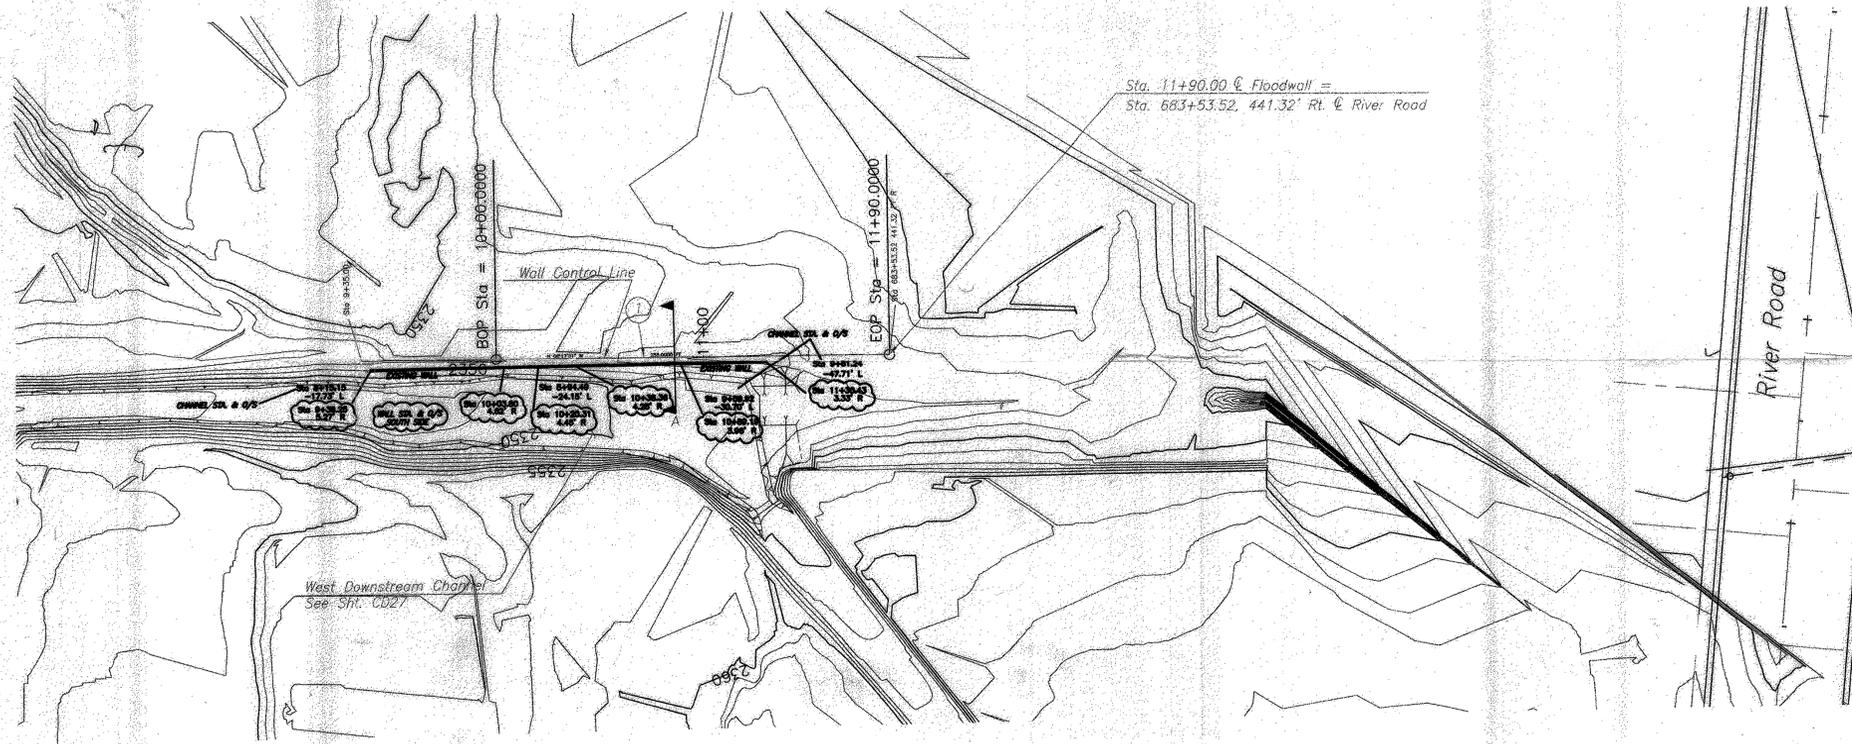
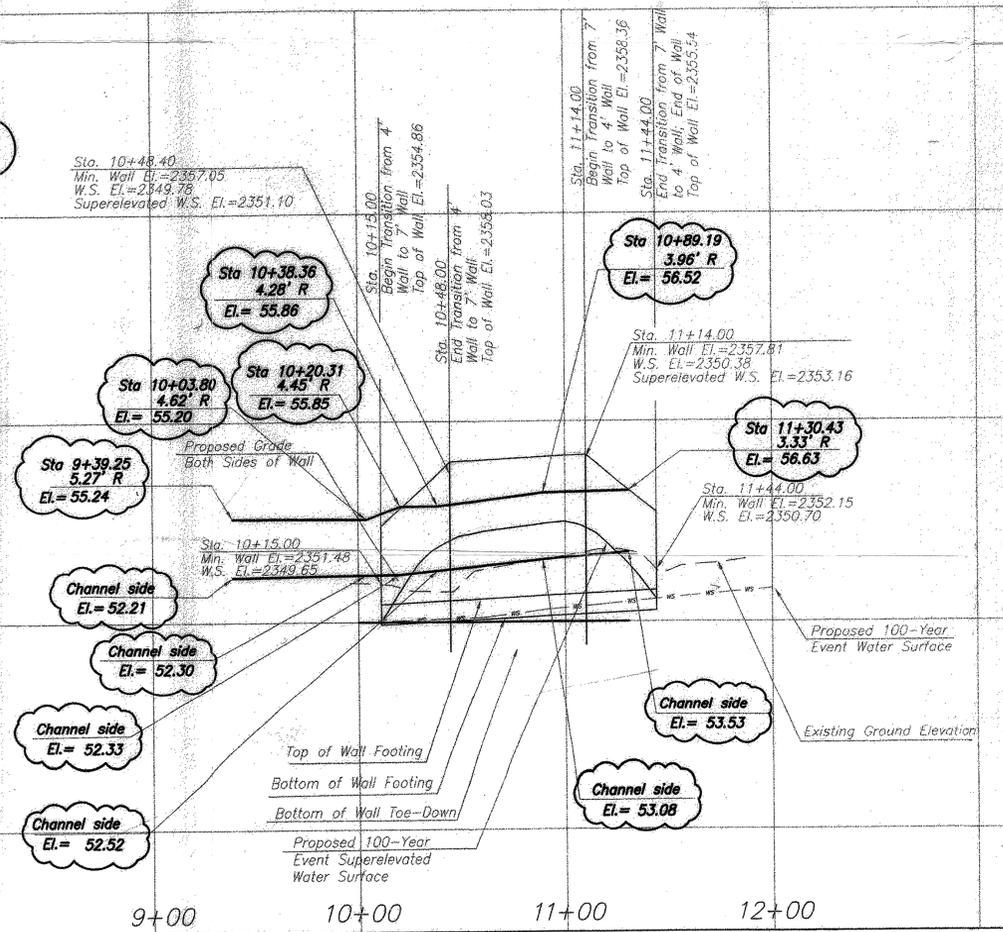
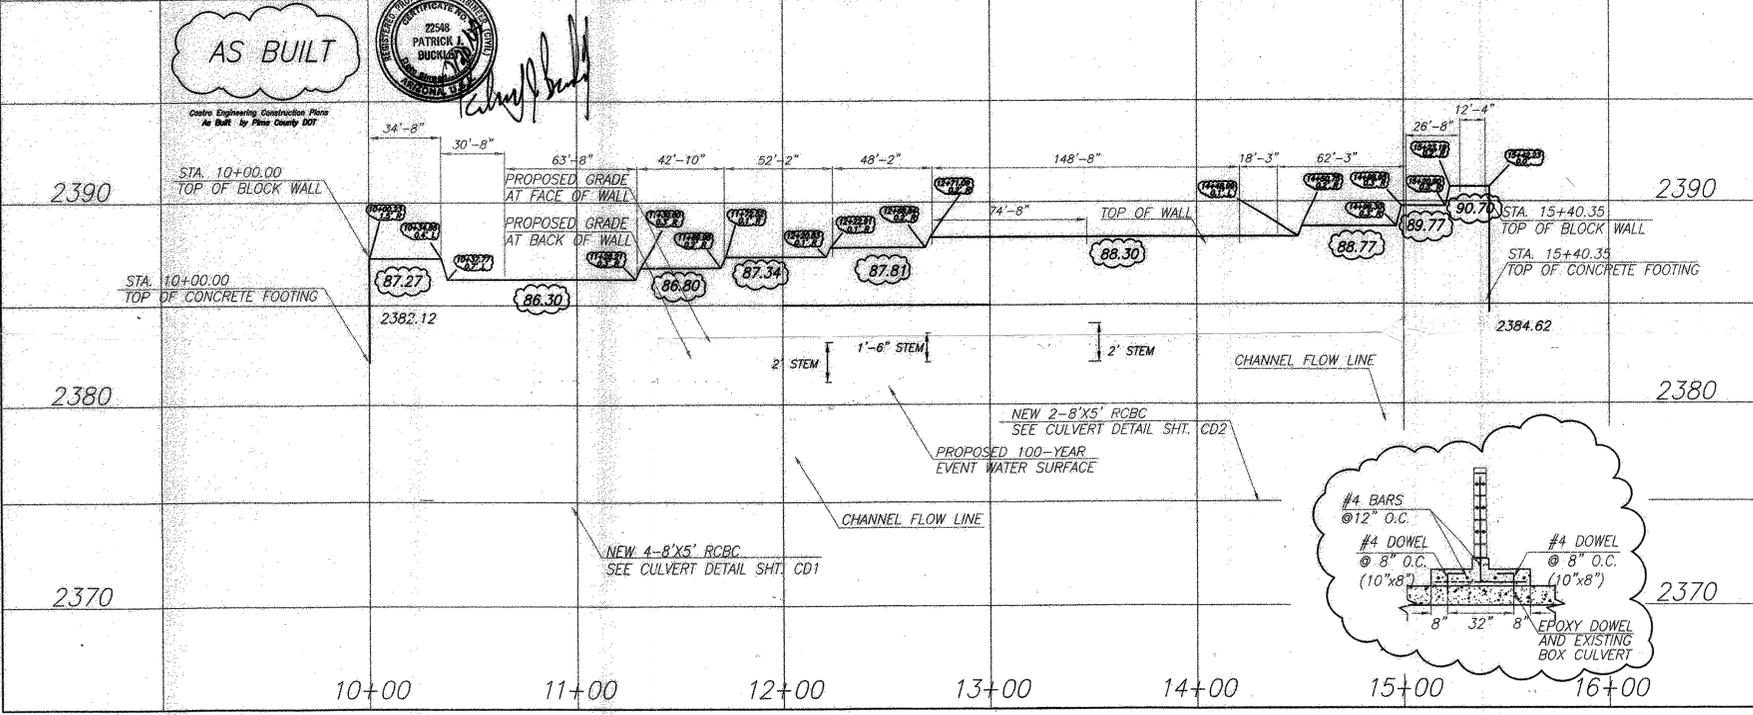
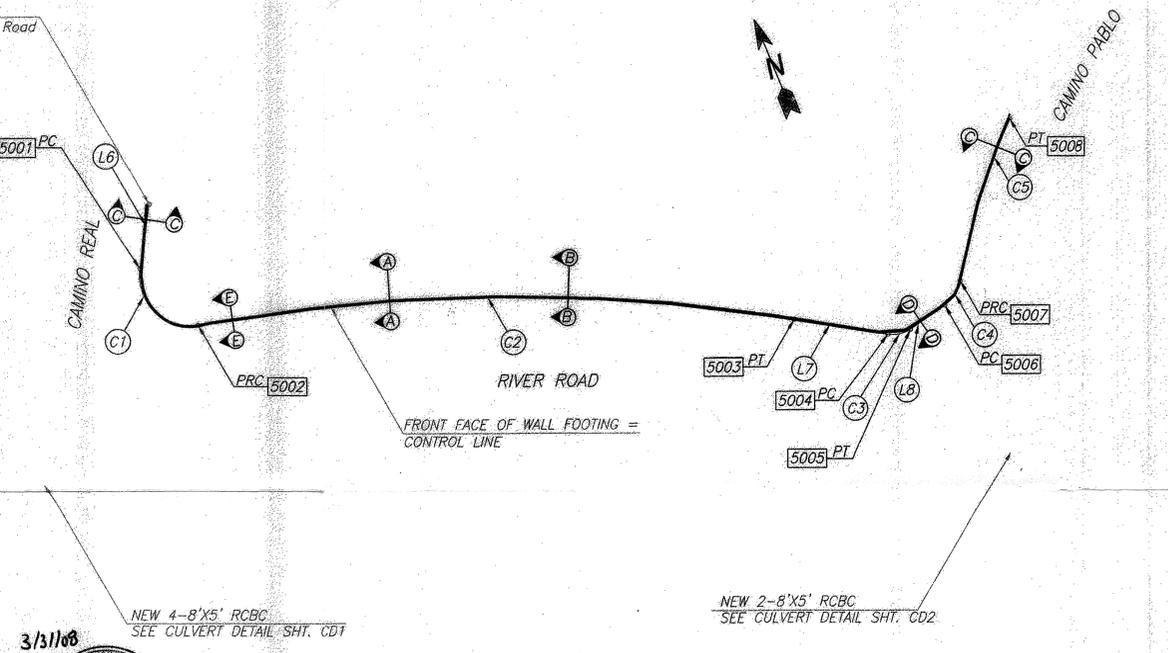
Scales	Horiz. 1" = 40'	Sheet FW2 FW2	Page 170 of 366
	Vert. 1" = 4'

**FLOODWALL HORIZ. CONTROL - CURVE DATA**

**FLOODWALL HORIZONTAL CONTROL - POINT DATA**

RIVER ROAD  
CAMPBELL AVE. TO ALVERNON WAY  
STRUCTURAL FLOODWALL  
PLAN & PROFILE  
W.O. AT/CA

Wall Control Line Data		
No.	Bearing	Length
1	S 00°17'51" E	190.00'

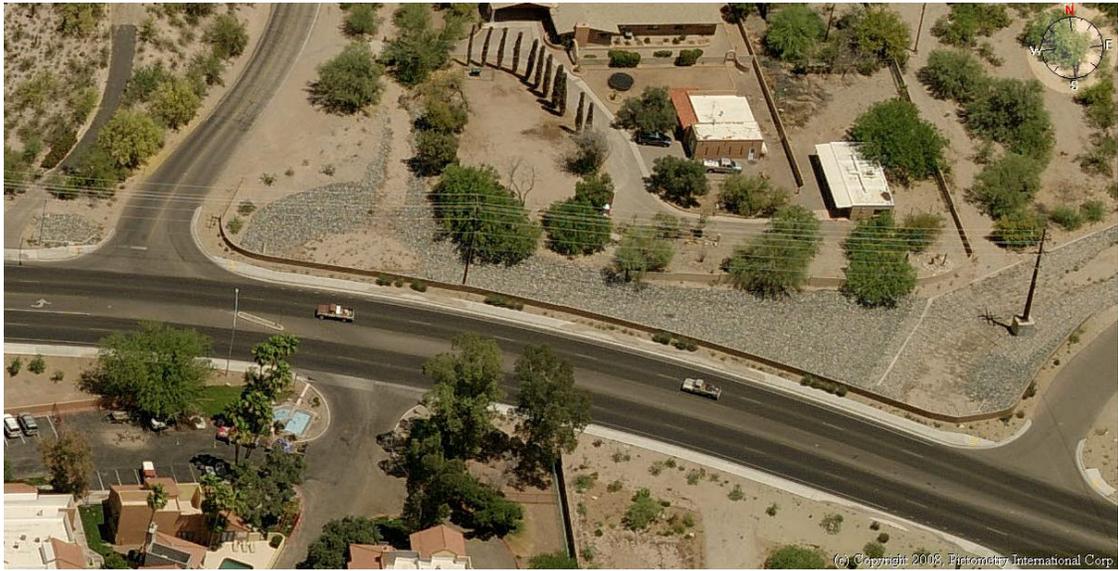
Looking north at north wall along River Road

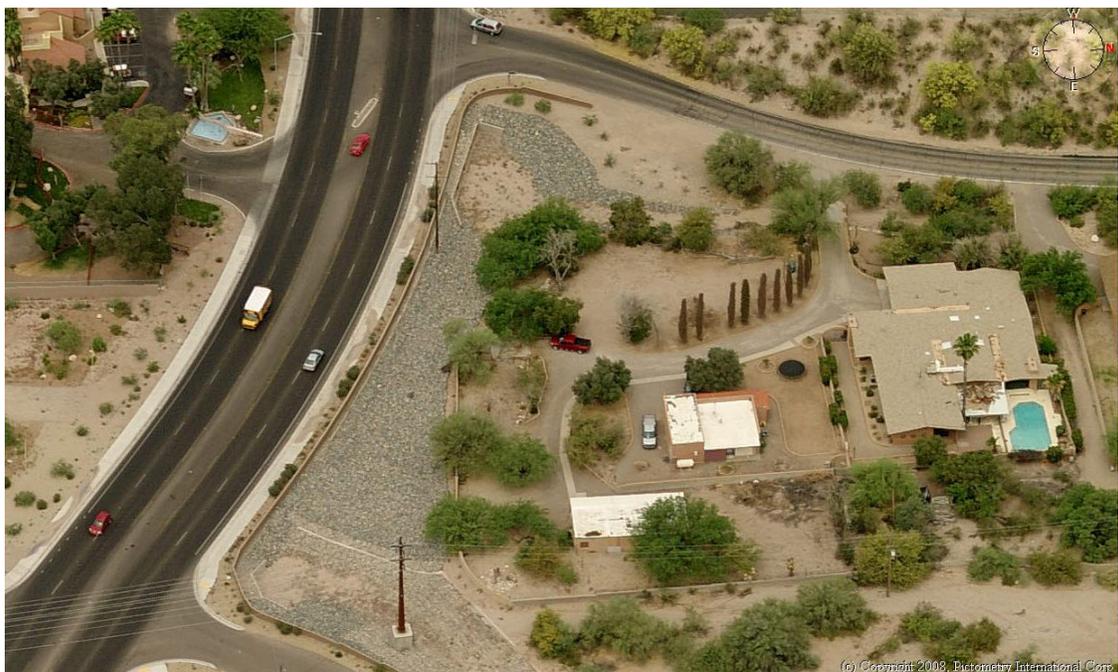
New culvert inlets and overflow channel along upstream side of north wall.

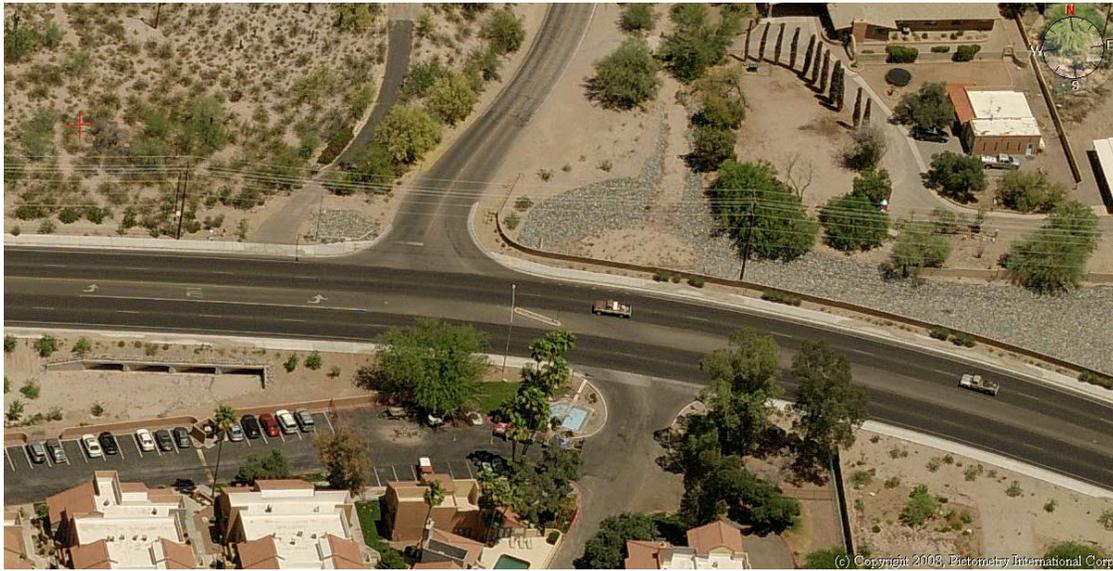
Looking north at outlet to new 4-8'x5' RCBC and at-grade property along south side of River Road.

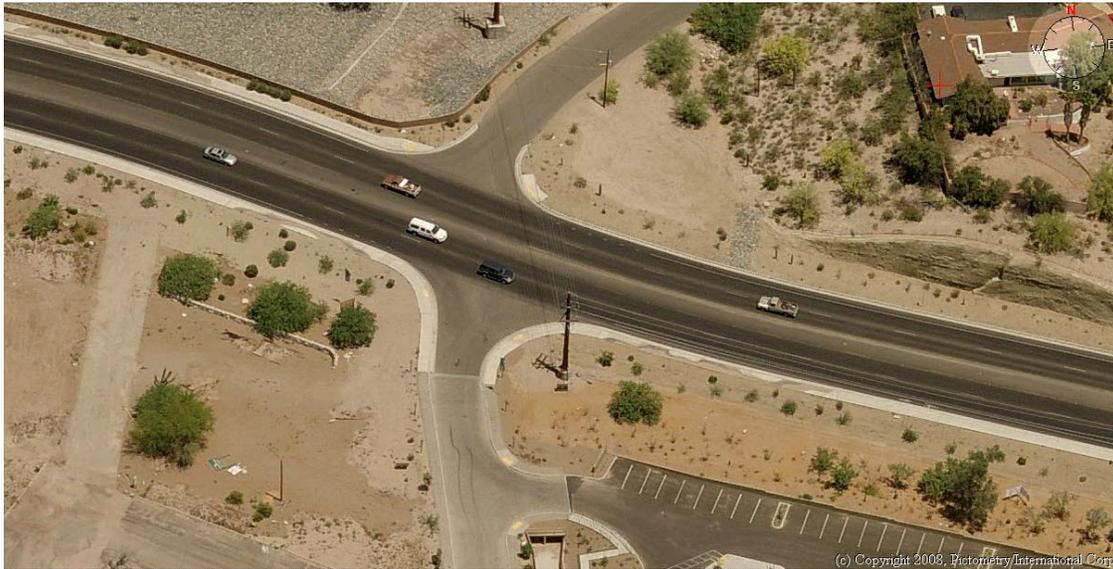
Looking north at outlet to new 2-8'x5' RCBC.

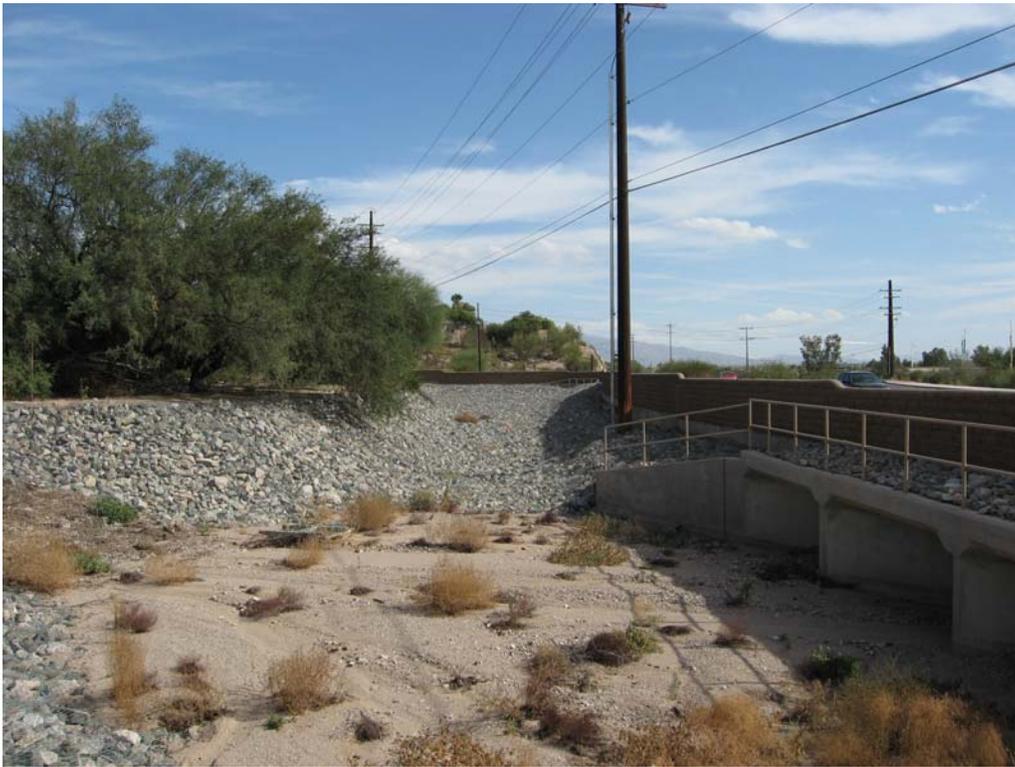
Looking east along overflow channel from inlet to the new 4-8'x5' RCBC. The north wall is visible along northern edge of River Road.

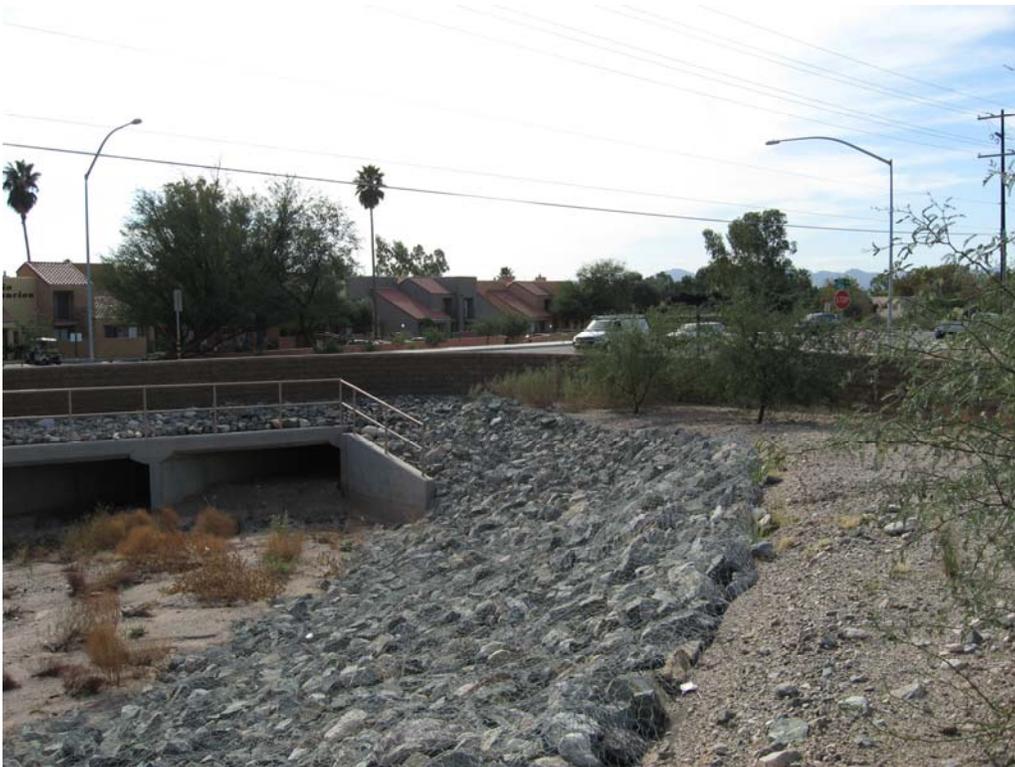
Looking southwest at River Road and properties to the south from inlet to new 4-8'x5' RCBC. The north wall, including the western tie-back portion, is also shown.

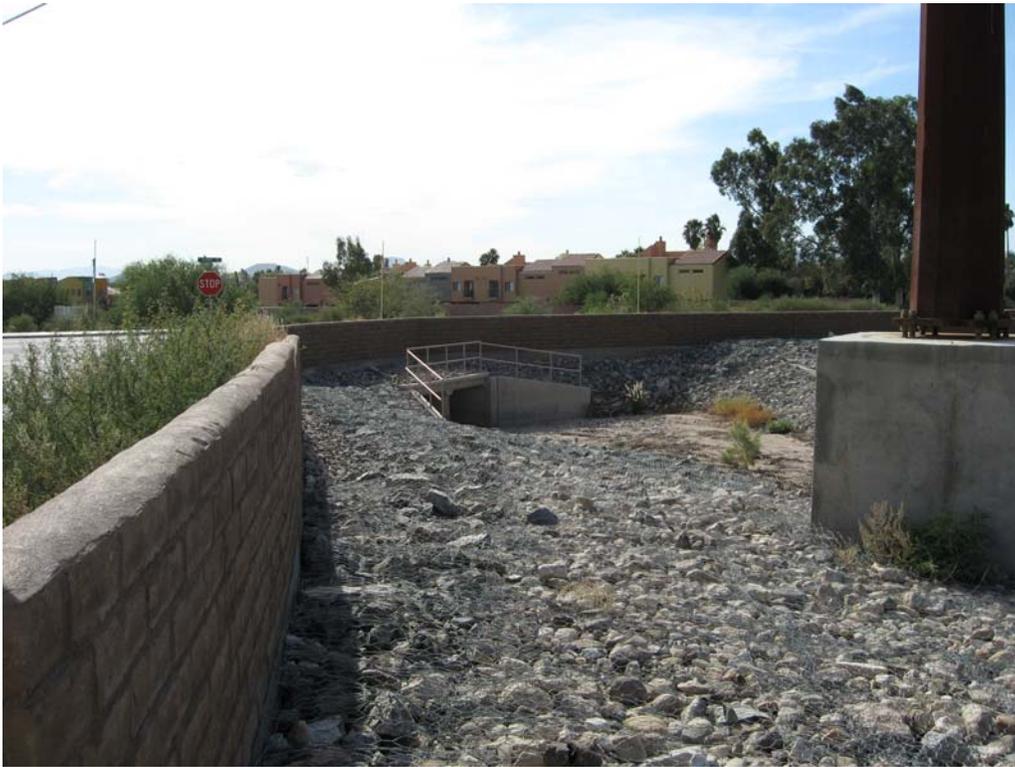
Looking south along the eastern tie-back portion of the north wall at the inlet to the new 2-8'x5' RCBC beneath River Road.

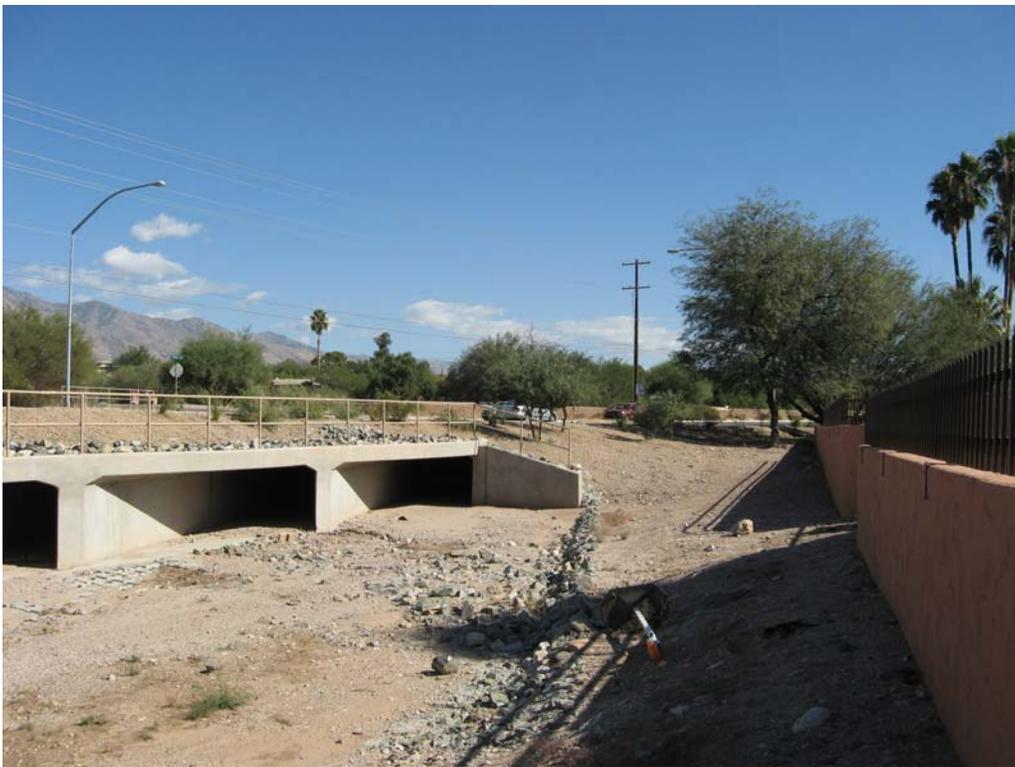
Looking northeast from the outlet of the new 4-8'x5' RCBC beneath River Road. North wall is visible in background.

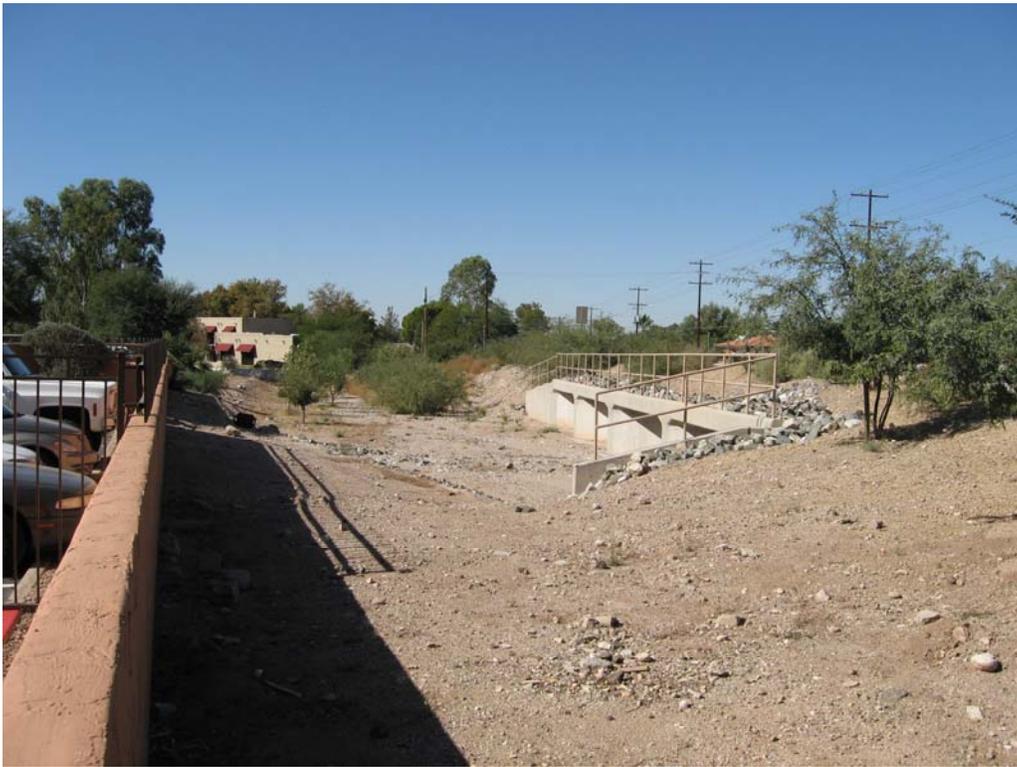
Looking west along western channel from outlet to new 4-8'x5' RCBC.

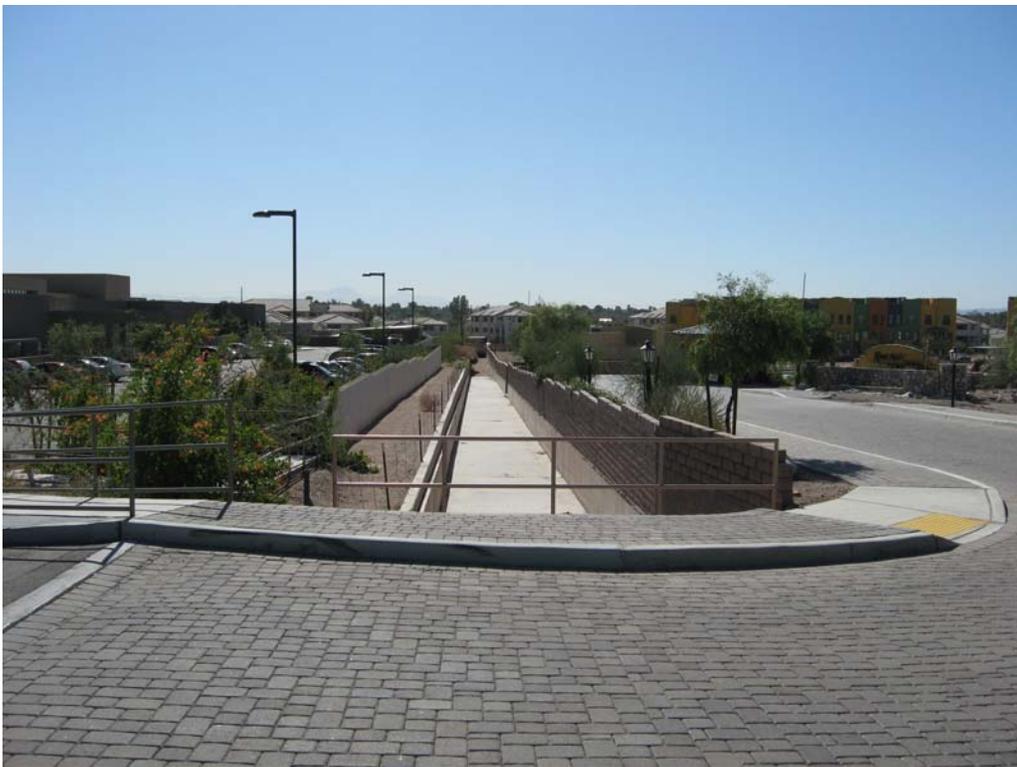
Looking south along eastern channel from outlet to new 2-8'x5' RCBC

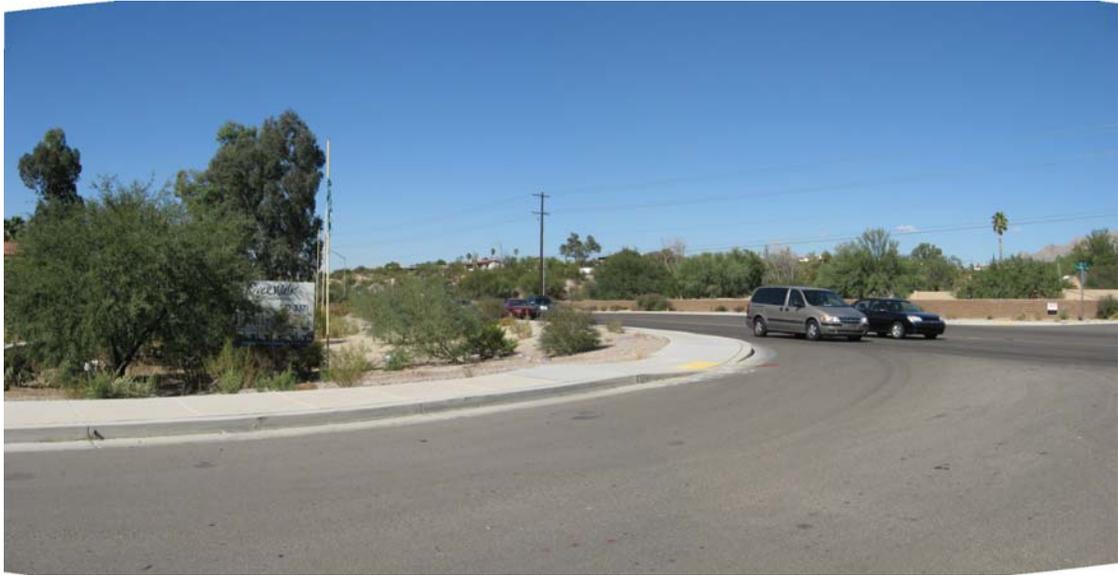
Looking northwest along south side of River Road.  
The north wall is visible along the north side.

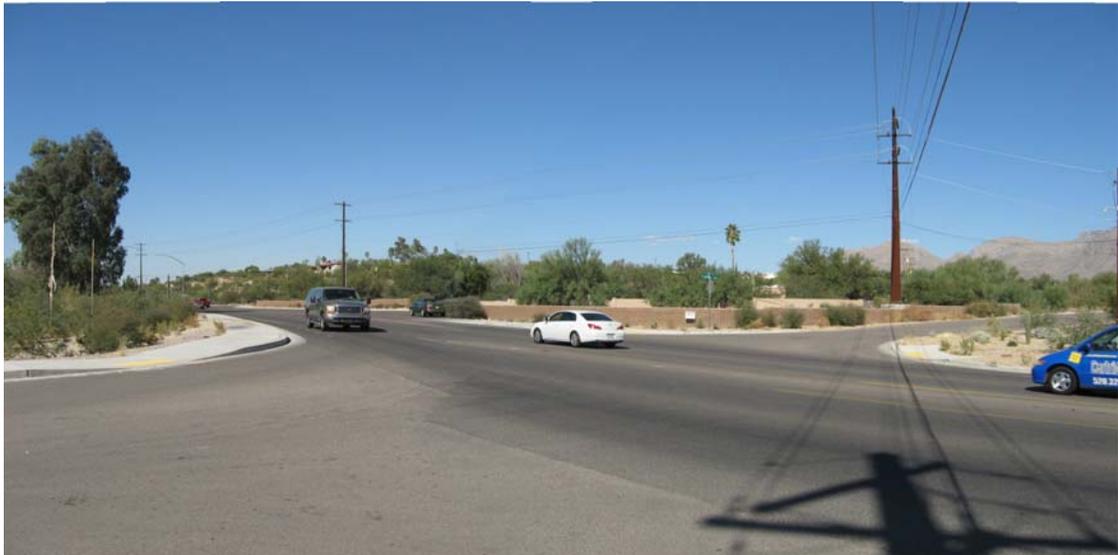
Looking northwest at north wall along north side of River Road.

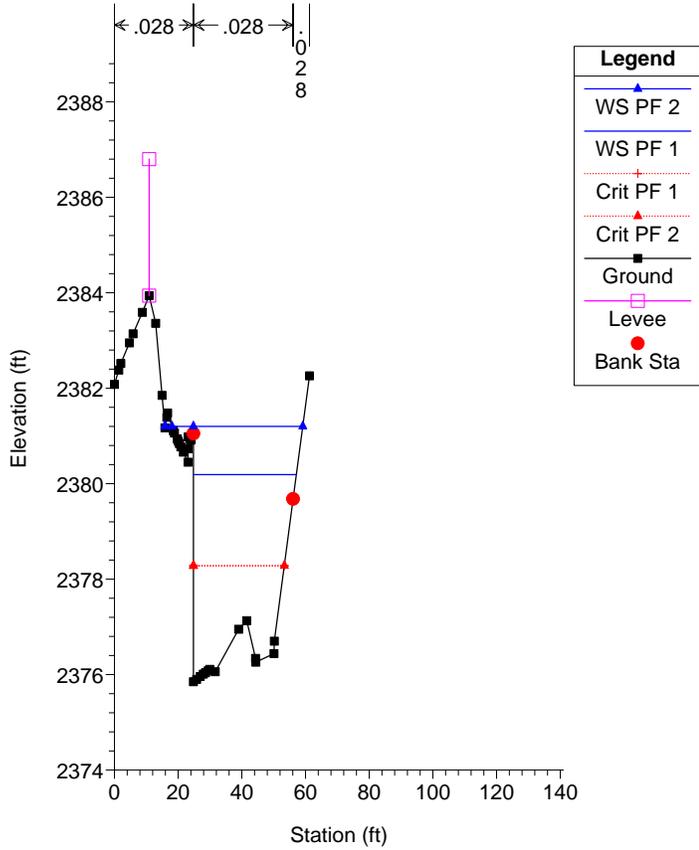
River = Overflow Reach = South RS = 0.002

Camino Real Plan: 1956cfs 6/19/2008

Geom: CaminoReal with walls

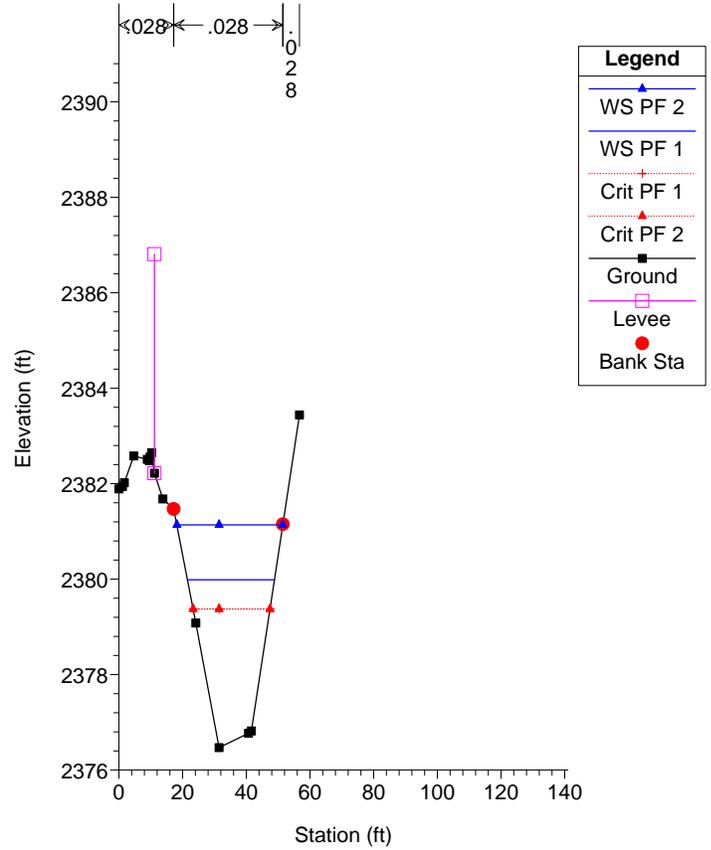
River = Overflow Reach = South RS = 25.041

Camino Real Plan: 1956cfs 6/19/2008

Geom: CaminoReal with walls

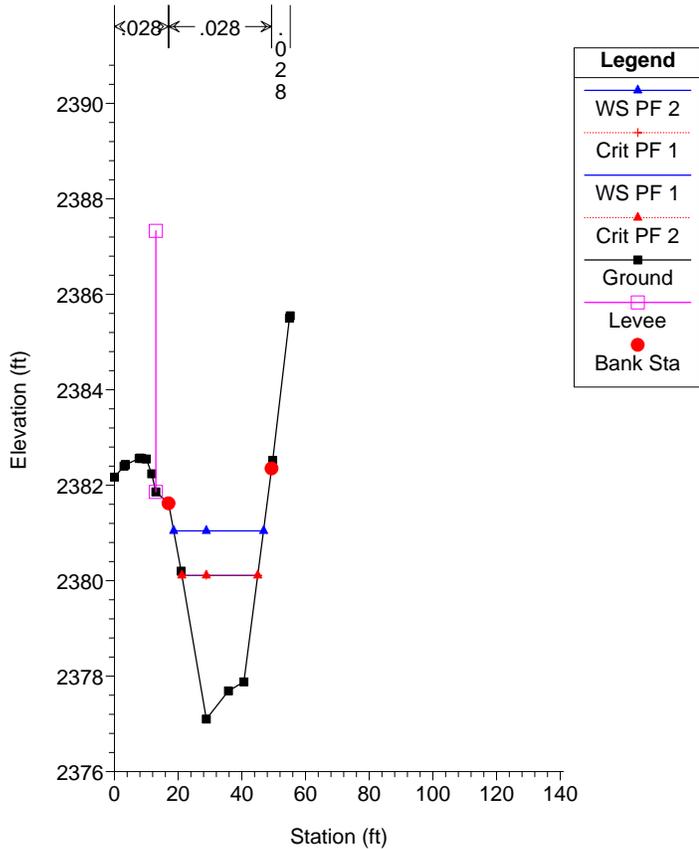
River = Overflow Reach = South RS = 50.145

Camino Real Plan: 1956cfs 6/19/2008

Geom: CaminoReal with walls

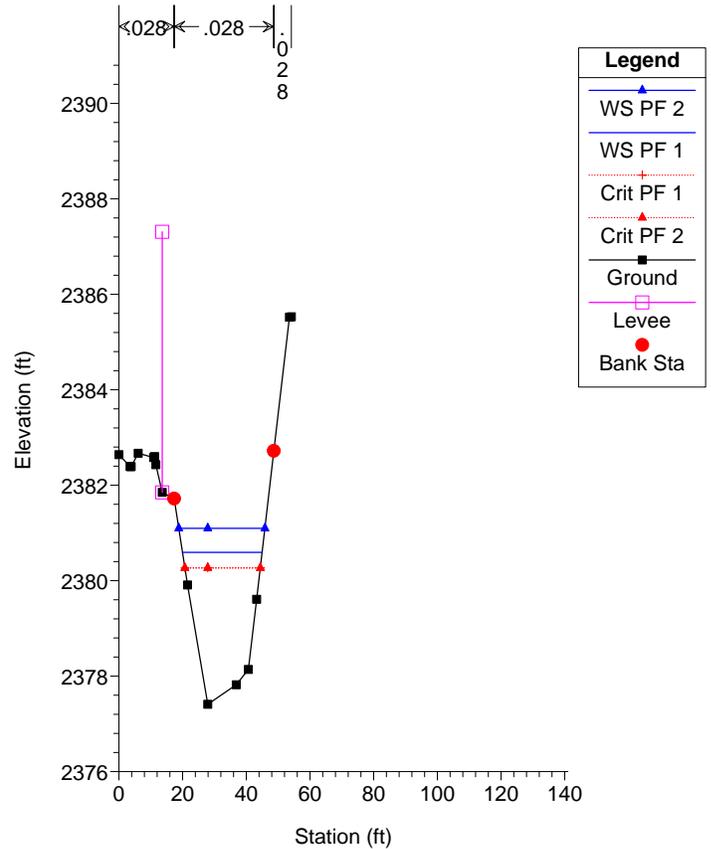
River = Overflow Reach = South RS = 74.912

Camino Real Plan: 1956cfs 6/19/2008

Geom: CaminoReal with walls

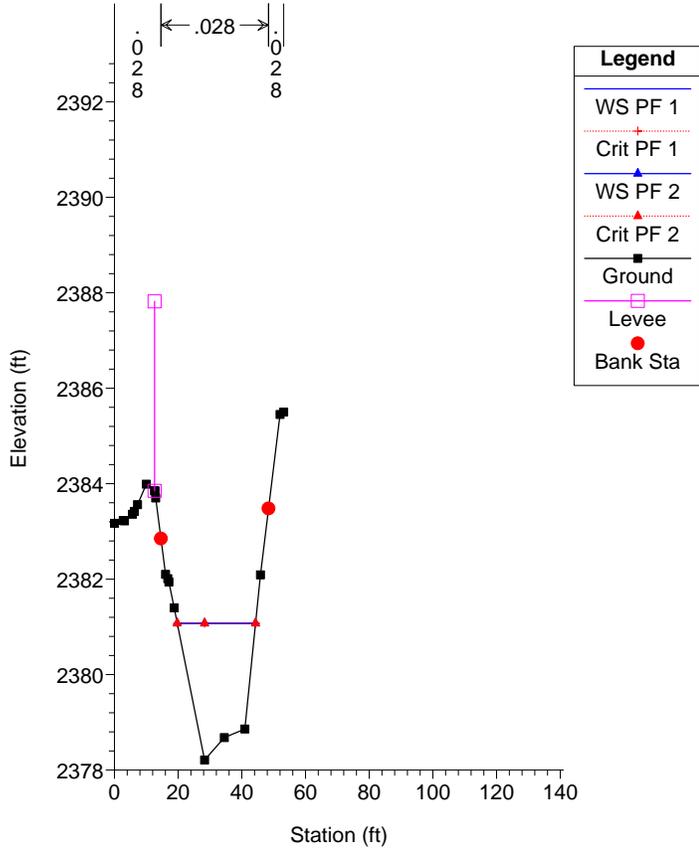
River = Overflow Reach = South RS = 99.652

Camino Real Plan: 1956cfs 6/19/2008

Geom: CaminoReal with walls

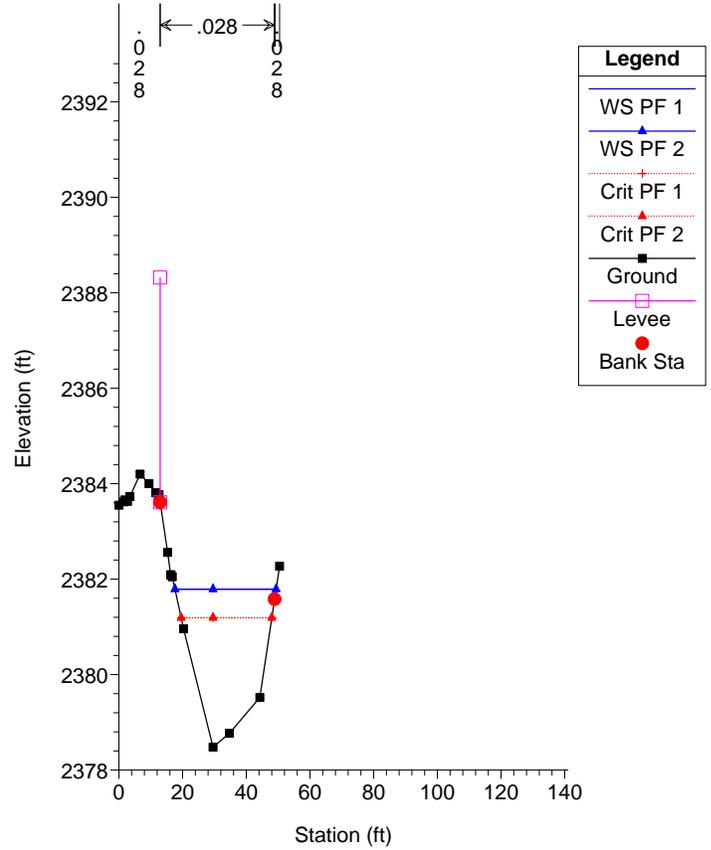
River = Overflow Reach = South RS = 129.767

Camino Real Plan: 1956cfs 6/19/2008

Geom: CaminoReal with walls

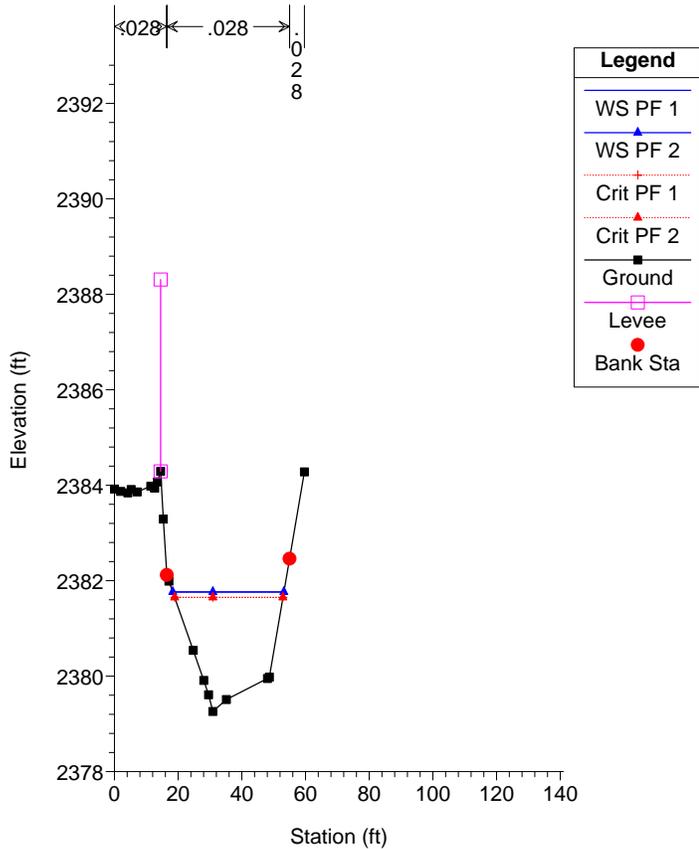
River = Overflow Reach = South RS = 149.791

Camino Real Plan: 1956cfs 6/19/2008

Geom: CaminoReal with walls

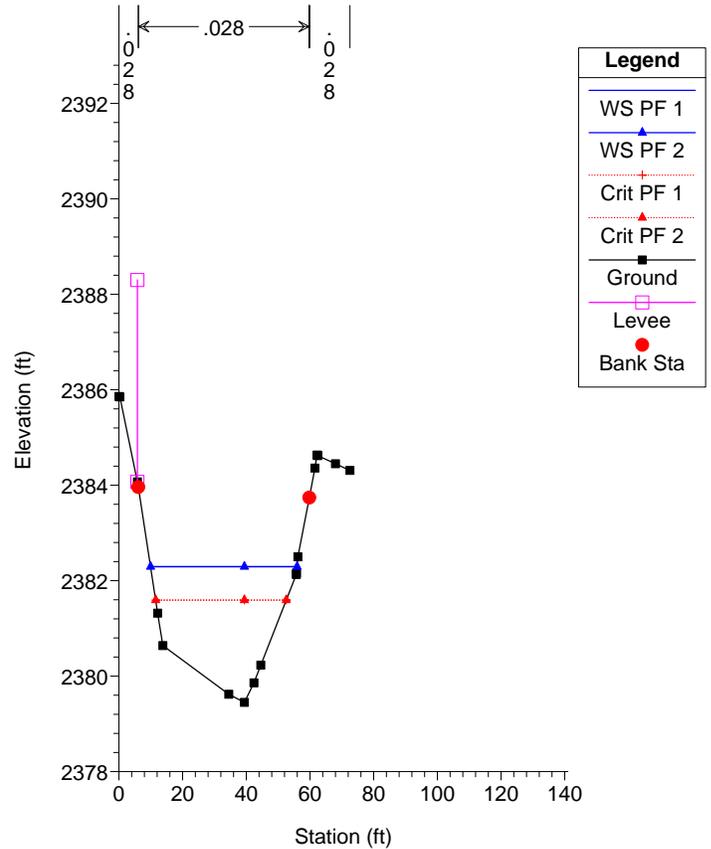
River = Overflow Reach = South RS = 174.844

Camino Real Plan: 1956cfs 6/19/2008

Geom: CaminoReal with walls

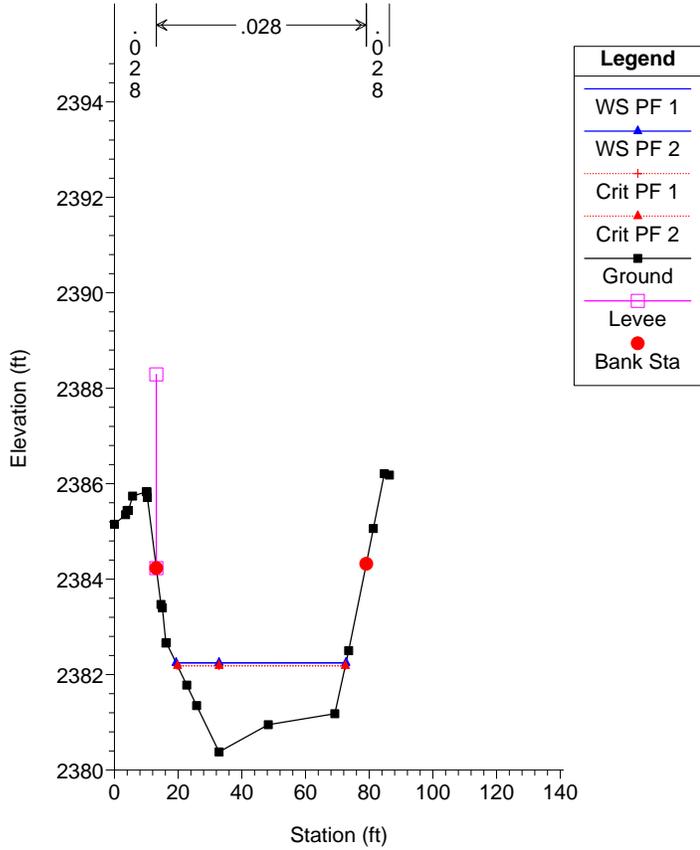
River = Overflow Reach = South RS = 199.788

Camino Real Plan: 1956cfs 6/19/2008

Geom: CaminoReal with walls

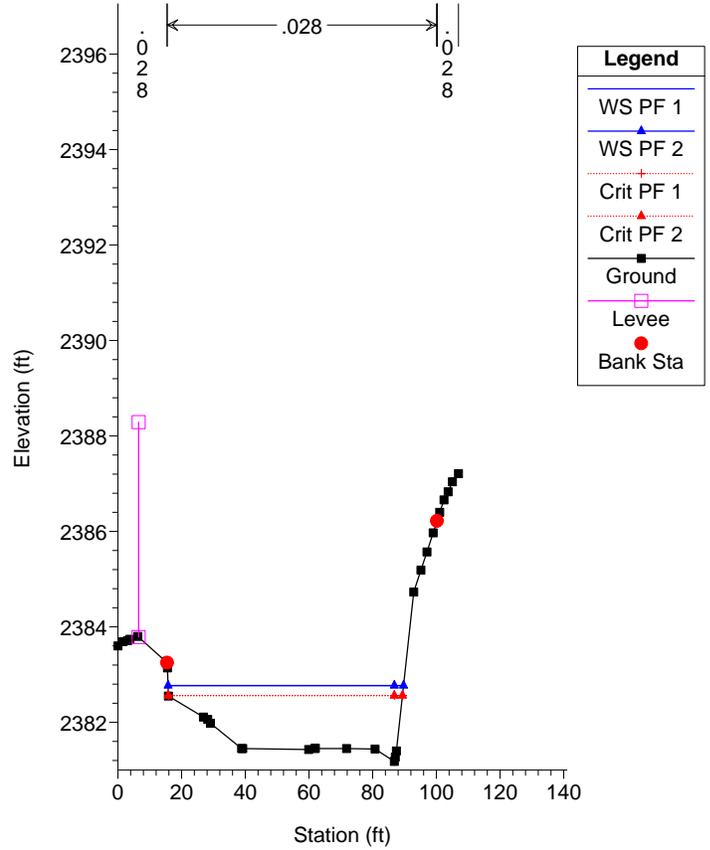
River = Overflow Reach = South RS = 237.369

Camino Real Plan: 1956cfs 6/19/2008

Geom: CaminoReal with walls
