**TECHNICAL DATA NOTEBOOK  
FOR**

**Camino Real Wash,  
Pima County, AZ**

**Contract #25-59-C-13522-0507**

**Prepared For:  
Pima County Regional Flood Control District  
97 E. Congress, 3<sup>rd</sup> Floor  
Tucson, AZ 85701**

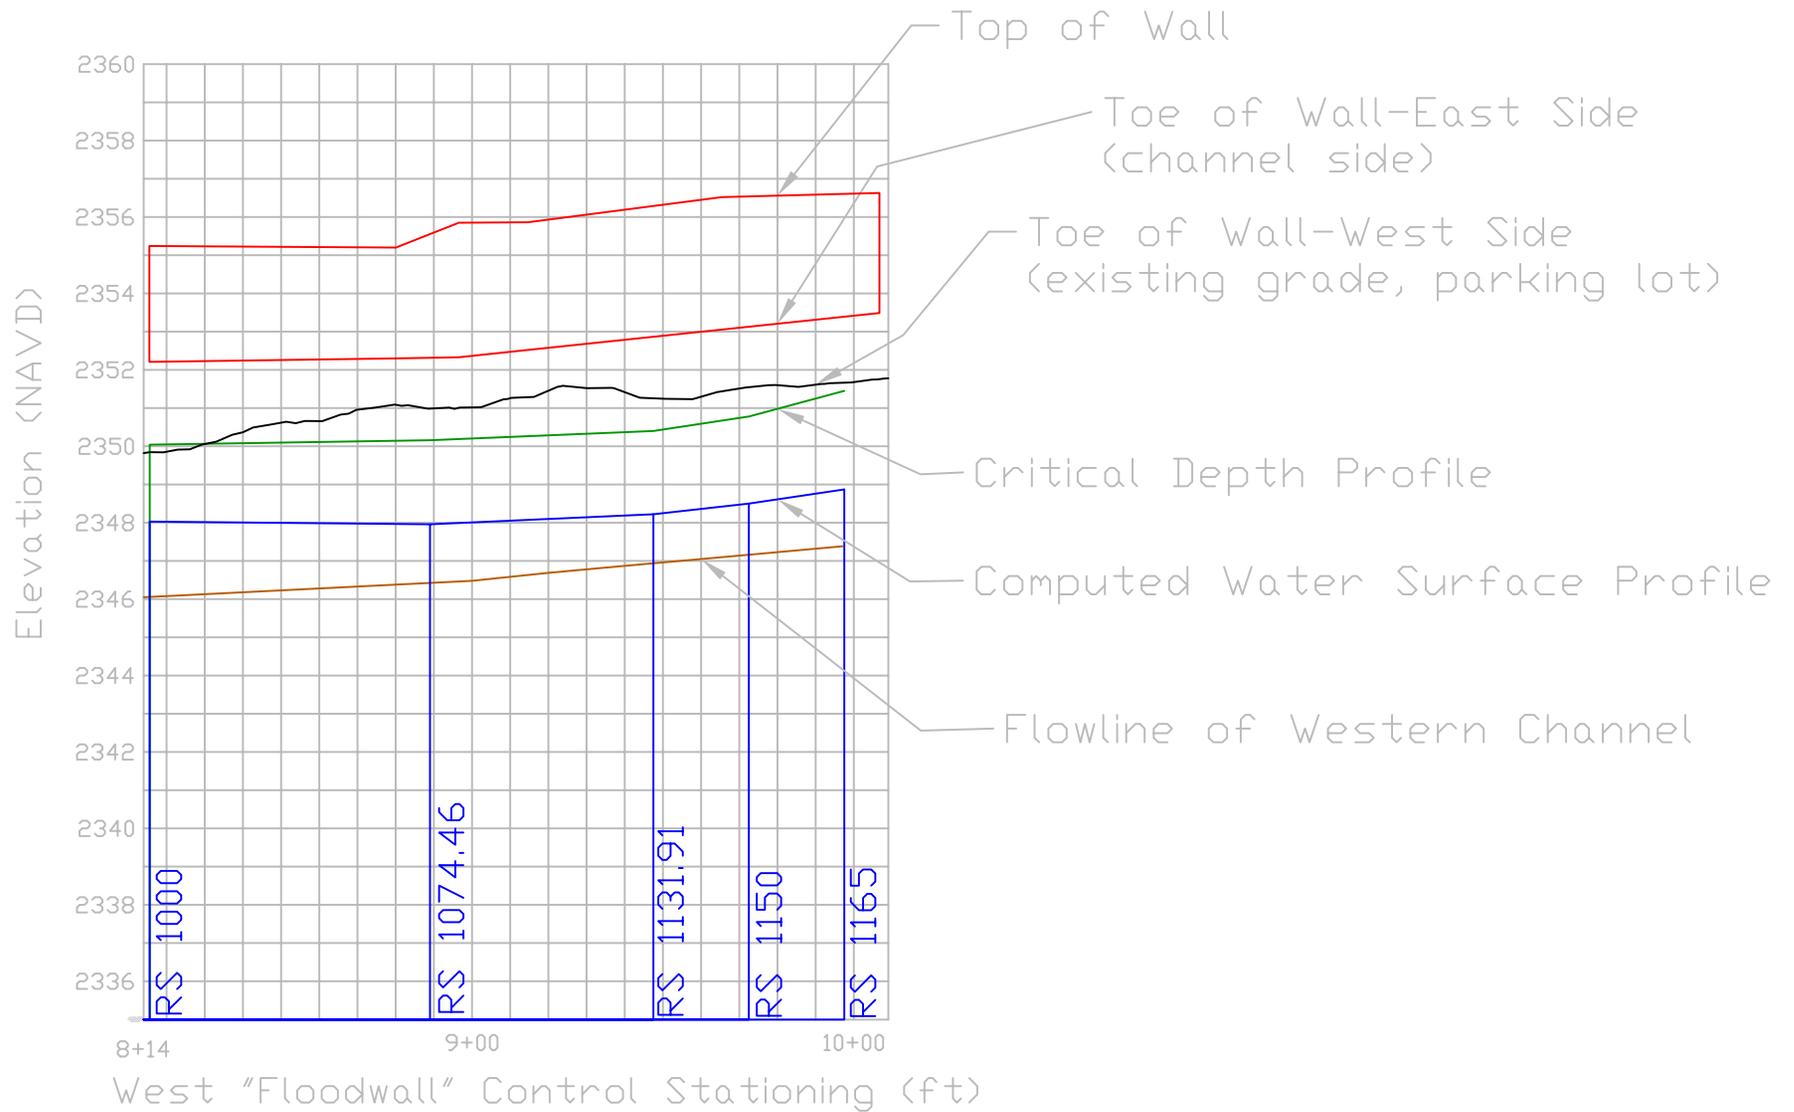
## Exhibit 2a

### Profile of West Wall

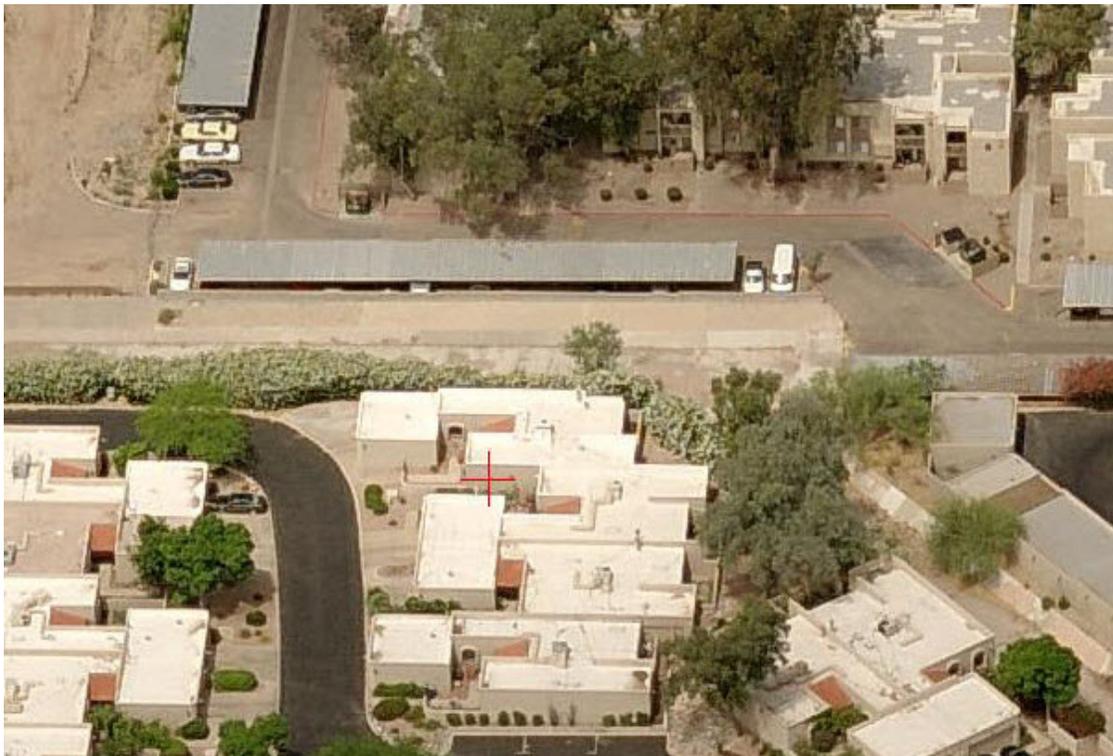
Looking west at the west wall (in front of carport) along the west top-of-bank of the north to south reach of the western channel.

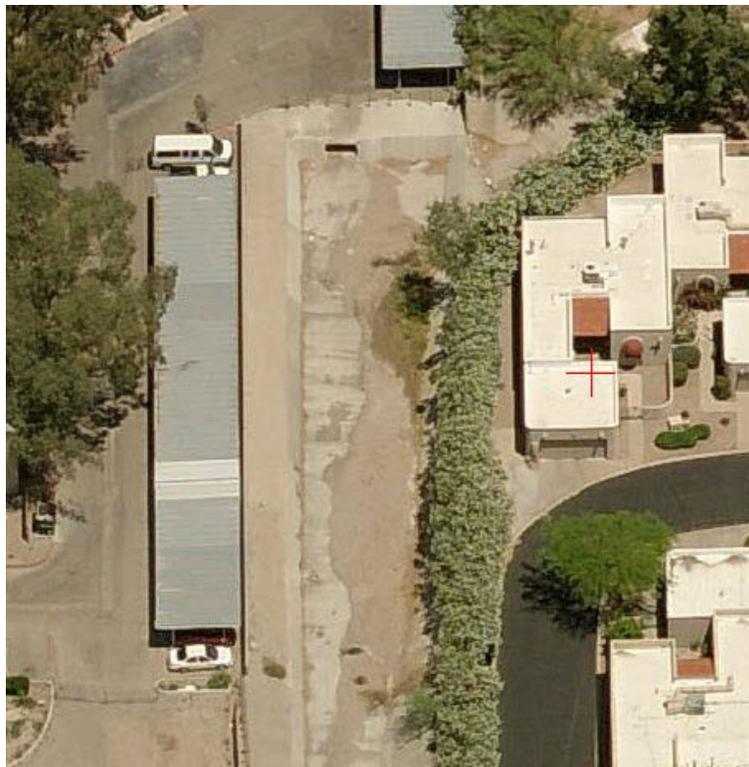
Looking down on the junction of the north to south reach with the northeast to southwest reach (entering at upper right corner of photograph) of the western channel.

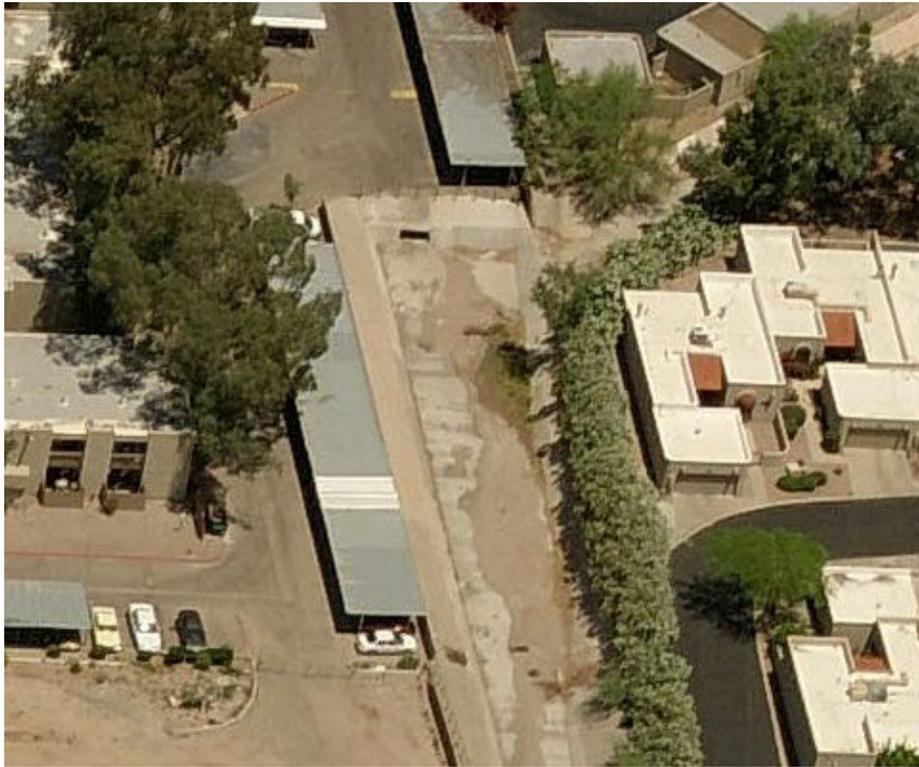
Looking northeast at the junction of the north to south reach with the northeast to southwest reach (entering at upper right corner of photograph).

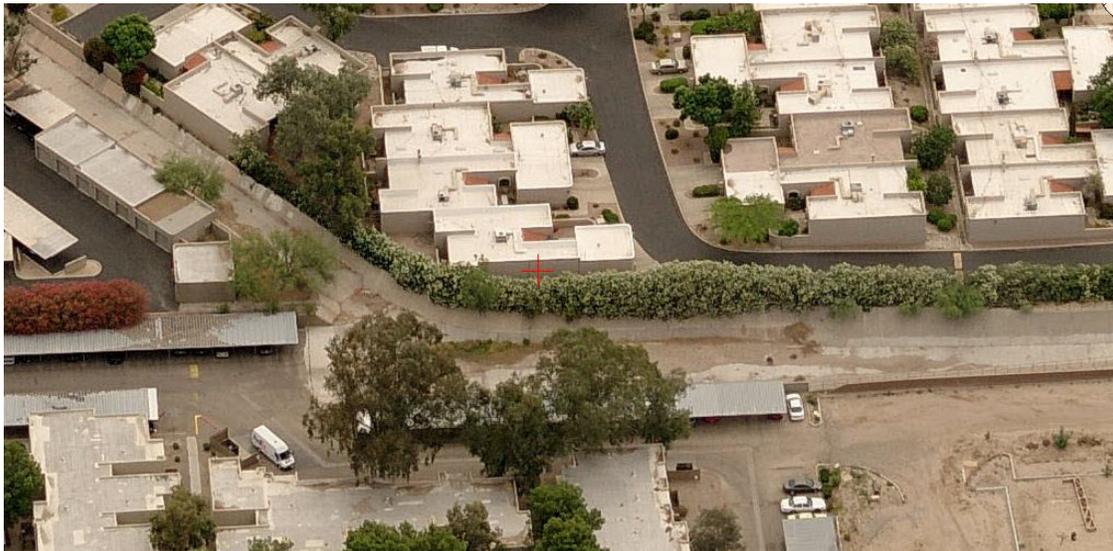
Looking east at junction of north-south reach with northeast-southwest reach (entering at upper left corner of photograph). The first in a series of two three-foot drops is visible just upstream of junction.

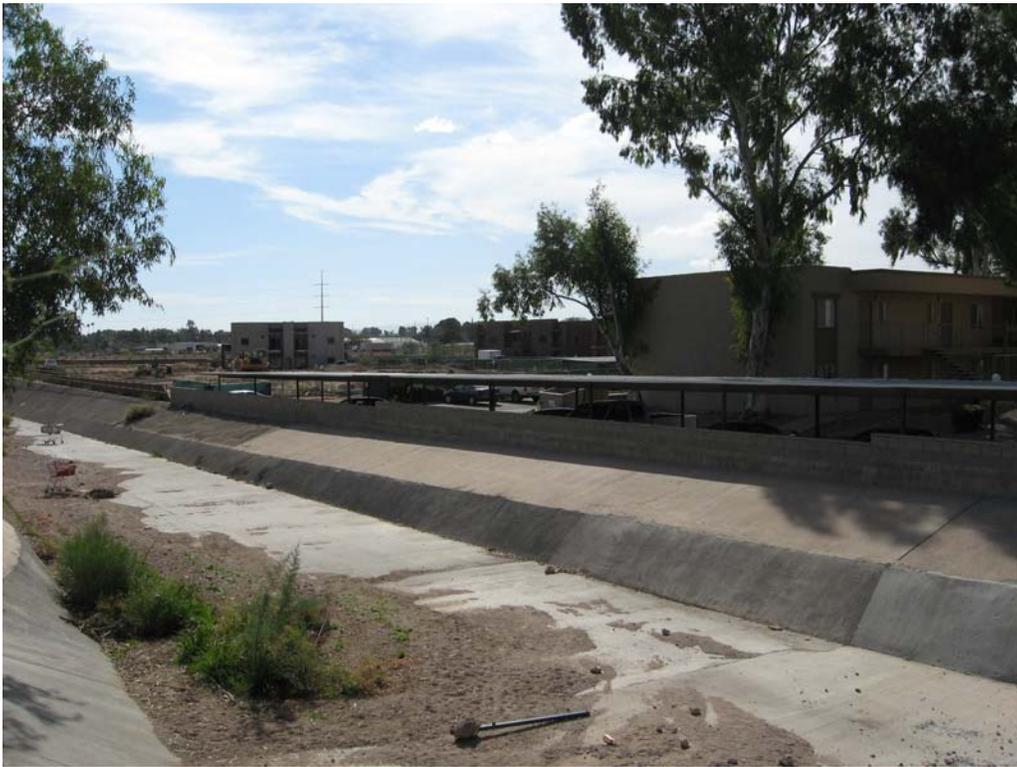
Looking southwest at the west wall along the top of bank of the north to south reach of the western channel.

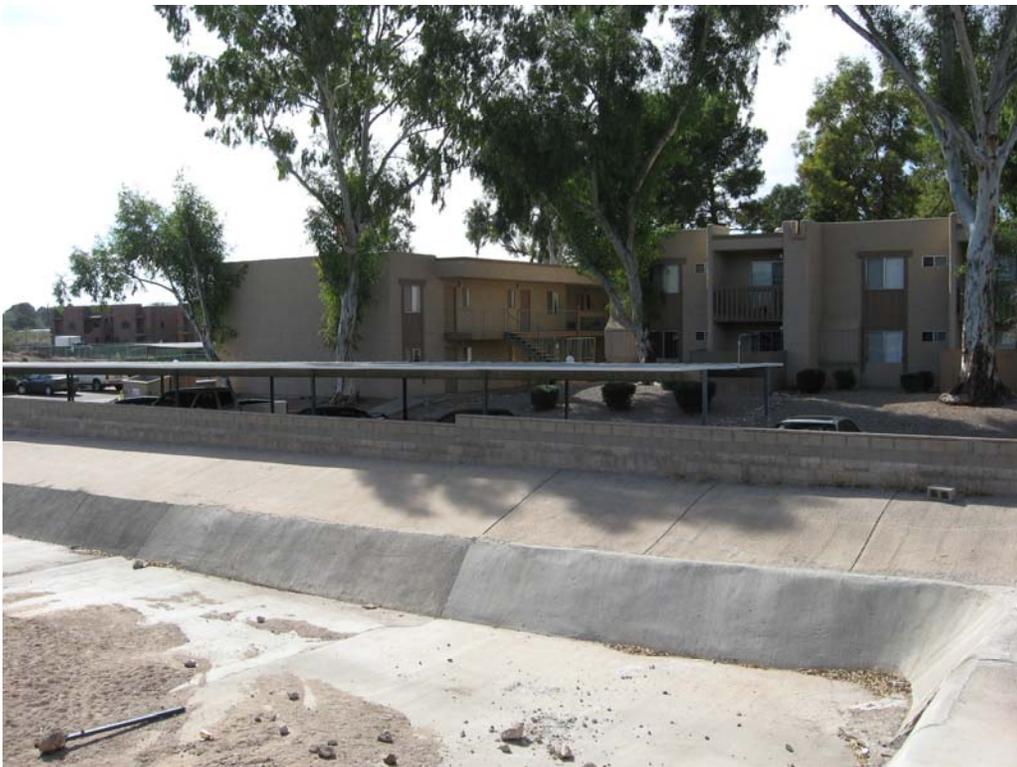
Looking southwest at the west wall along the top of bank of the north to south reach of the western channel.

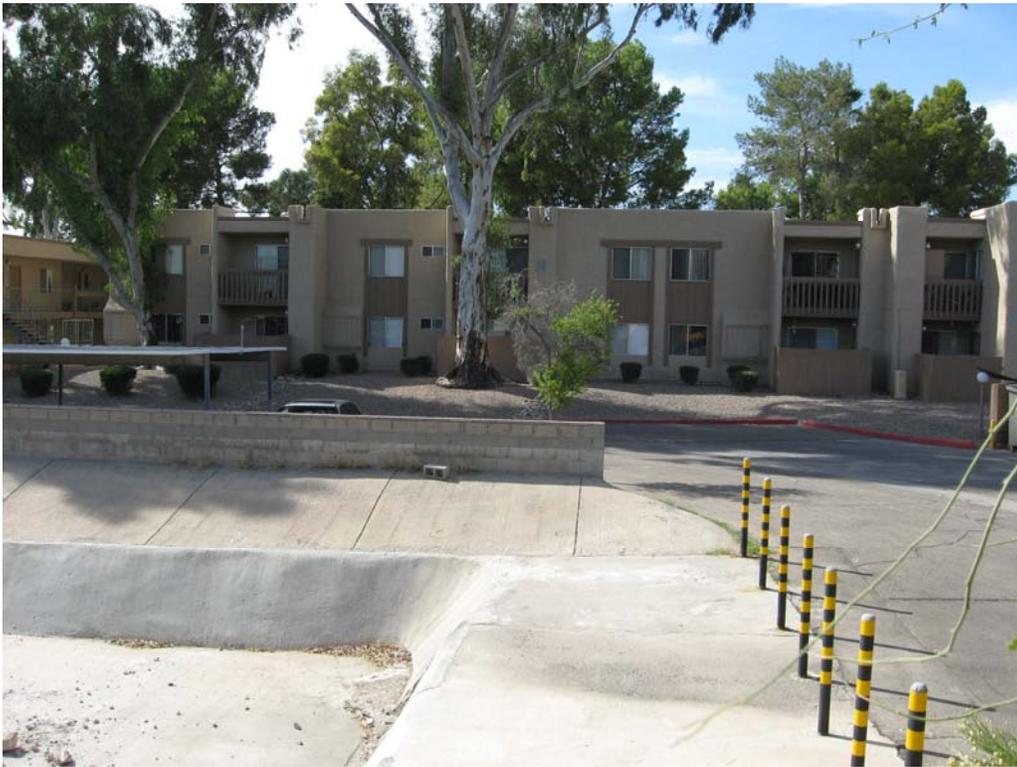
Looking west at the northern limit of the west wall  
along the top of bank of the western channel

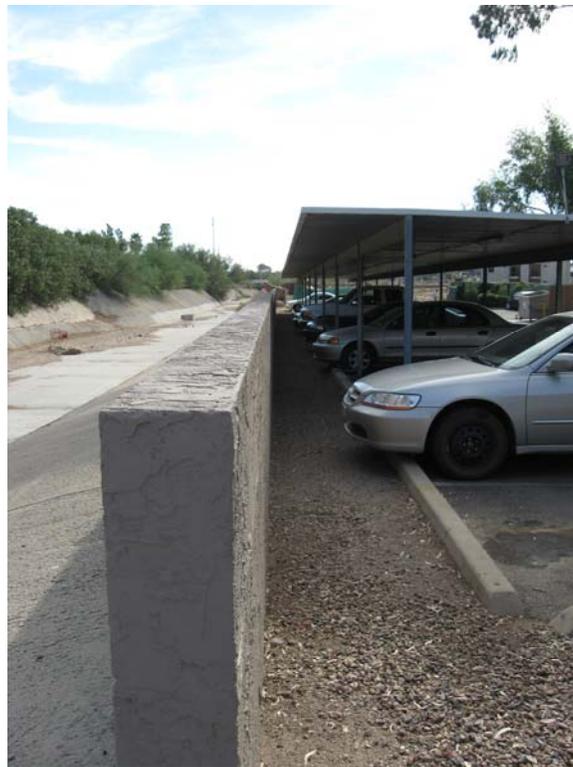
Looking south along the parking lot side of the west wall from the north limit.

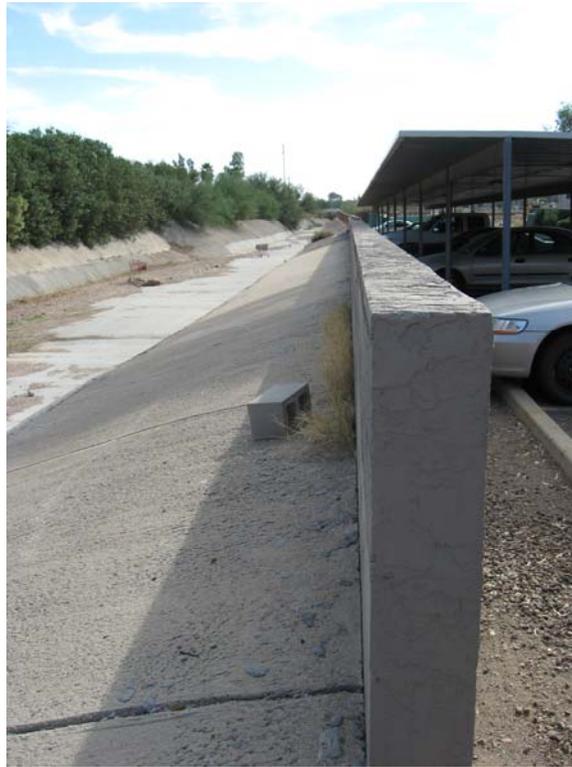
Looking south along the channel side of the west wall from the north limit.

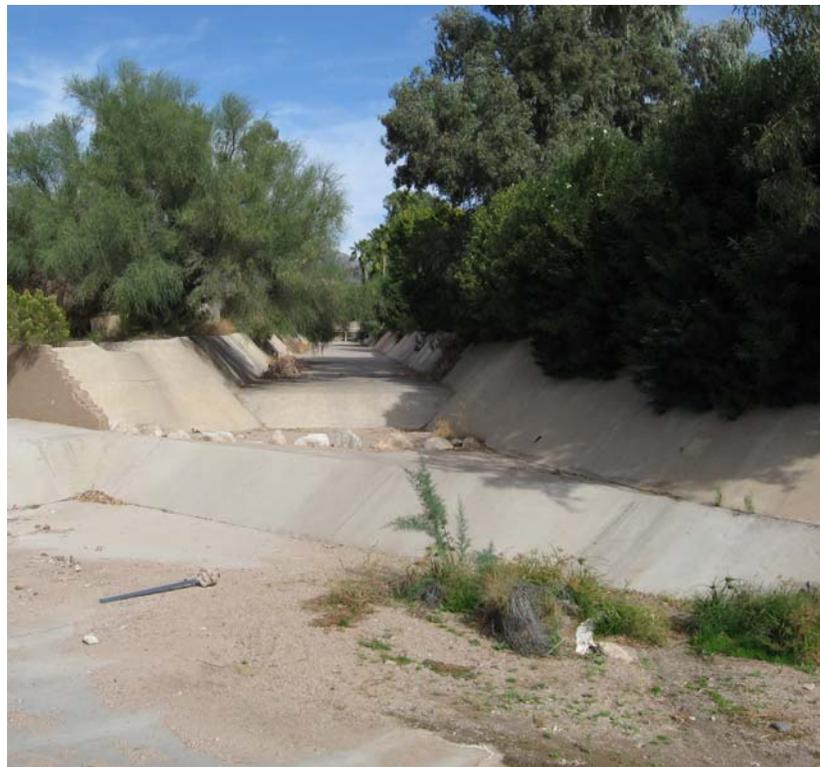
Looking northeast along the northeast to southwest reach of the western channel from its junction with the north to south reach (note the series of two three-foot drops in the flow line just upstream of the junction).

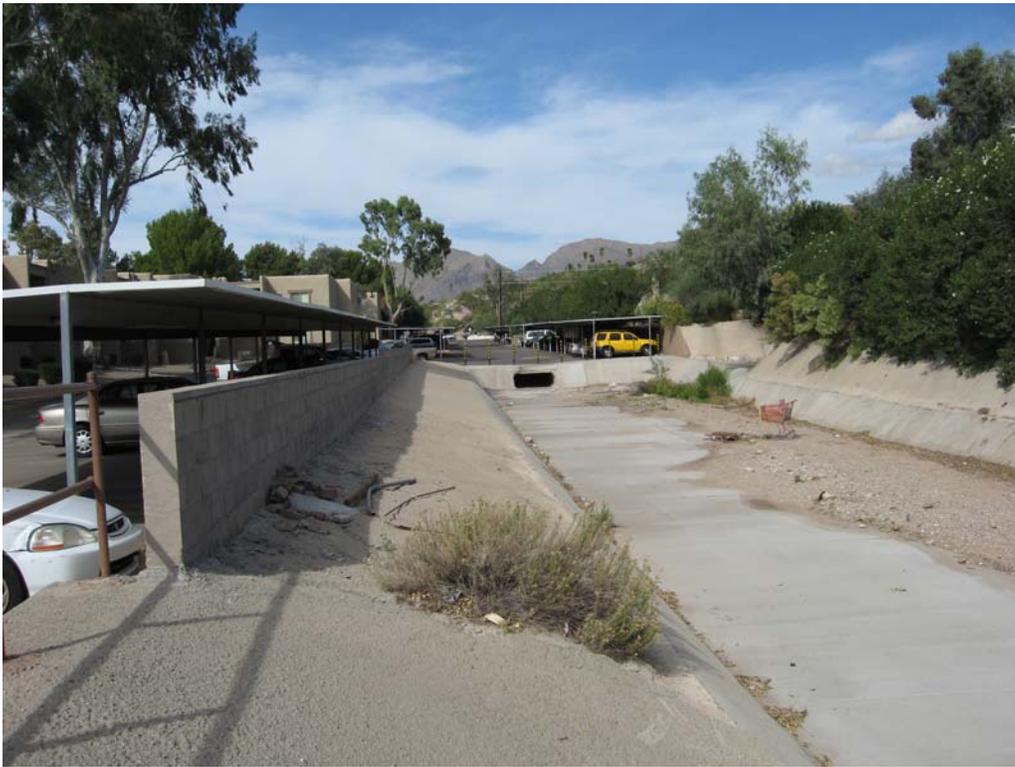
Looking north (upstream) at the junction of the north to south reach of the western channel with the northeast to southwest reach, including the southern limit of the west wall.

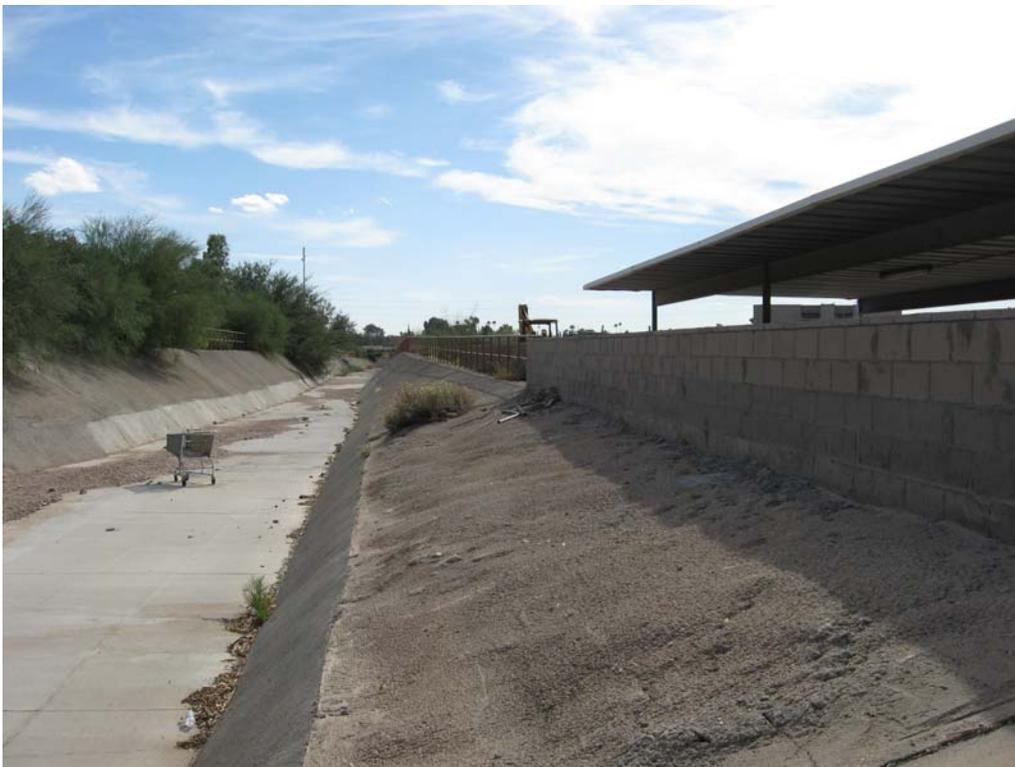
Looking downstream along the west bank from the junction of the north to south reach of the western channel with the northeast to southwest reach.

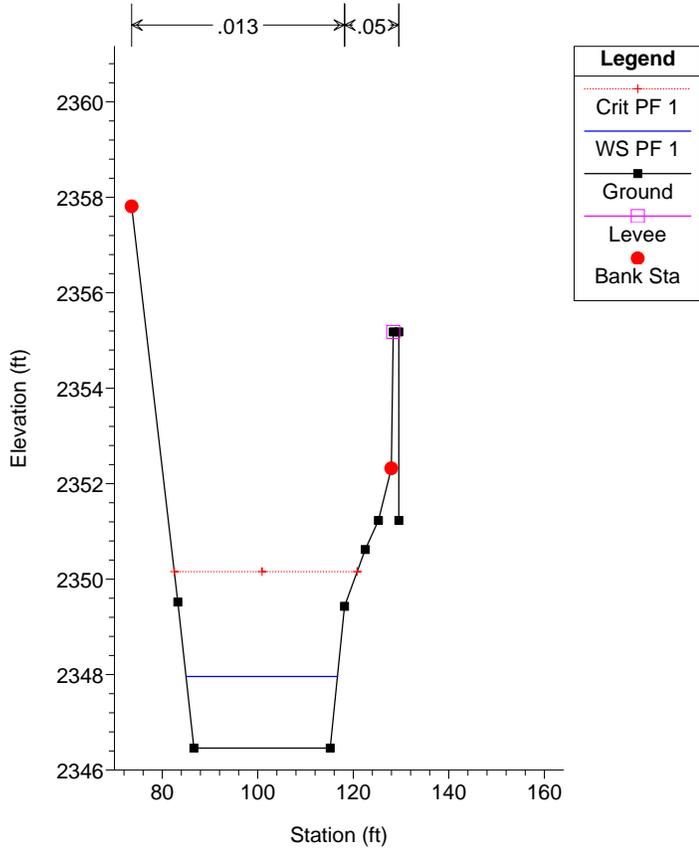
Geom: West d/s channel\_As-Builts corrected  
 River = Stream Centerli Reach = Reach 1 RS = 1074.46

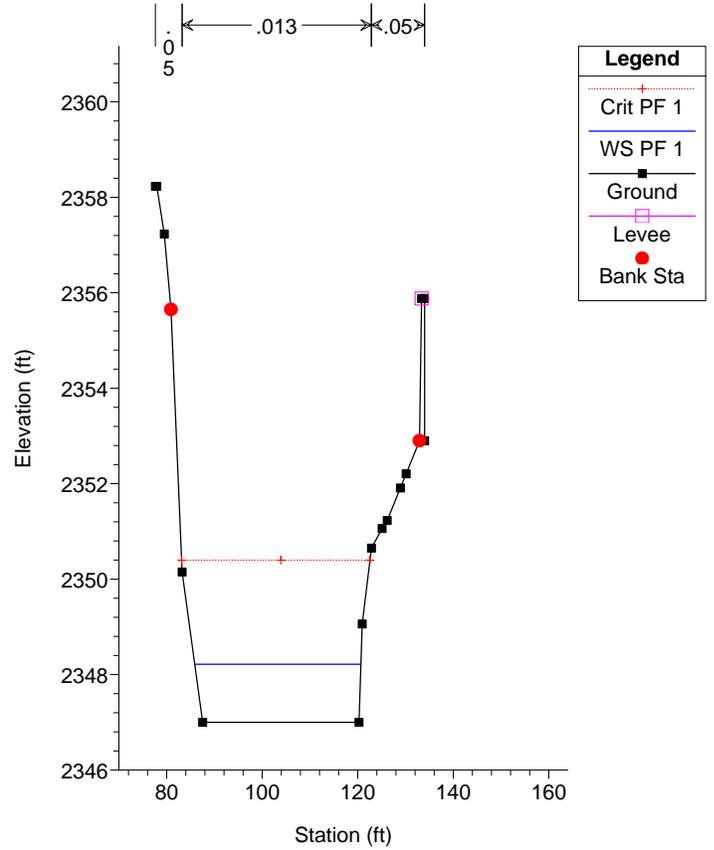
Geom: West d/s channel\_As-Builts corrected  
 River = Stream Centerli Reach = Reach 1 RS = 1131.91

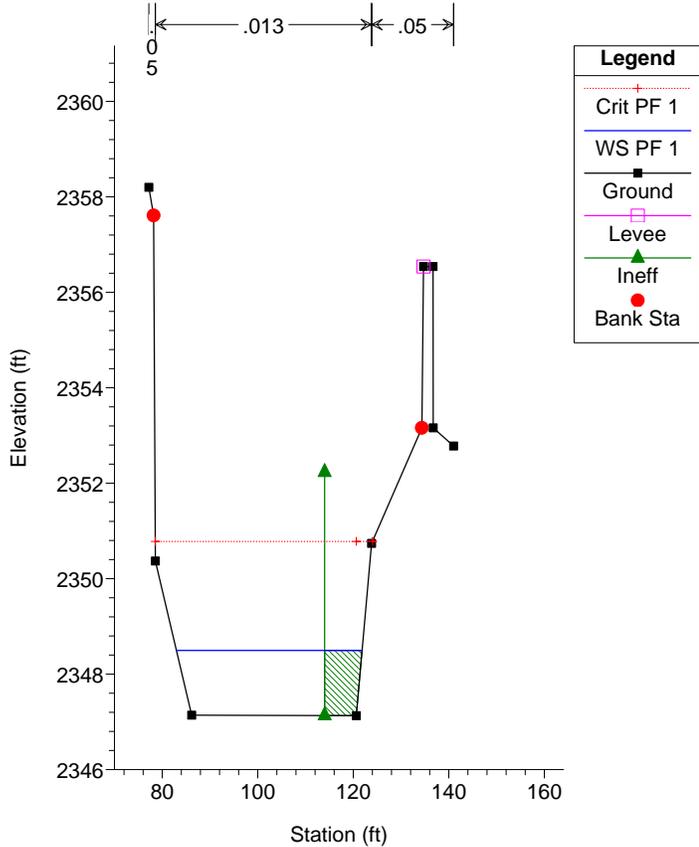
Geom: West d/s channel\_As-Builts corrected  
 River = Stream Centerli Reach = Reach 1 RS = 1150

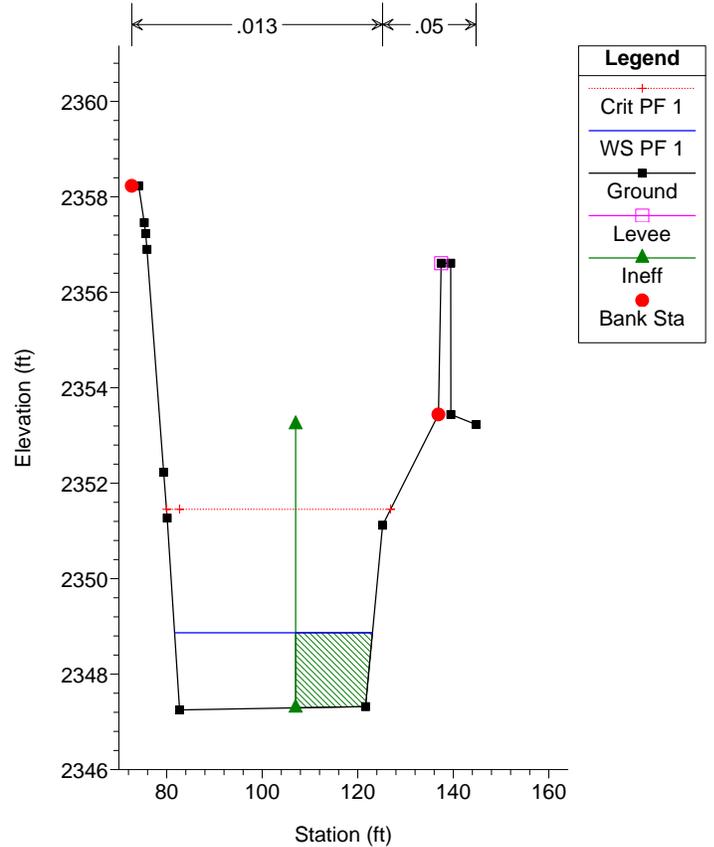
Geom: West d/s channel\_As-Builts corrected  
 River = Stream Centerli Reach = Reach 1 RS = 1165

1 in Horiz. = 40 ft 1 in Vert. = 4 ft

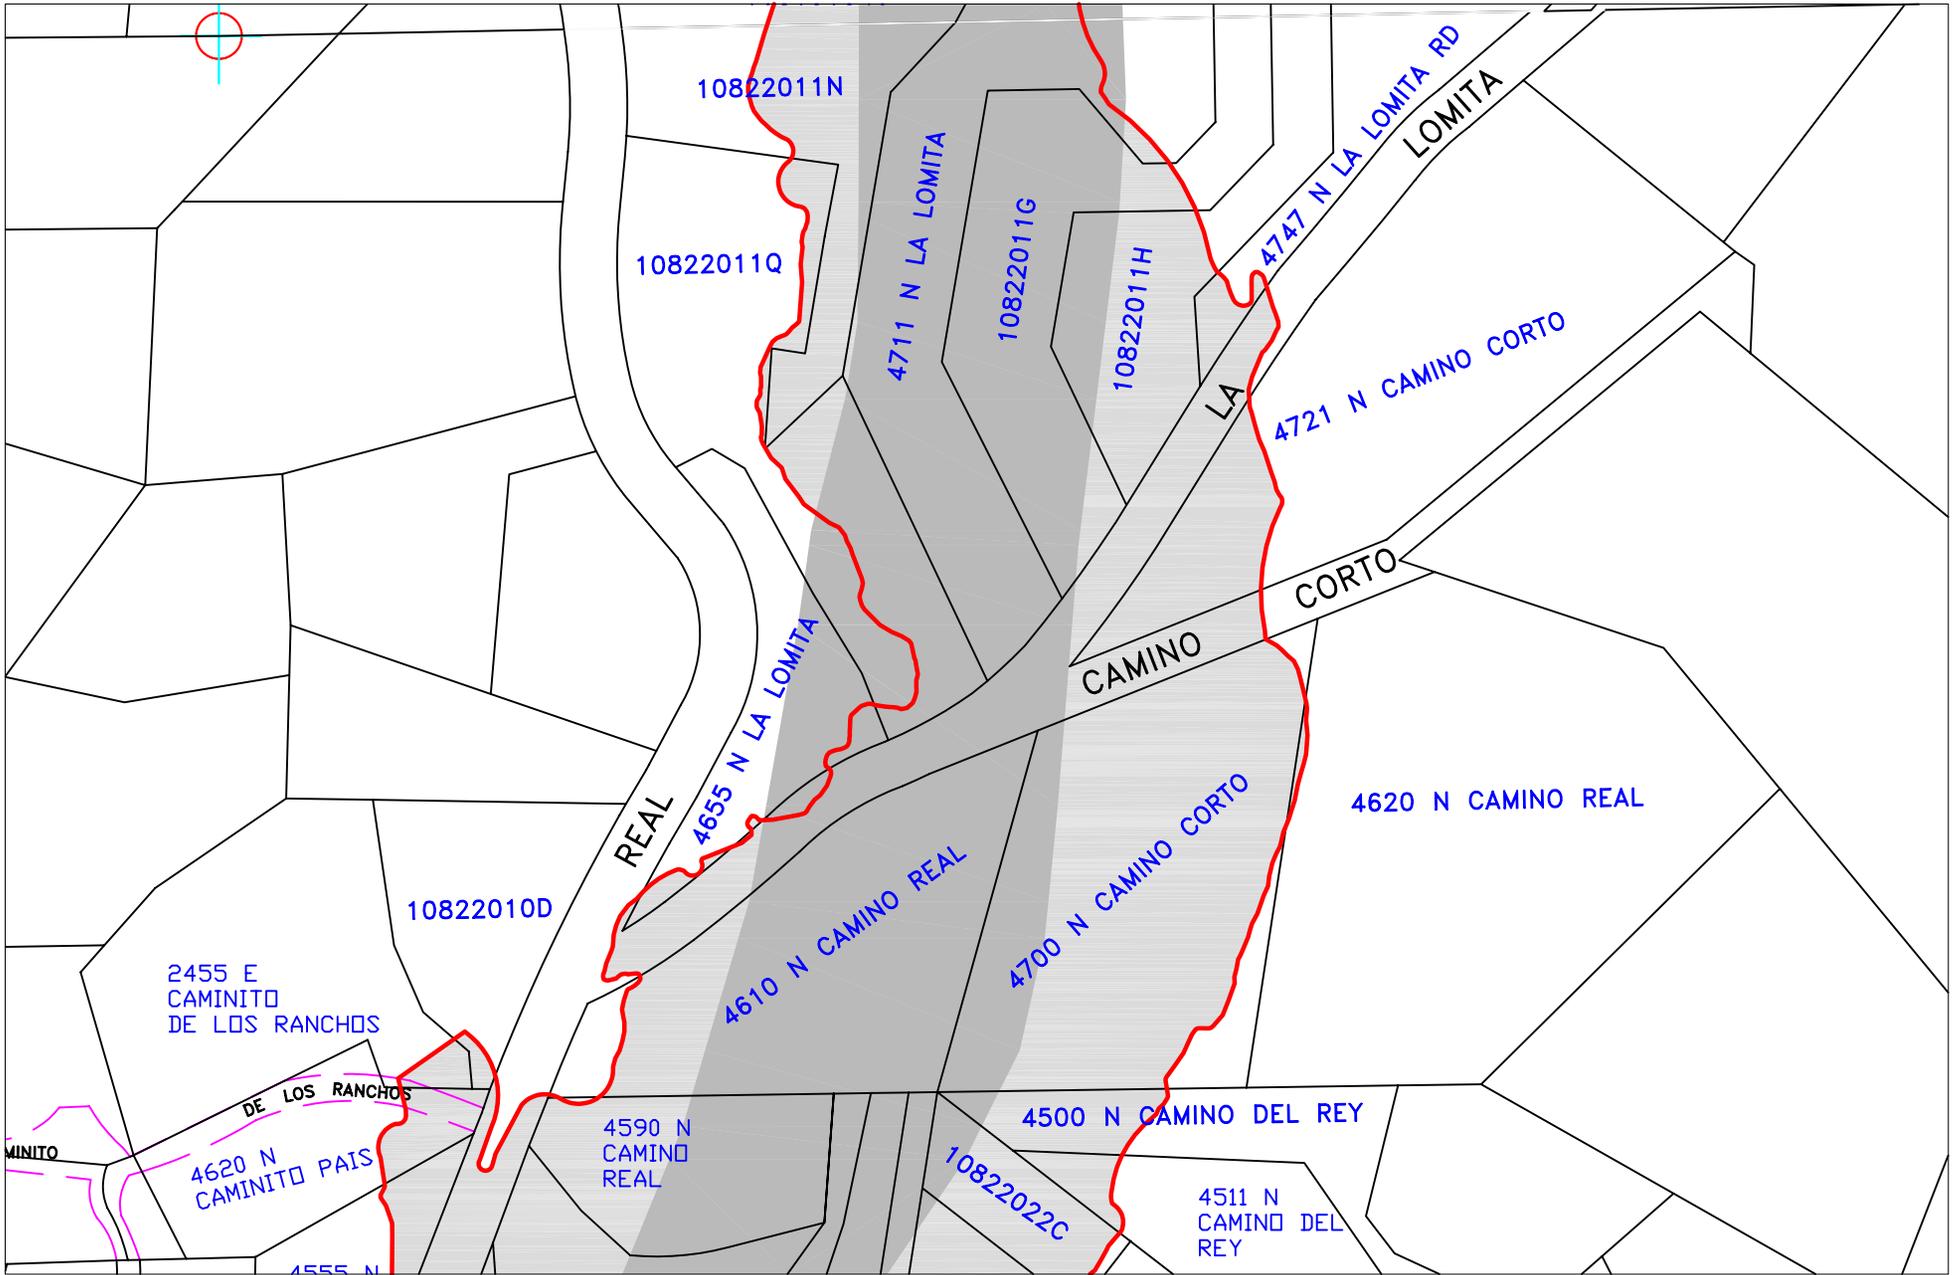
Revised Floodplain Exhibit

Revised Zone A Boundary (Map 2)

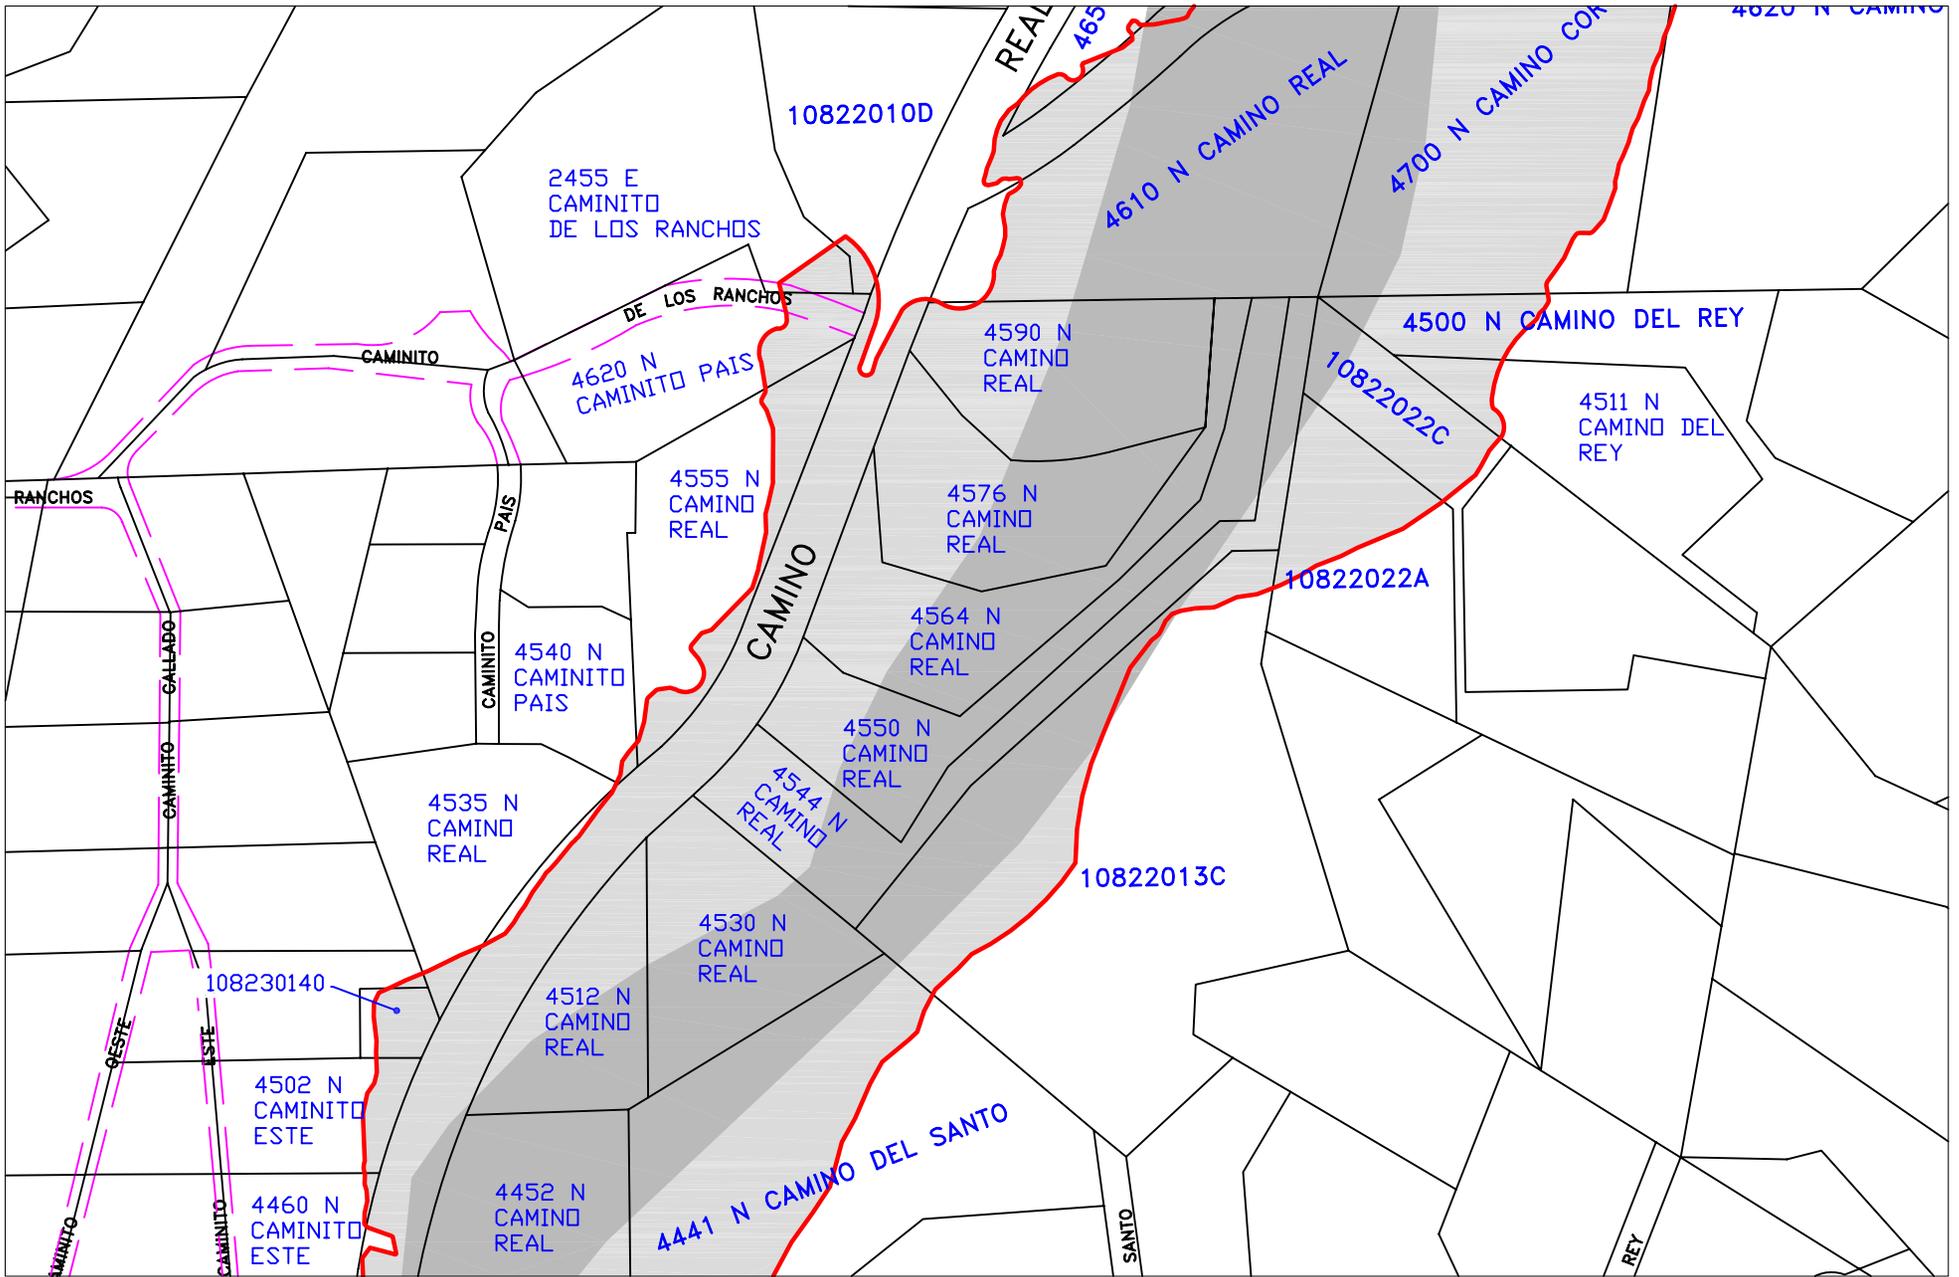
**Revised Floodplain Exhibit**

Revised Zone A Boundary (Map 3)

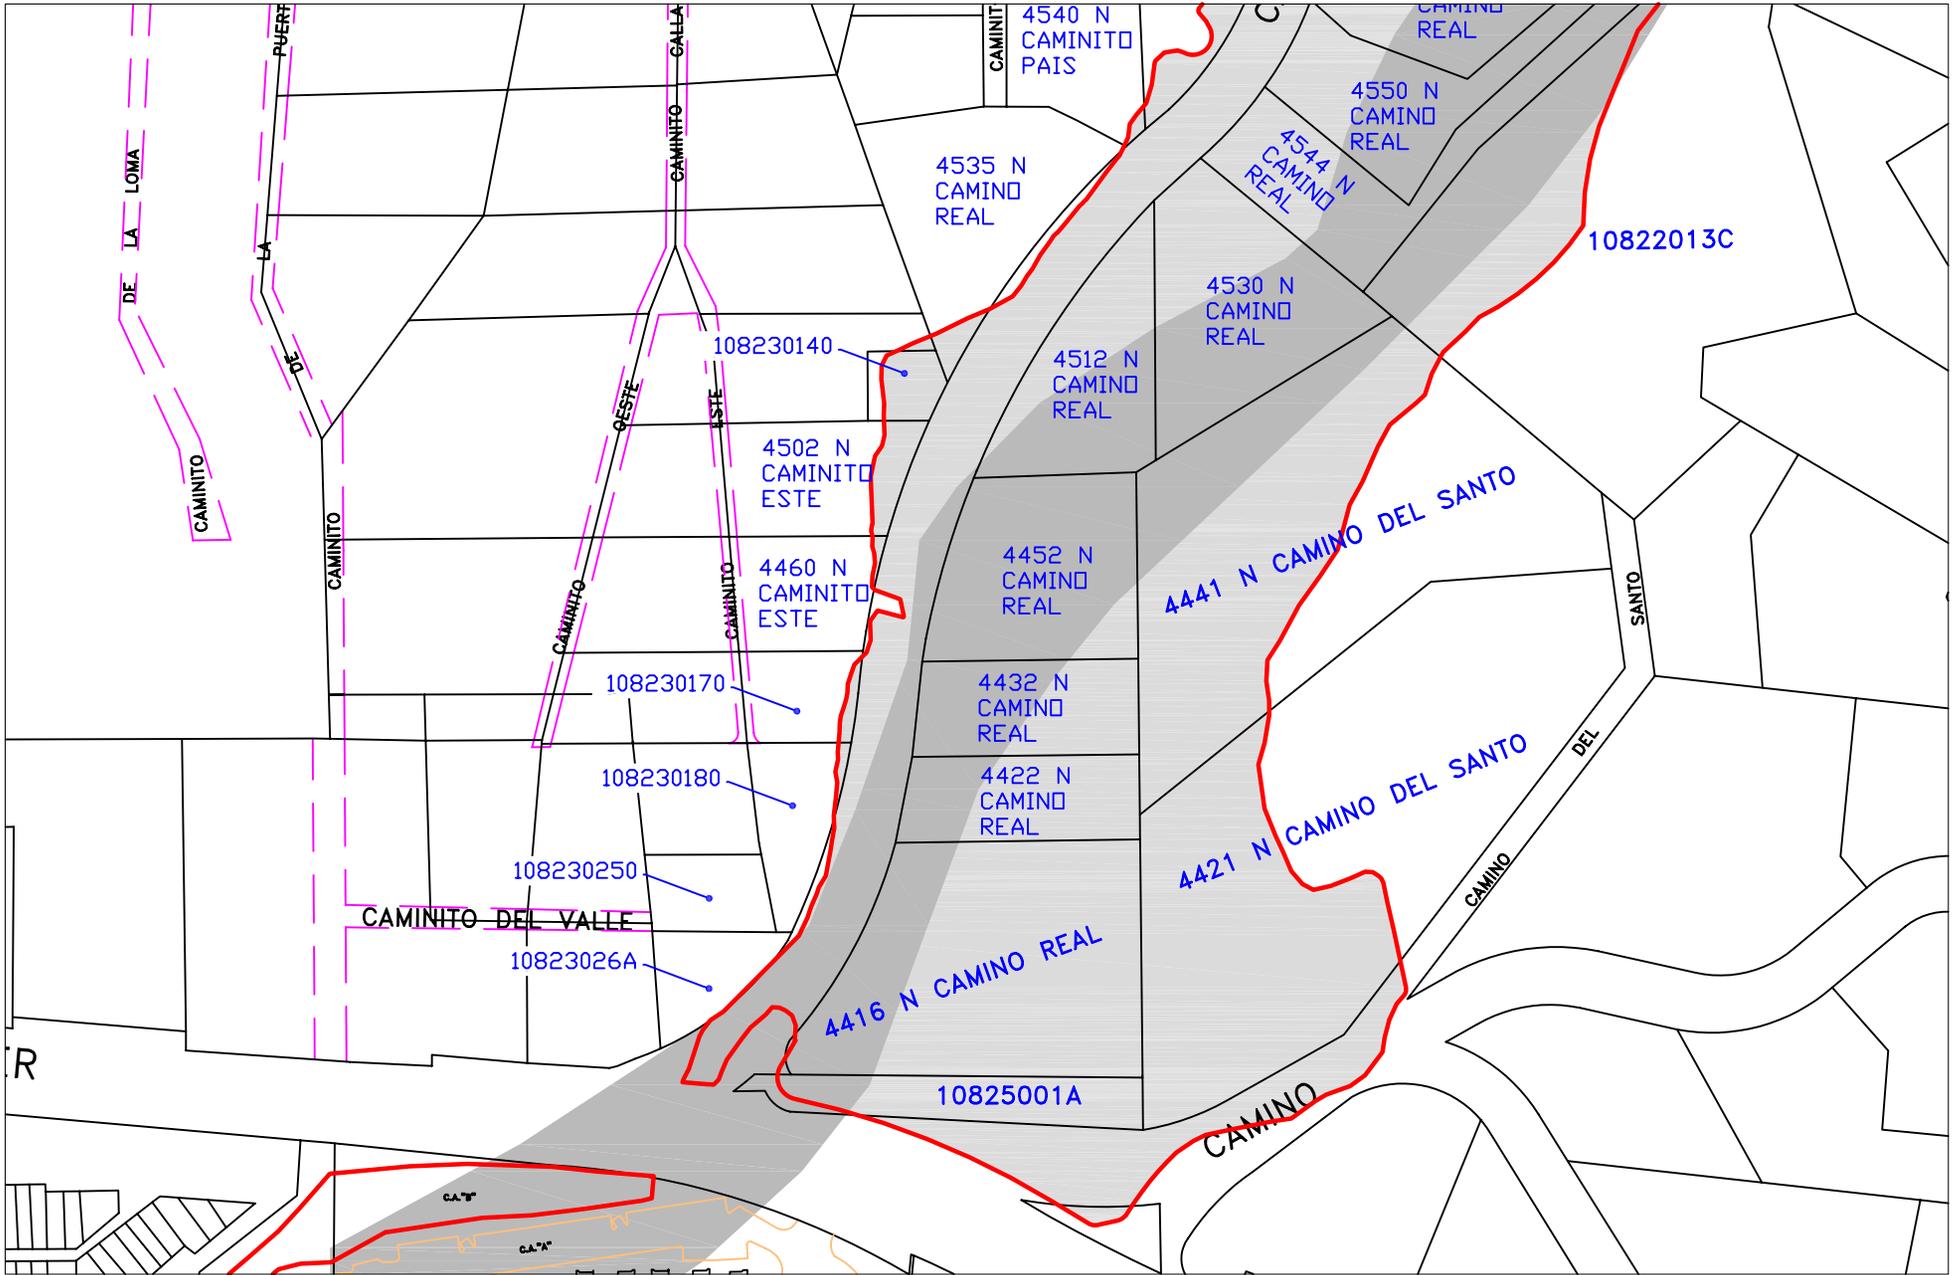
- Current Zone A Boundary
- Revised Zone A Boundary (Map 4)

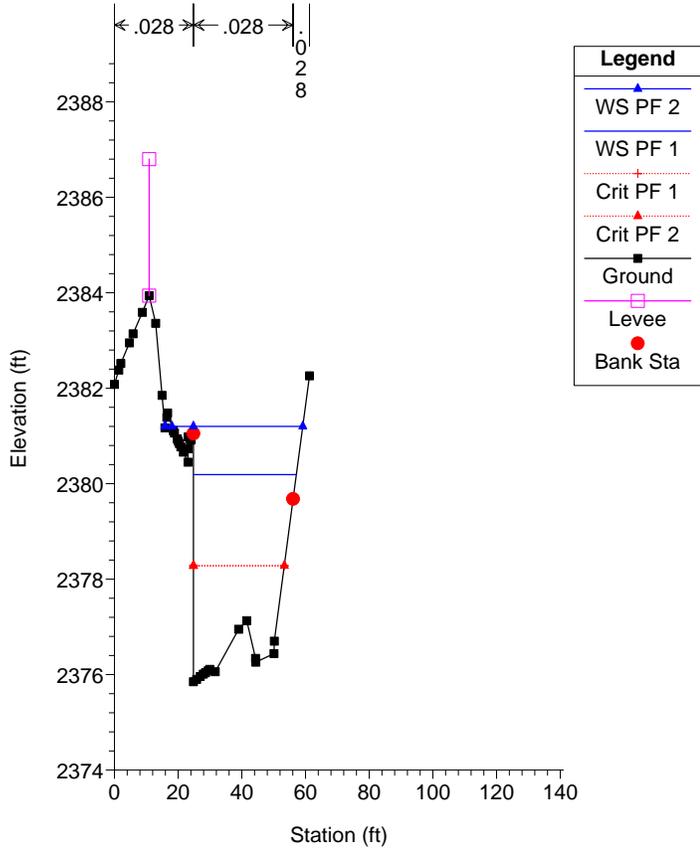
Geom: CaminoReal with walls

River = Overflow Reach = South RS = 0.002

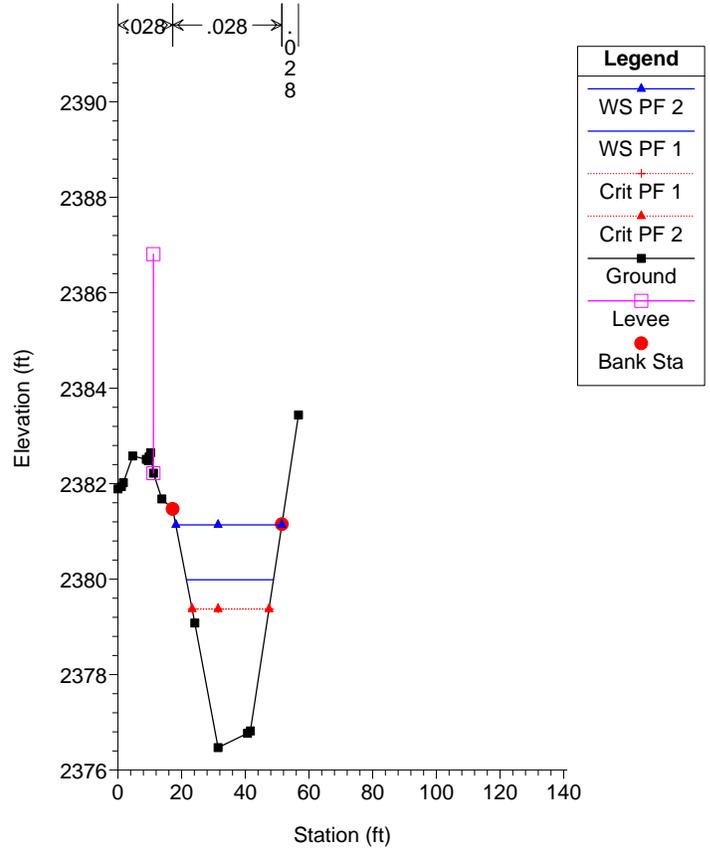
Geom: CaminoReal with walls

River = Overflow Reach = South RS = 25.041

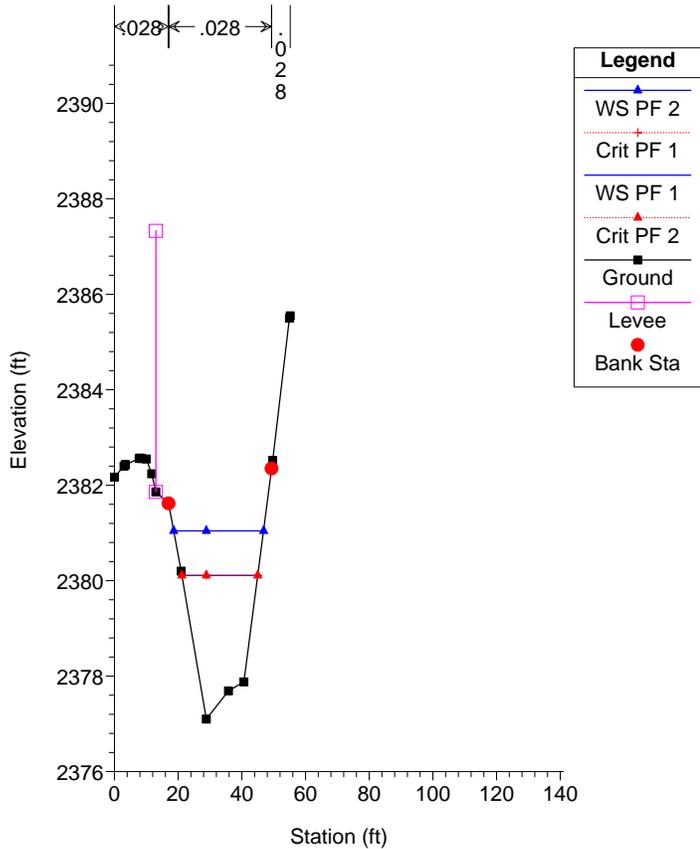
Geom: CaminoReal with walls

River = Overflow Reach = South RS = 50.145

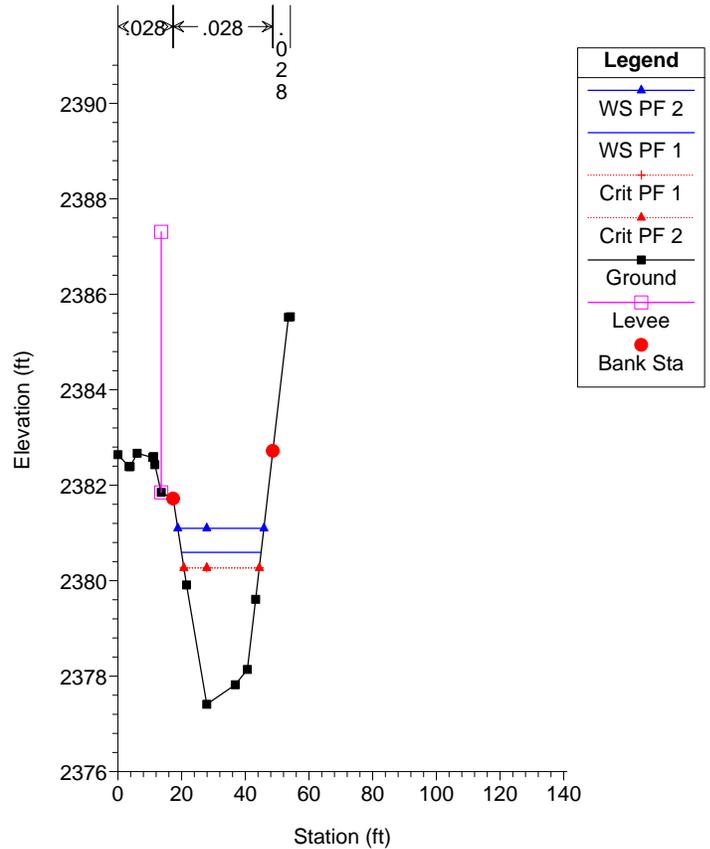
Geom: CaminoReal with walls

River = Overflow Reach = South RS = 74.912

1 in Horiz. = 60 ft 1 in Vert. = 4 ft
