**TECHNICAL DATA NOTEBOOK  
FOR**

**Camino Real Wash,  
Pima County, AZ**

**Contract #25-59-C-13522-0507**

**Prepared For:  
Pima County Regional Flood Control District  
97 E. Congress, 3<sup>rd</sup> Floor  
Tucson, AZ 85701**

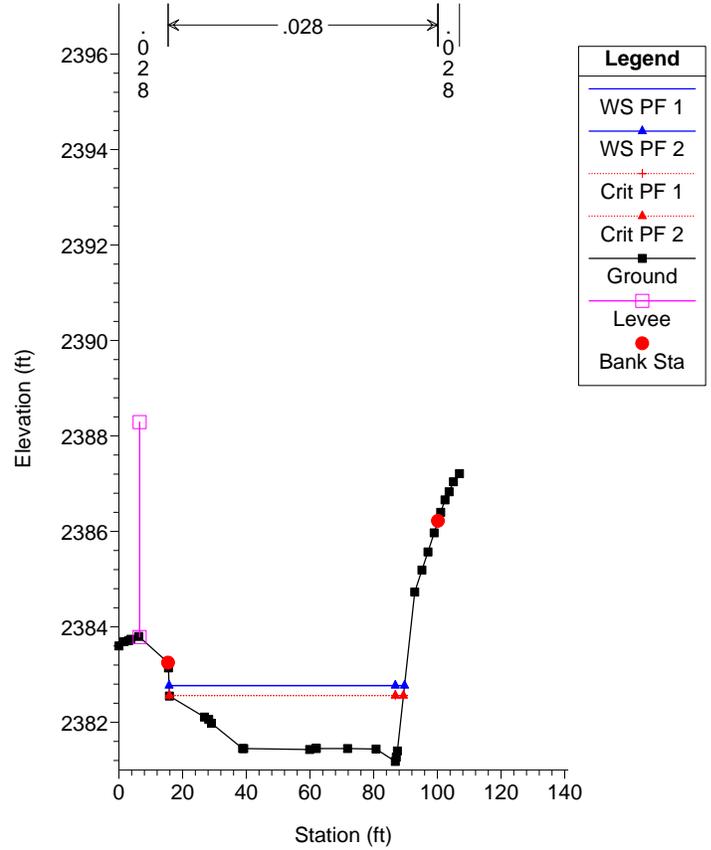
Geom: CaminoReal with walls

River = Overflow Reach = South RS = 237.369

1 in Horiz. = 60 ft 1 in Vert. = 4 ft

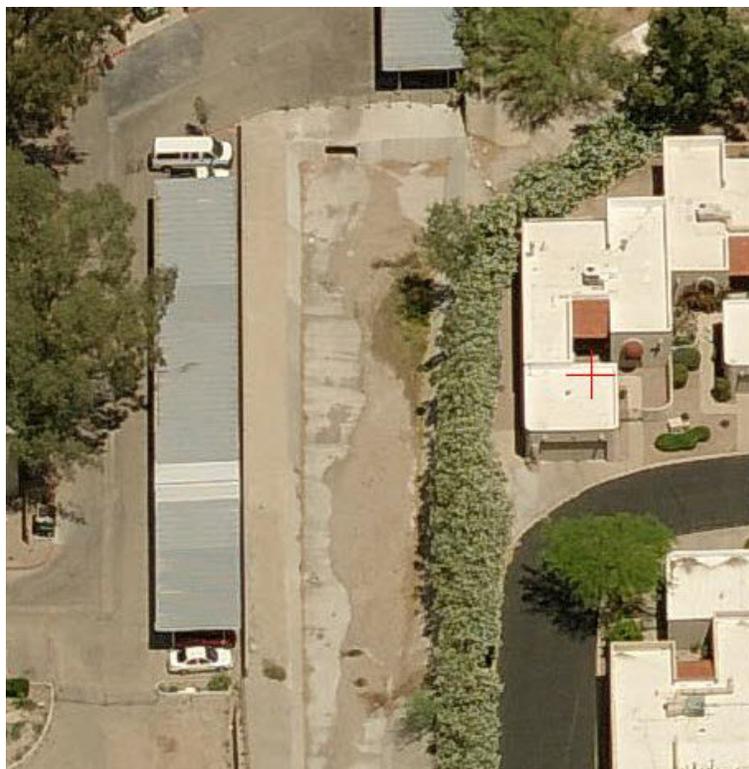
Looking down on the junction of the north to south reach with the northeast to southwest reach (entering at upper right corner of photograph) of the western channel.

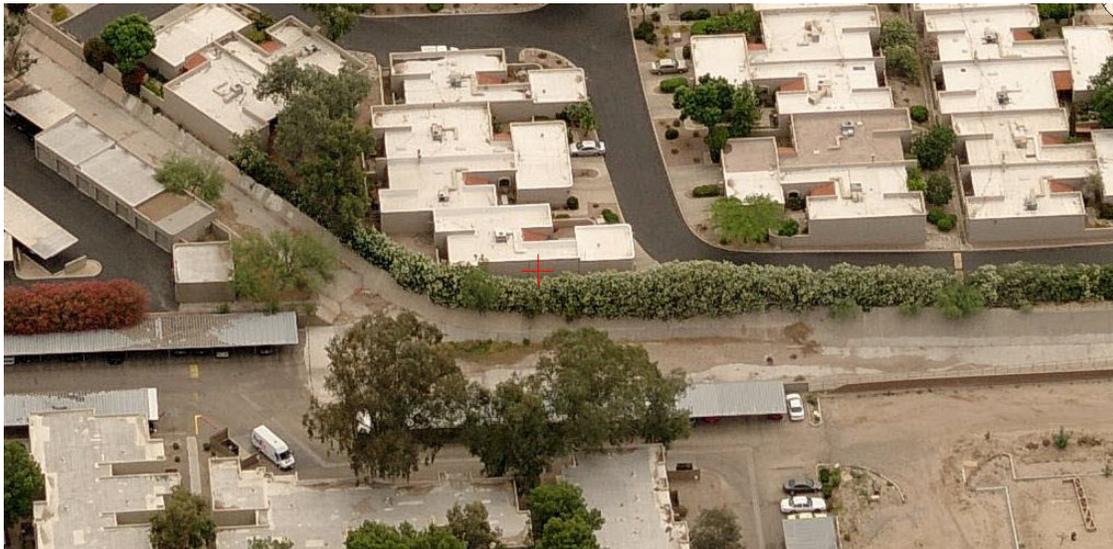
Looking east at junction of north-south reach with northeast-southwest reach (entering at upper left corner of photograph). The first in a series of two three-foot drops is visible just upstream of junction.

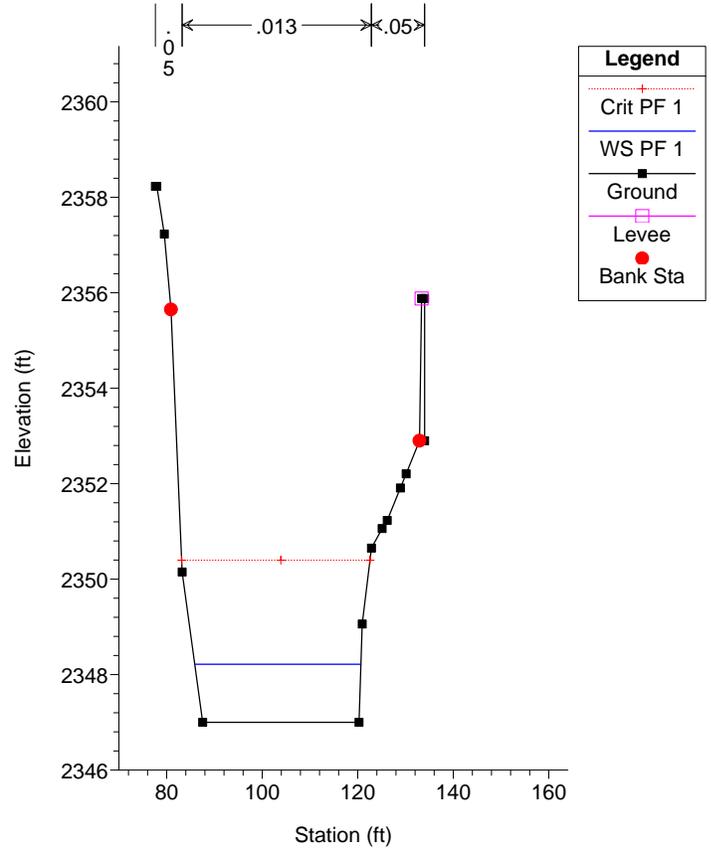
Geom: West d/s channel\_As-Builts corrected  
River = Stream Centerli Reach = Reach 1 RS = 1131.91

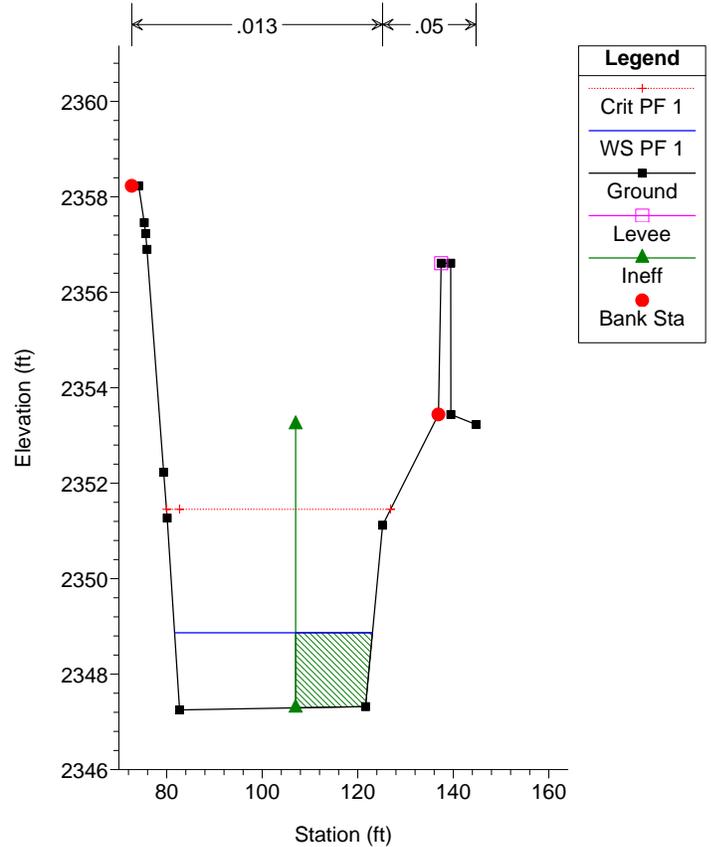
Geom: West d/s channel\_As-Builts corrected  
River = Stream Centerli Reach = Reach 1 RS = 1165

1 in Horiz. = 40 ft 1 in Vert. = 4 ft
