## Kolb Detention Basin Retrofit

### A. Project Specifications

#### 2. **Project Type (e.g. consider ADEQ list of project types, New or Retrofit):** Flood control project – Retrofit.

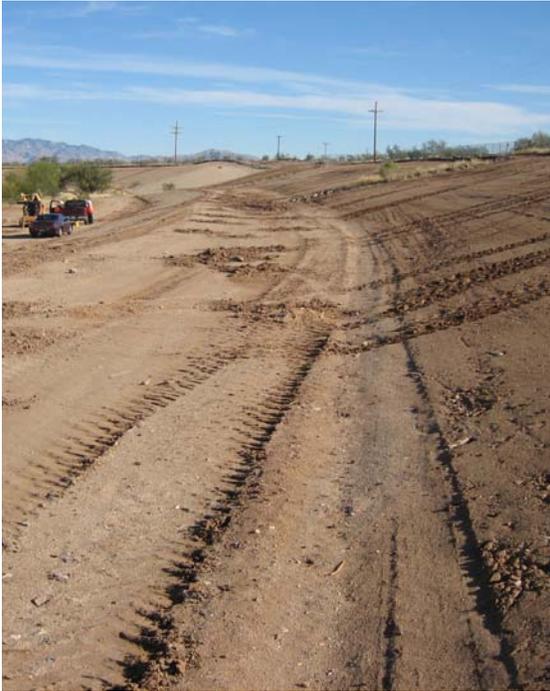
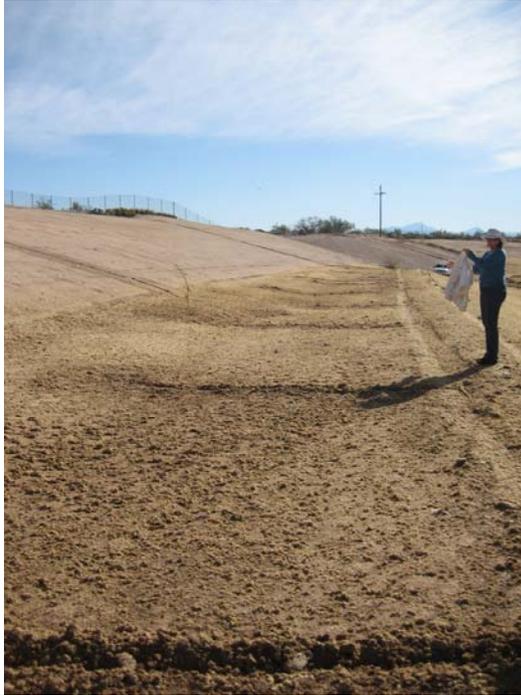
Mid-slope bench water harvesting basin on contour for slope bottom vegetated area.

- a. Design Features (BMPs, Site Design considerations etc): A low flow depressed planting area was built and a mid-slope bench water harvesting basin was constructed to minimize erosion and encourage growth of vegetation on the slope.

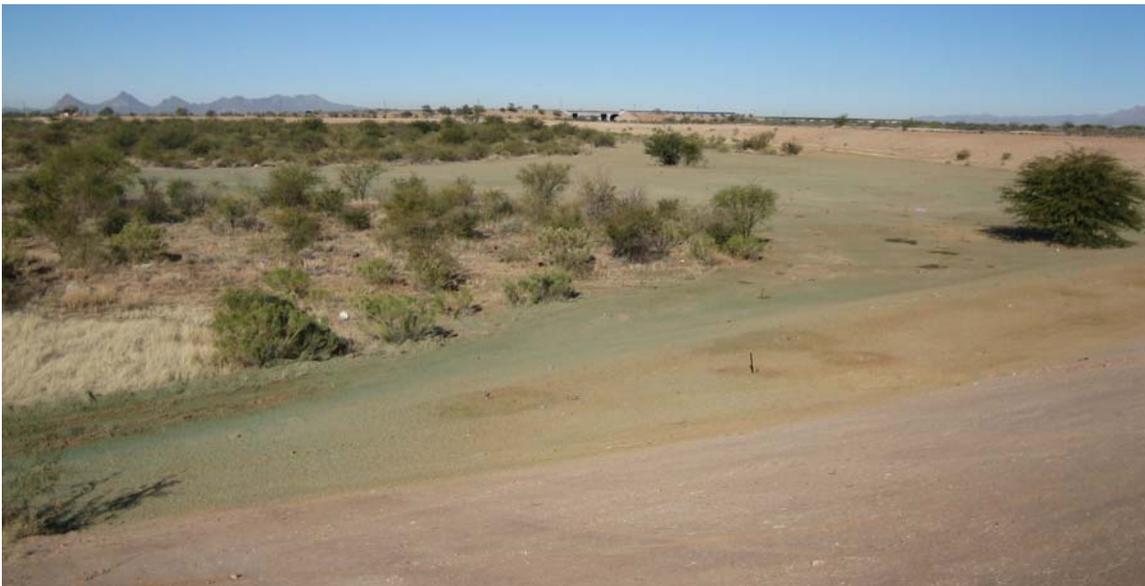
Overview showing depressed basin.

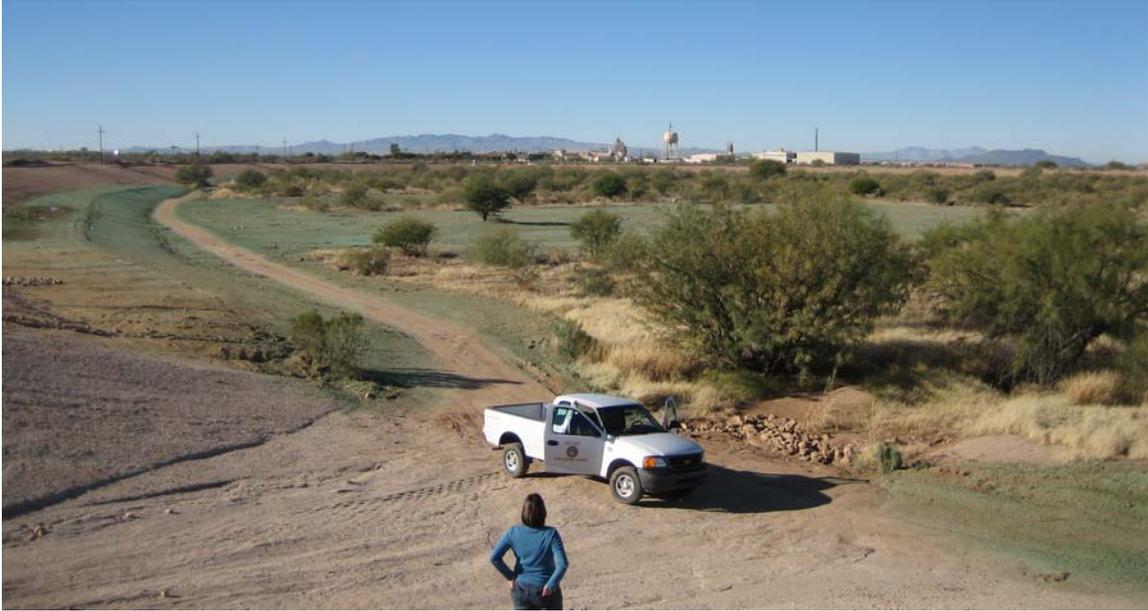
Overview showing depressed basin and mid-slope bench water harvesting basin.
