**Environmental Restoration Projects in Arizona:  
The U.S. Army Corps of Engineers' Approach  
Final Report\*  
June 2005**

Sharon B. Megdal, Ph.D. \*\*  
Director, Water Resources Research Center  
University of Arizona, Tucson AZ

\* This report is the fourth and final deliverable of Project Number W912PL04P0045, entitled “Ecosystem Restoration Projects in Arizona.”

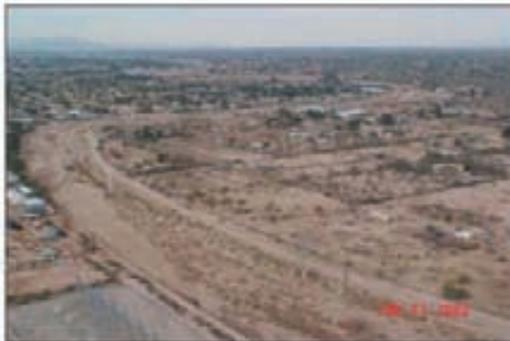
Existing Condition

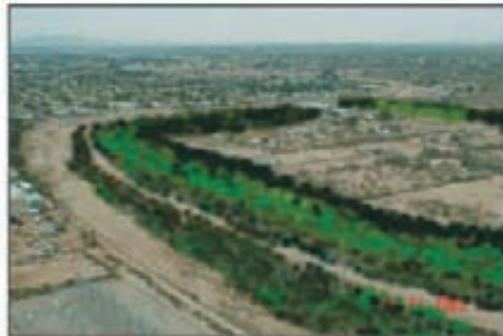
Future with Implementation of the Recommended Plan

**Recommended Plan:** Alternative 2H– 1 Terrace without buffer “A set of terraces in the area known as the “Bend;” Cottonwood/willow, mesquite, shrub and grasses planted in the channel, in tributary mouths, and in water harvesting basins on the tributaries; A culvert and pipeline from upstream will allow water to flow behind the soil cement in 2-year and higher events to provide water to riparian plant communities along the north bank in the upstream portion of the study area; A high and low flow channel created to support a mesquite community and connect the Finger Rock Wash to the Rillito River; Water harvesting basins at each upstream tributary mouth; and A distribution system for effluent supporting planted vegetation until established and in dry periods.”<sup>48</sup>

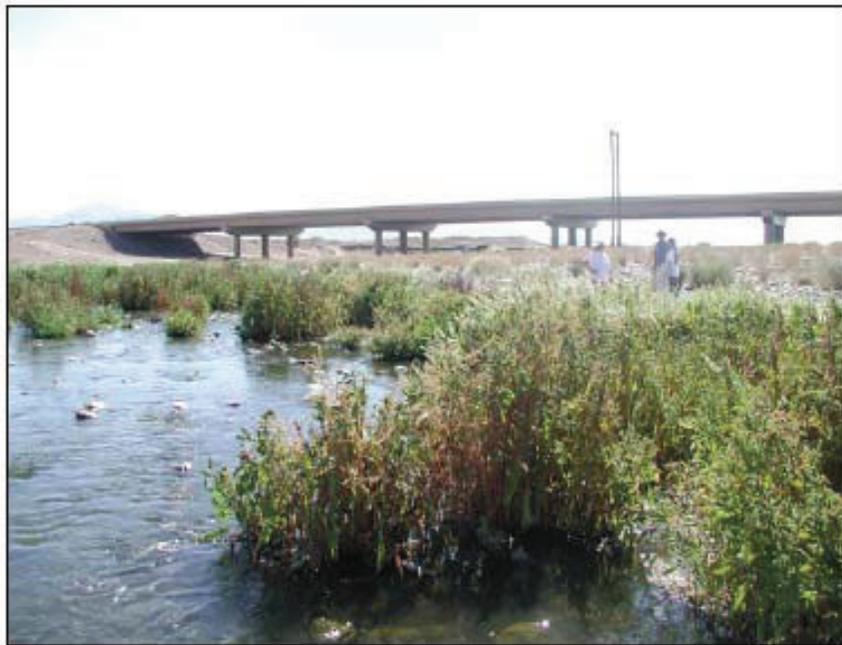
*Low flow channel with wetland vegetation, immediately upstream of 51<sup>st</sup> Avenue Bridge.*

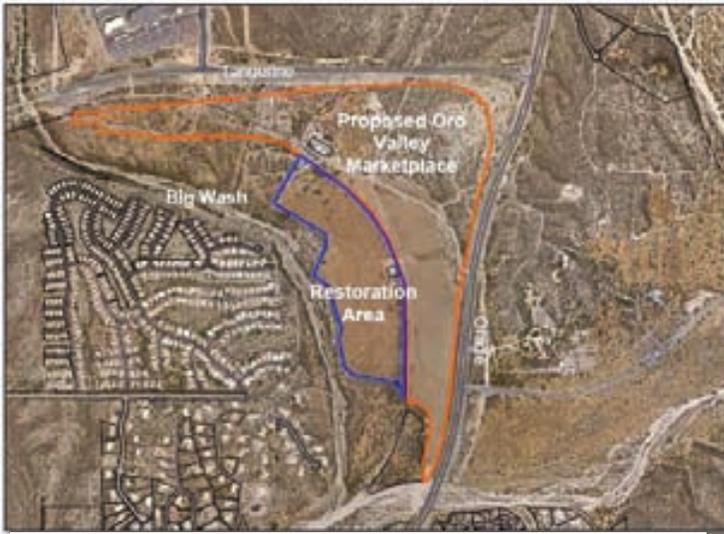
**Existing conditions: restoration area outlined in blue, Vestar development outlined in red.**

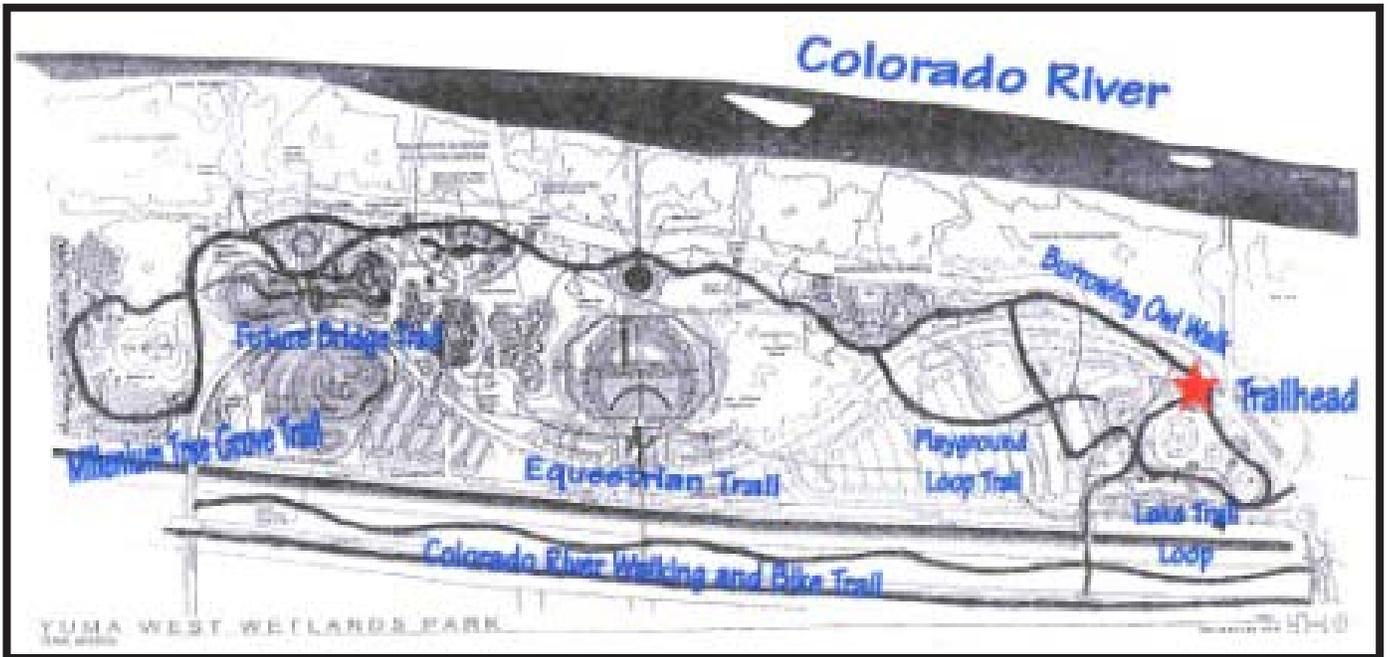
Project site map  
Yuma West Wetlands

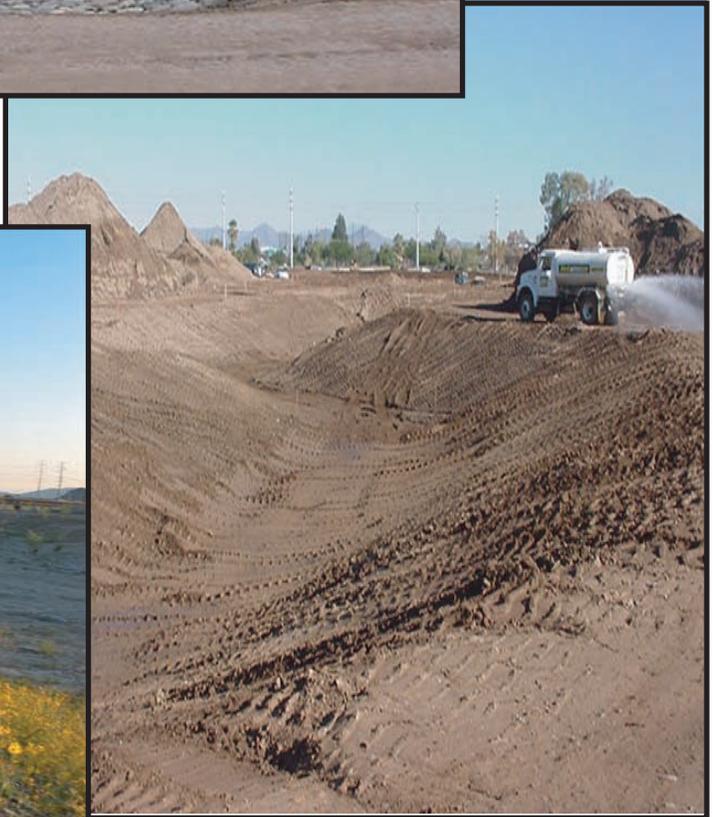
Indian Bend Wash Construction  
Rio Salado Tempe

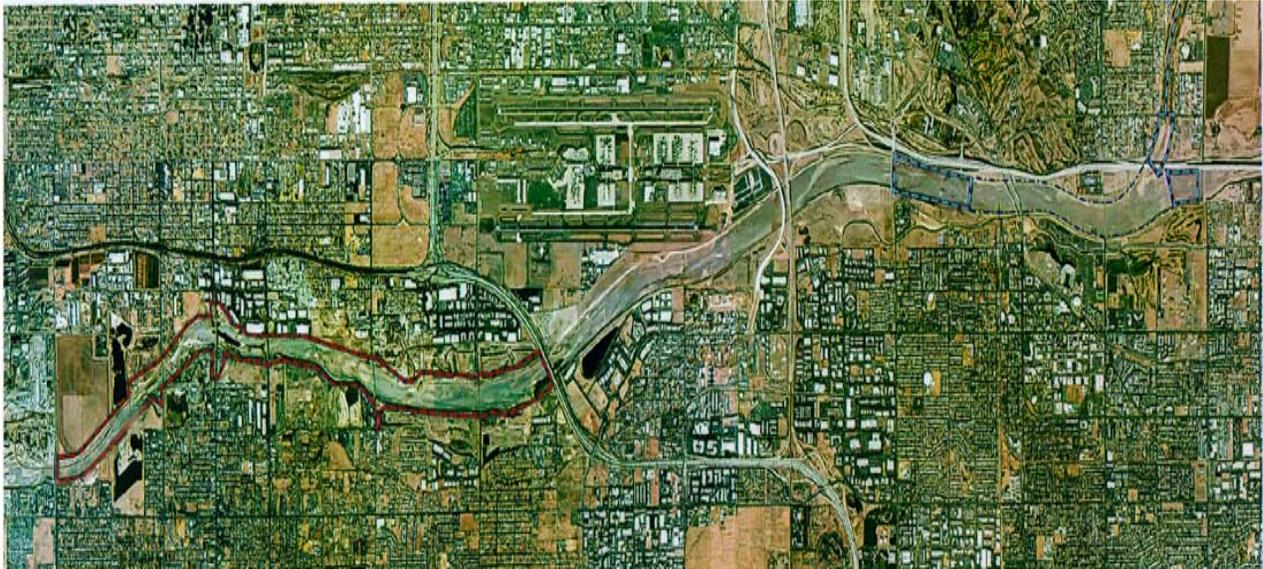
Aerial photo with project area outlined  
Rio Salado Tempe

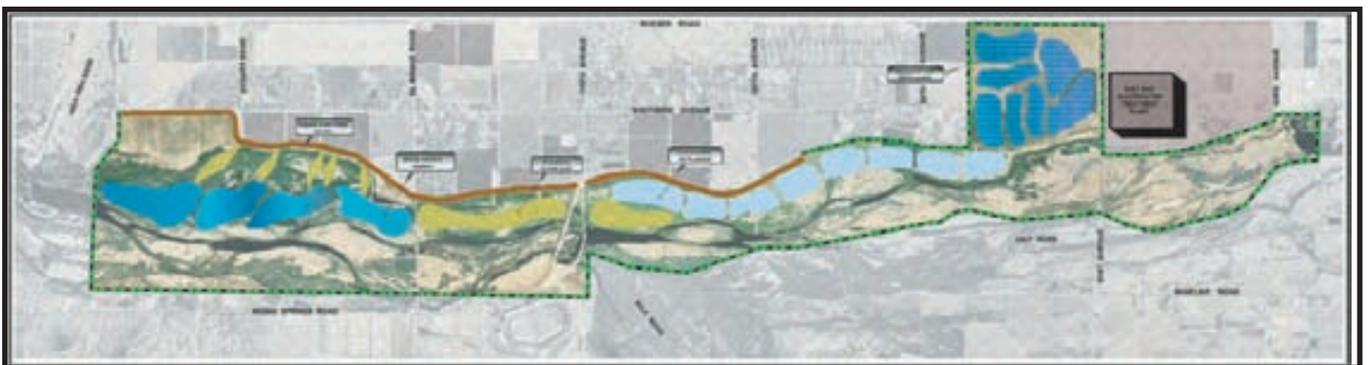
Map of project area  
Tres Rios

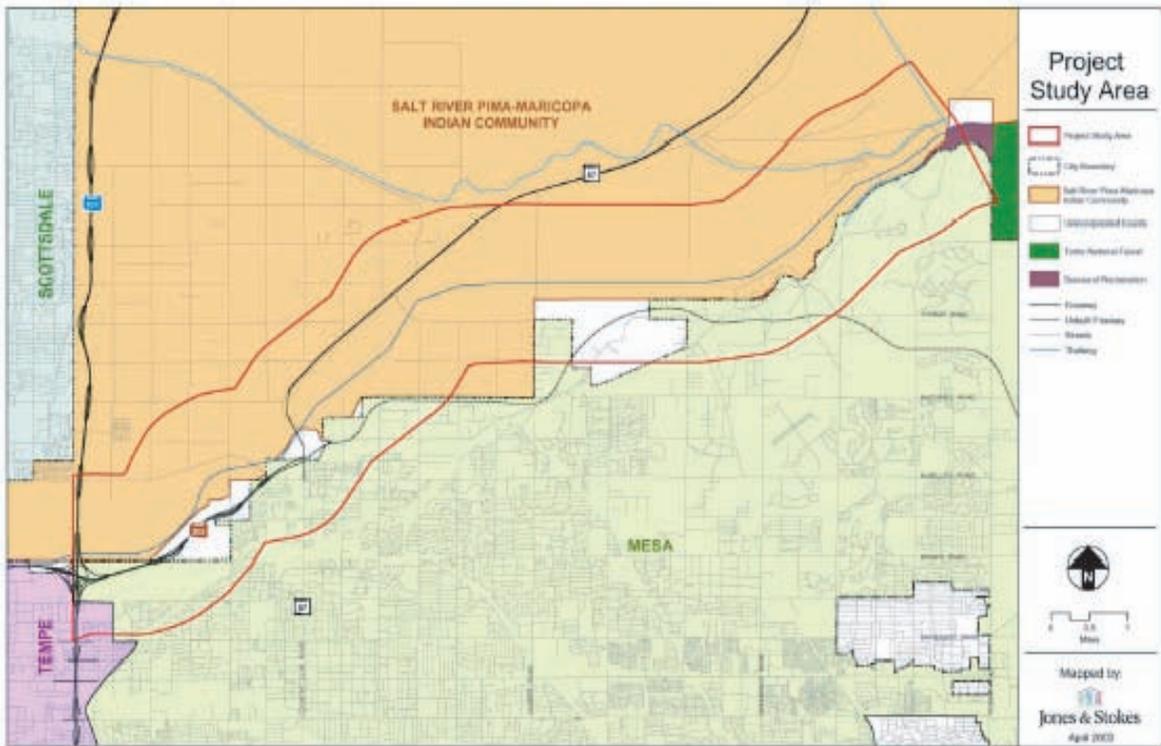
Map of project area  
Va Shly'ay Akimel

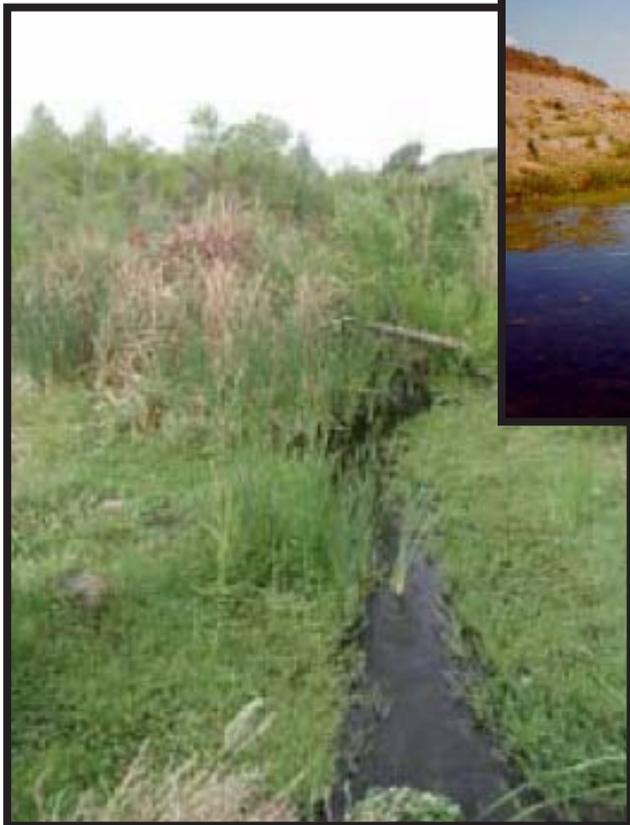
Wetland created behind dam  
Va Shly'ay Akimel

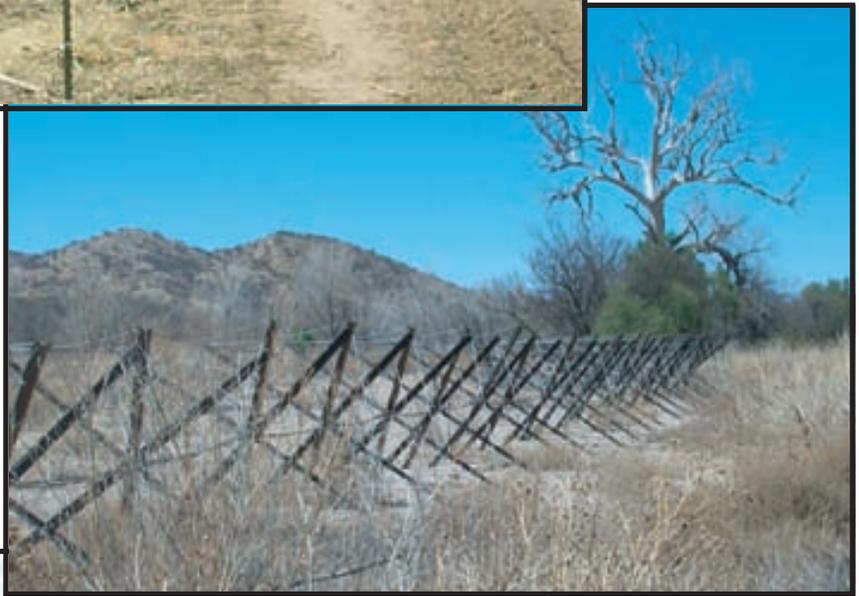
Ungulate proof fence  
Sante Fe Ranch

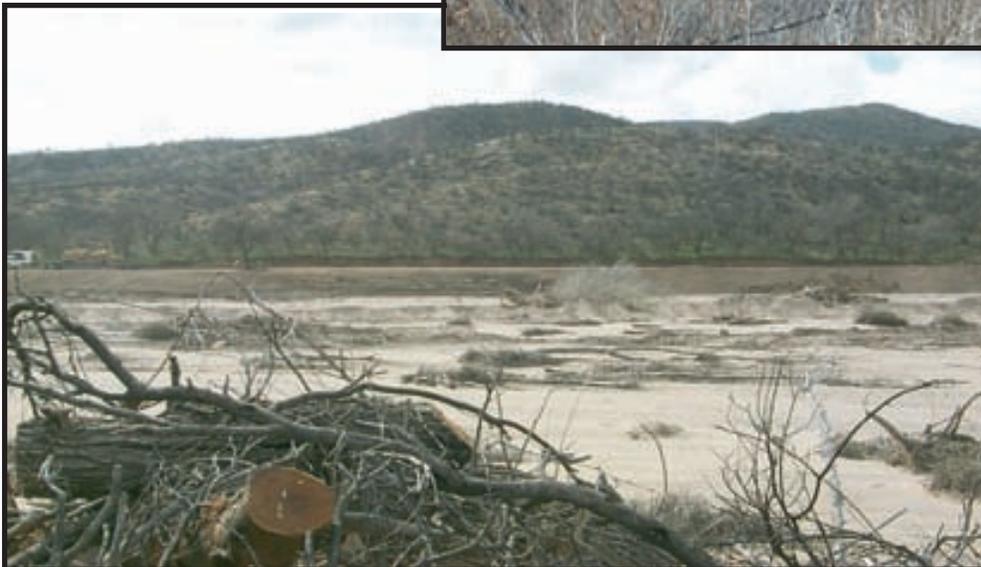
Kellner jack site  
Sante Fe Ranch

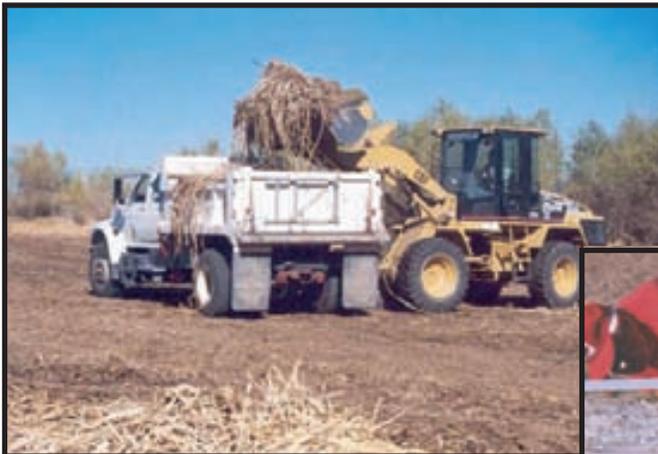
Operations- removing vegetation  
from infiltration basin  
Sweetwater Wetlands
