**RILLITO RIVER, PIMA COUNTY, ARIZONA**  
**EL RIO ANTIGUO**  
Draft Feasibility Study

SUBJECT: Final Feasibility Report for Rillito River, Pima County, Arizona (El Rio Antiguo)  
(PWI #013544)

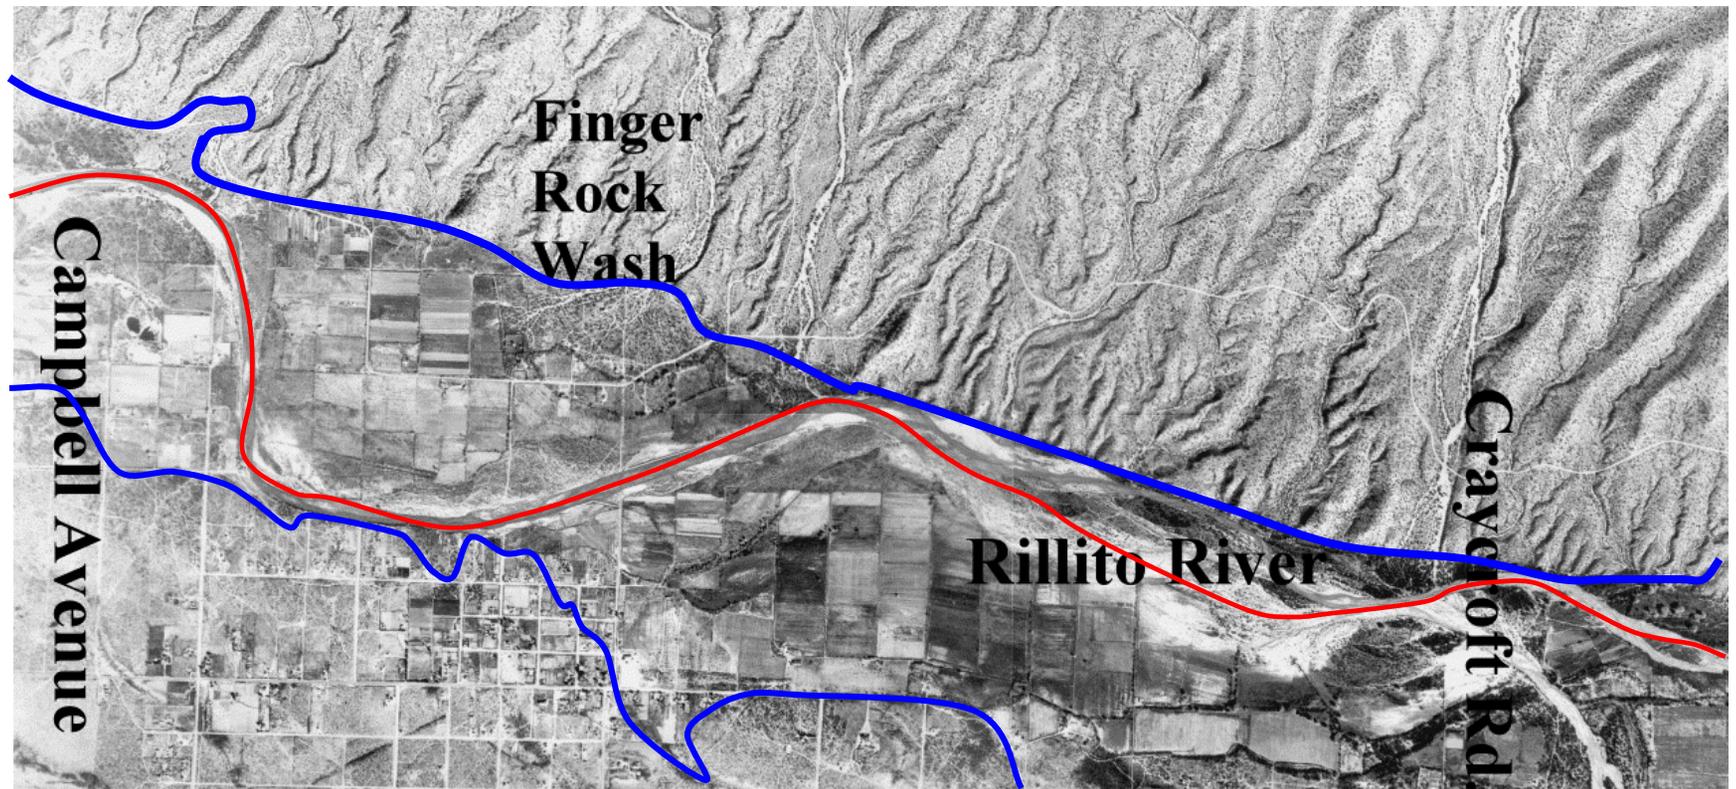
*Figure 2.6 Rillito River in 1936 (Photo provided by the Arizona Geological Survey)*

Note the braided nature of the stream, remaining riparian areas, and the wider floodplain. By 1936, the encroachment of agriculture has begun to influence the channel, reducing floodplain area, and channel meander. However, at the time of this photo, the channel still had some ability to meander across the floodplain (indicated by the blue lines). Today, the channel (indicated in red) is entirely confined, straightened, and unable to interact with its geologic floodplain.

The Rillito was once at grade with a braided, meandering streambed and a broad floodplain. By 1936, farming practice had begun to have an effect on the floodplain. Finger Rock Wash was cut off from the Rillito and riparian vegetation was removed and replaced with agricultural fields. Comparison of aerial photos taken in 1936 (Figure 2.6, page II-10) to recent photos (Figure 2.2, page II-11) shows that the channel was at grade in 1936 with some remaining riparian areas and a much wider flood plain.

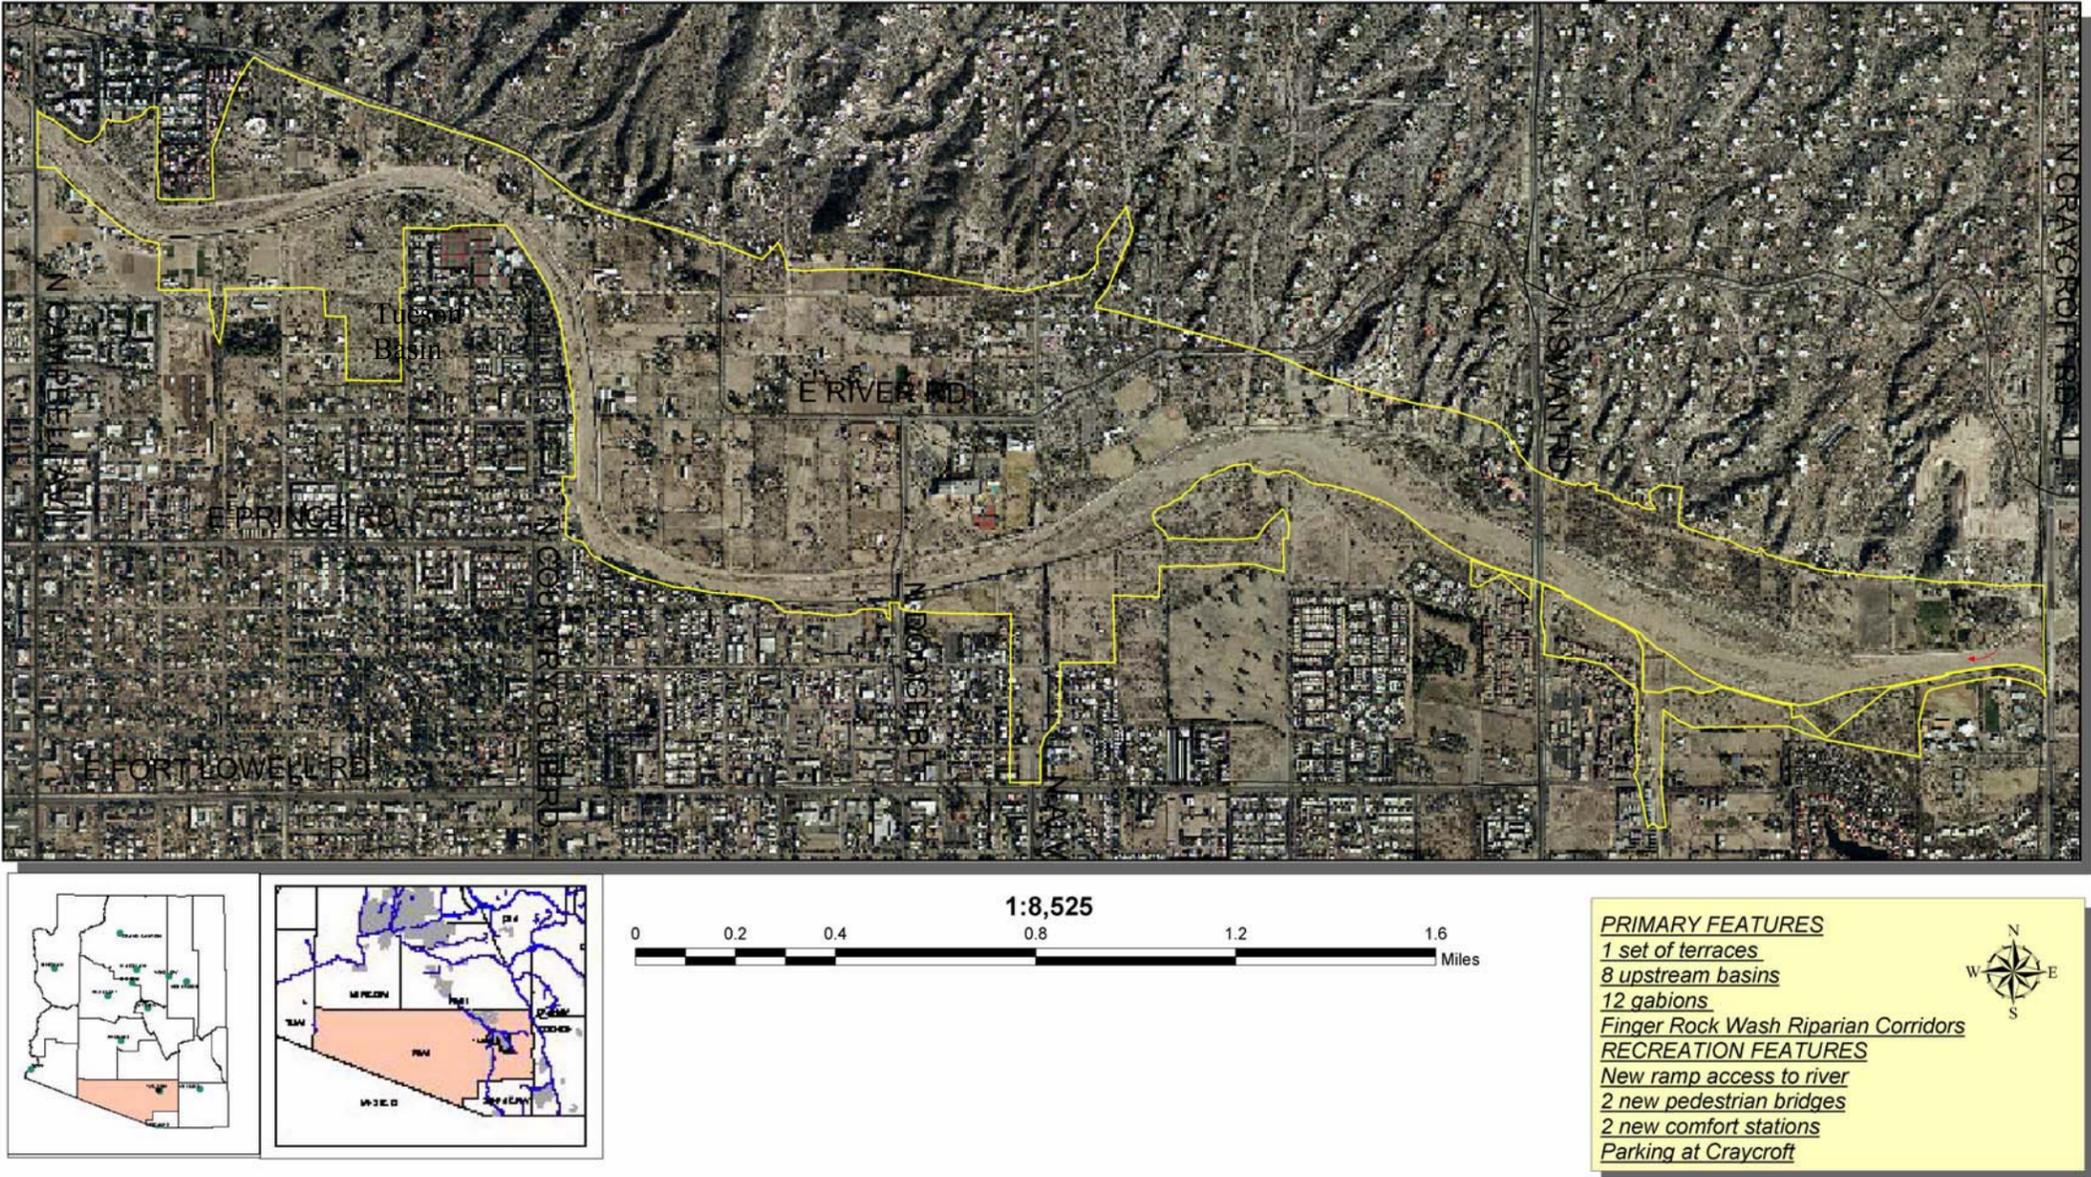
Figure 2.2 Study Area Vicinity

The study area sits at the northern edge of the City of Tucson and is highly developed to the south. The north and south boundaries represent the perceived boundaries for restoration potential. The north boundary runs along the edge of the floodplain at the mountain front. The southern study boundary encompasses open areas with potential availability.

The changes in more recent times are thoroughly documented. It is clear that lateral migration of the Rillito channel was a major channel morphology element. The Rillito channel has been straightened in numerous segments due to flood-induced lateral erosion (Figure 2.2 on page II-11, Figure 4.1). Straighter channels mean higher flow velocities. Higher flow velocities can result in downcutting of stream channels, which can be very serious, setting off wide-ranging cycles of erosion on tributaries and damage to infrastructure and environment, including draining

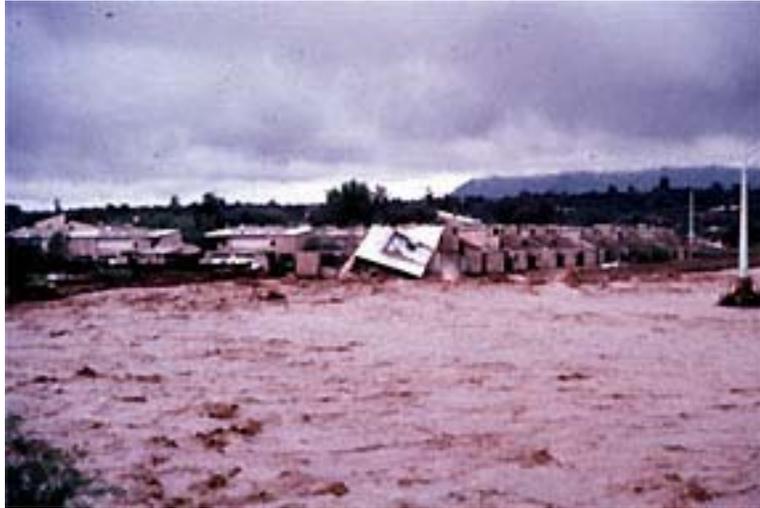
***Figure 4.1 Lateral Migration of the Rillito Channel***

Figure 4.1 shows lateral migration of the Rillito channel caused damage to infrastructure resulting in the need for the bank stabilization project recently completed by the Corps of Engineers on the Rillito. (Baker, V., 1998, Picture of the Rillito River near Prince Road downstream of the study area, Tucson, University of Arizona)

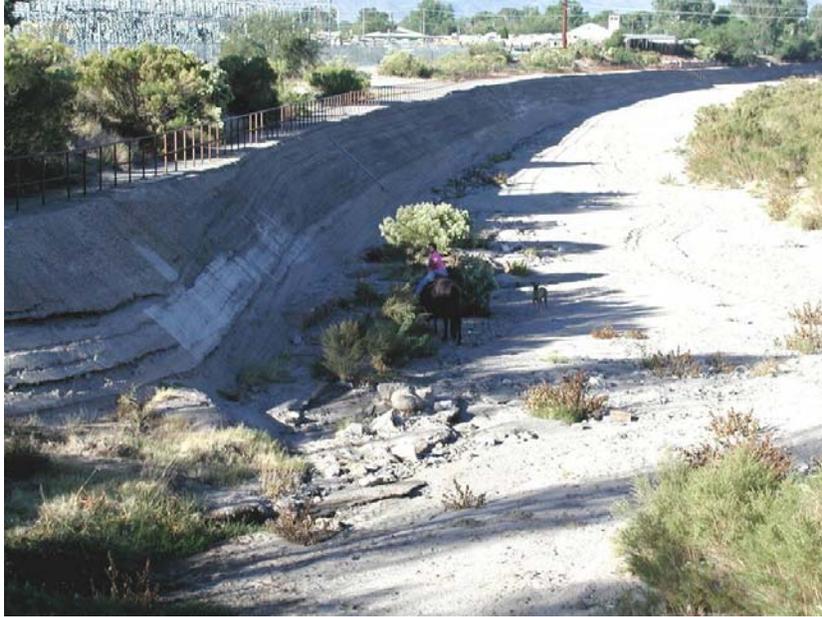
*Figure 4.2 Soil Cement was used to stabilize banks and prevent lateral migration.*

The newest significant impact on channel morphology of the Rillito is soil-cement bank stabilization for flood-control purposes. As of 1984, soil-cement protection was being added to select, discontinuous locations on both banks of the Rillito. Soil cement protection is near continuous within the study area on both banks of the stream (See Figures 4.2 and 4.3). There is a gap in the soil cement on the south bank between Alamo Wash and Alvernon Wash where there was no threat to property requiring protection. That area has been incorporated into a Corps restoration study currently in progress. There are other gaps at tributary inlets that allow for some minor habitat development (Cover Photo).

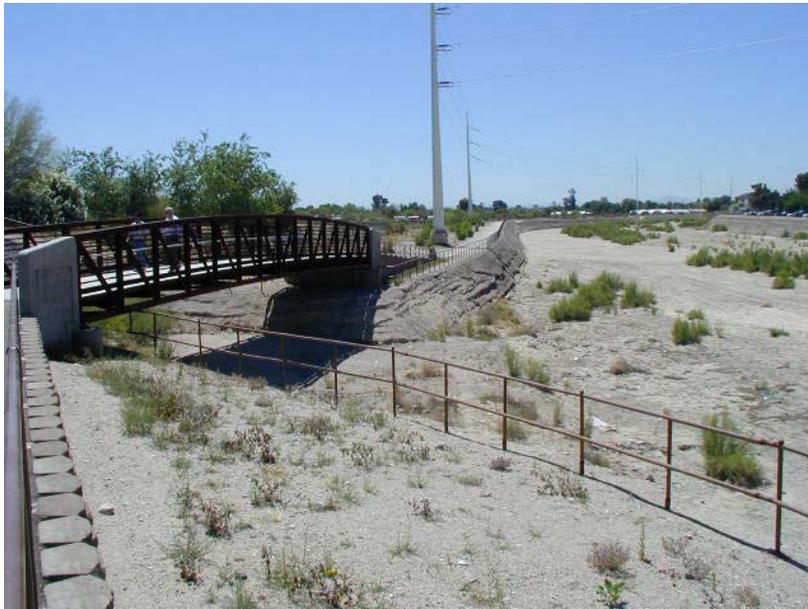
*Figure 4.3 Gaps in Soil Cement Banks*

Soil cement has gaps to allow for inflows from tributaries. These areas are often bridged to allow for recreation along the banks.

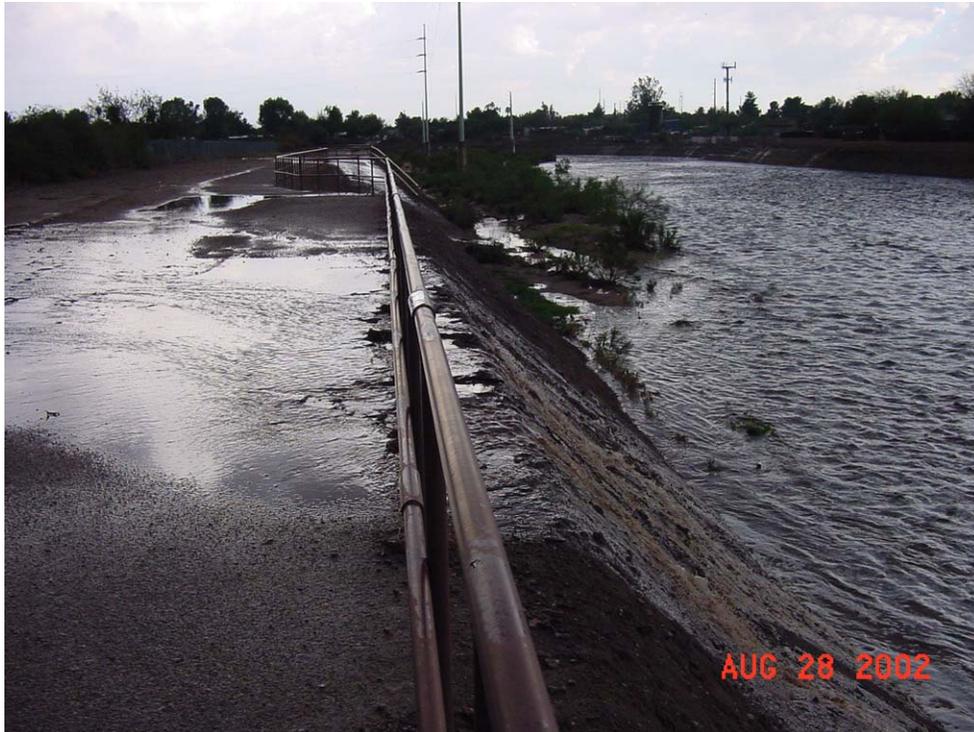
***Figure 4.6 Storm runoff from a typical 1year probability summer storm.***

Storm water runoff from nine tributaries, the Tanque Verde and the Pantano contribute to surface flows in the Rillito. The Rillito itself flows an average of eleven times per year. A 2-year event flow entirely inundates the channel from bank to bank. There is some bank inundation occurring in the Bend Area at the 50-year event.

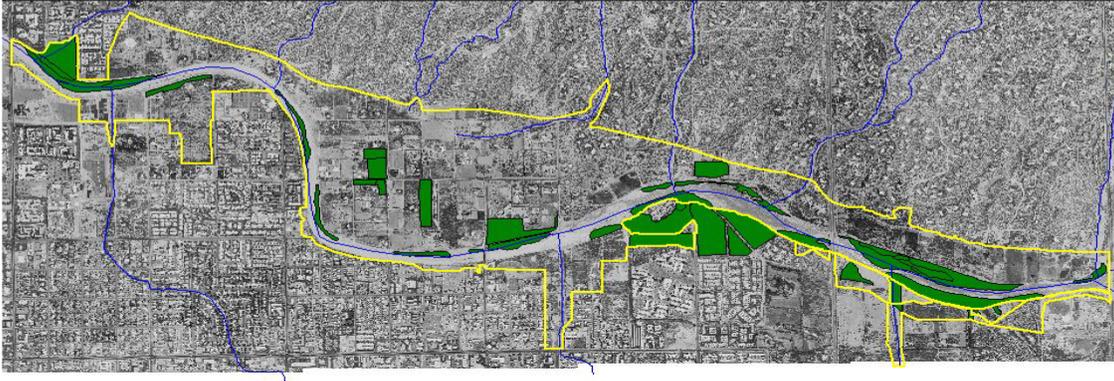
**Figure 4.9 Invasive Plant Species**

Invasive plants (in green) within the study reach threaten the survival of native species.

Riparian communities on the Rillito have been impacted by diversion of and reduction in stream flow, depletion of groundwater tables, competition by exotic plant species, the effects of grazing and fire, loss of floodplain function by undercutting caused by flood control activities, and encroaching urban and agricultural uses. The map of exotic and invasive species (Figure 4.9) within the study area shows the extensive competition that native species within the study area face.

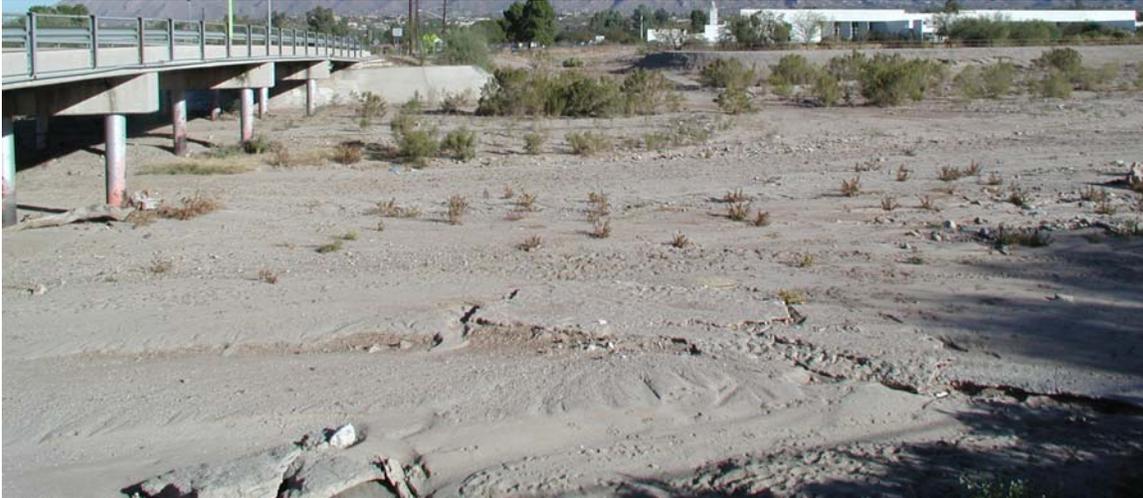
***Figure 4.13. Rillito River Bottom***

Note that the Riverbottom is largely un-vegetated and more barren than it was in the past due to past land uses in the area and in the River itself (Nov 2001).

The Rillito riverbottom has been disturbed by gravel mining operations (now prohibited on the Rillito). Low flow channels and depressions within the river bottoms of the Rillito River have been almost entirely eliminated. These features are generally unvegetated when present. Vegetation, when present, consists of scattered patches of Bermuda grass, salt heliotrope, and sedges. Due to the composition and lack of diversity within the project area river bottom, low flow channel, and emergent wetlands are all combined into this one cover type.

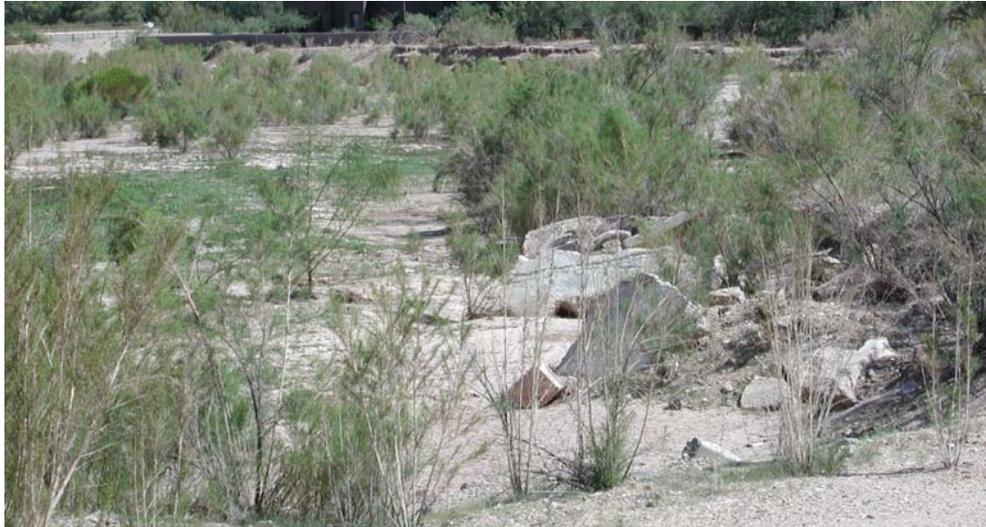
**Figure 4.14 Buffer Areas**

Buffer areas may be former sand and gravel sites or abandoned fields (Aug 2002)

The buffer cover type consists of unoccupied lands that create a protective barrier between habitat areas and urban areas. It was measured for length, width and nativeness. About one third of the study area is currently classified as buffer. Over two thirds of the existing protective buffer is expected to become urban and disappear in the without project condition by 2058.

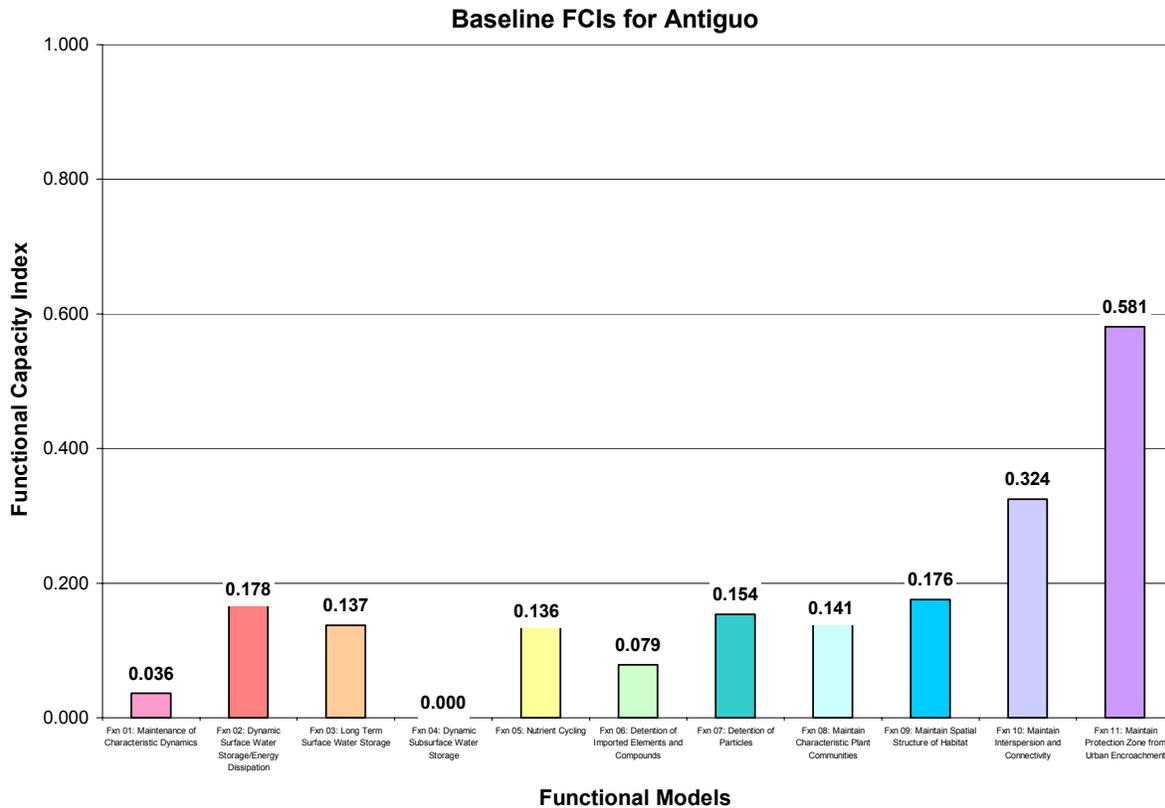
**Figure 4.16 Baseline Functional Capacity Index Results**

When compared to the functional capacity indices for Arizona reference sites the El Rio Antiguo study area is clearly functioning at a very low capacity. This is illustrated in Figure 4.18 and in Table 4.10 following. In a healthy ecosystem, it is assumed that there is sufficient acreage of each cover type to maintain system function. Functional Capacity Units are calculated by multiplying cover type acreage times the functional capacity index indicating the health of that acreage

Figure 4.16 below illustrates the functional level of the El Rio Antiguo study area. Nearly all indices show that the site is poorly functioning. Figure 4.17 provides additional descriptive detail to explain the index values depicted in Figure 4.16. The average FCI is .177 for El Rio Antiguo and .499 for Tanque Verde Creek.

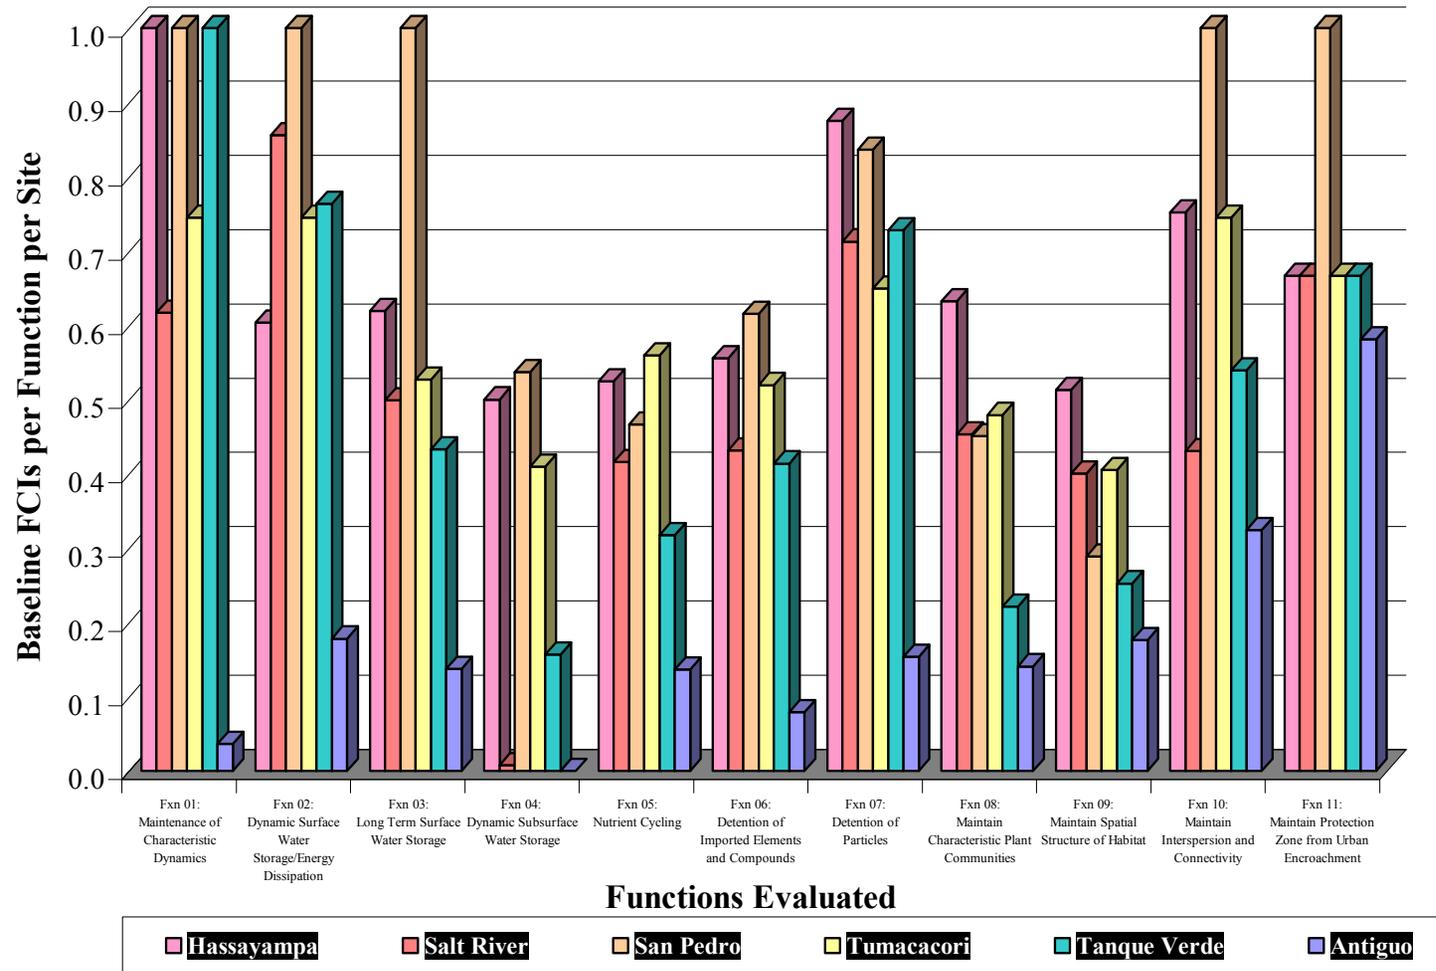
**Figure 4.18 FCI Comparisons**

Comparisons to Reference sites Existing Results for Functional Capacity Units

This table compares the difference between each of the functional capacity indices of the Arizona reference sites selected for comparison in this model and the study site. No Arizona site was fully functional. The last line in the table shows the average functional capacity for each reference site in comparison to El Rio Antiguo. The average functional capacity of the reference sites arranges from moderately healthy (.50) to good (.50 -.66) or even very good (.74) while the study site is functioning at a very poor level (.18).

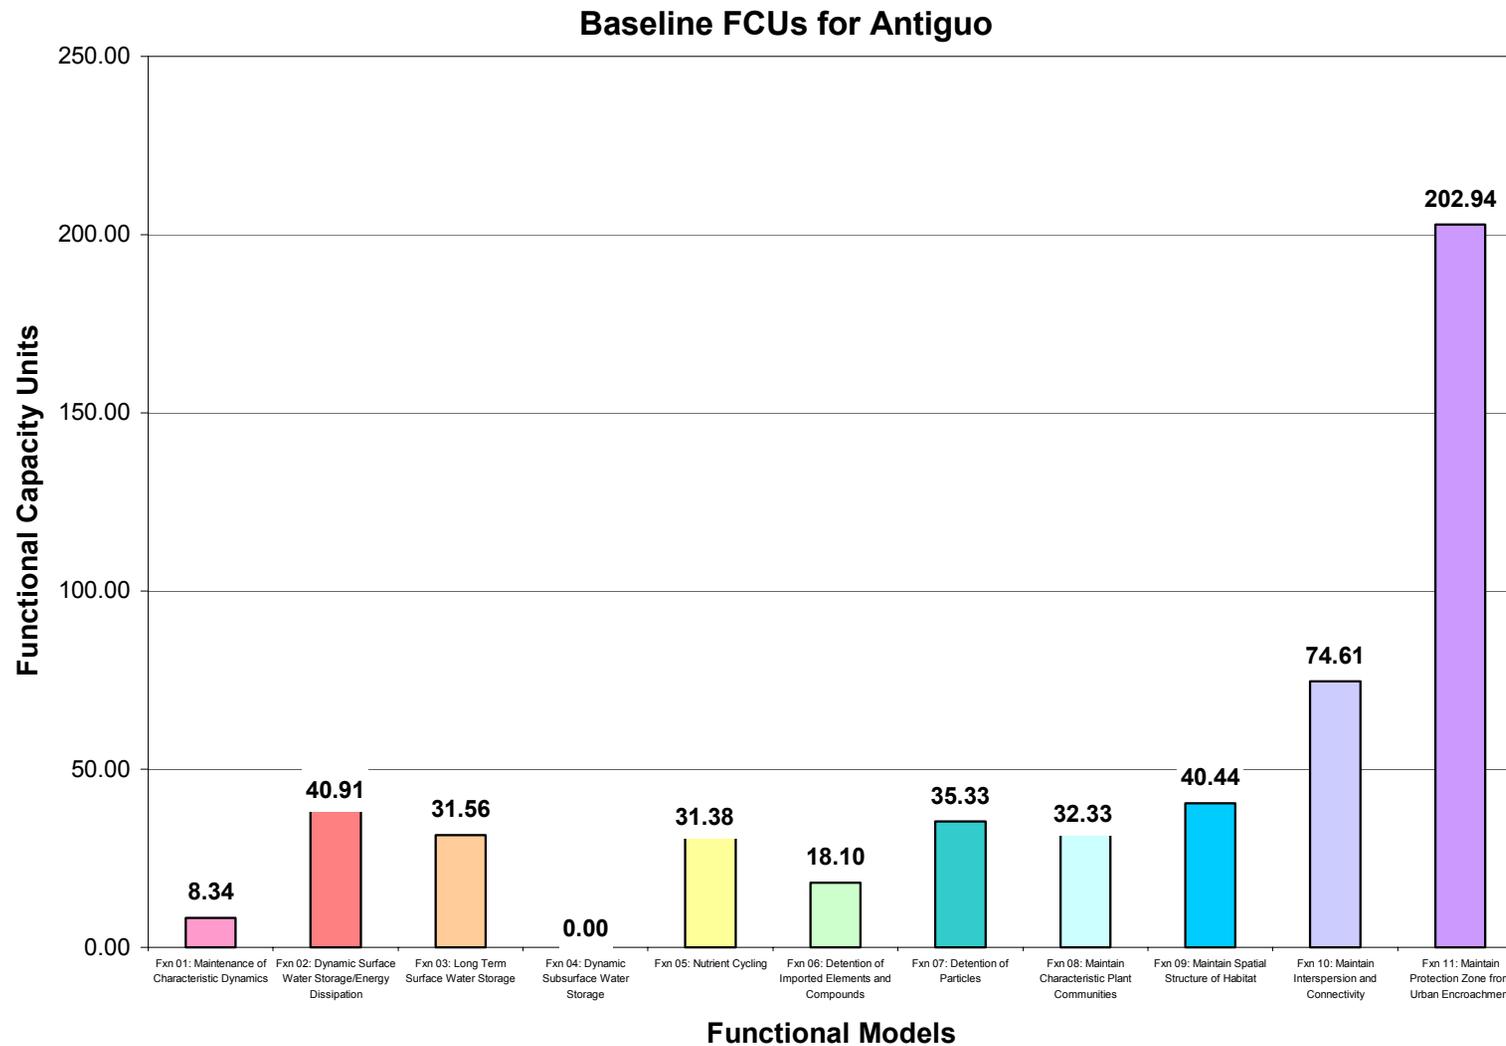
**Figure 4.19 Results for Baseline Functional Capacity Units**

Functional capacity at the reference sites is 2 ½ to 4 times higher than at the study site using consistent acreages.

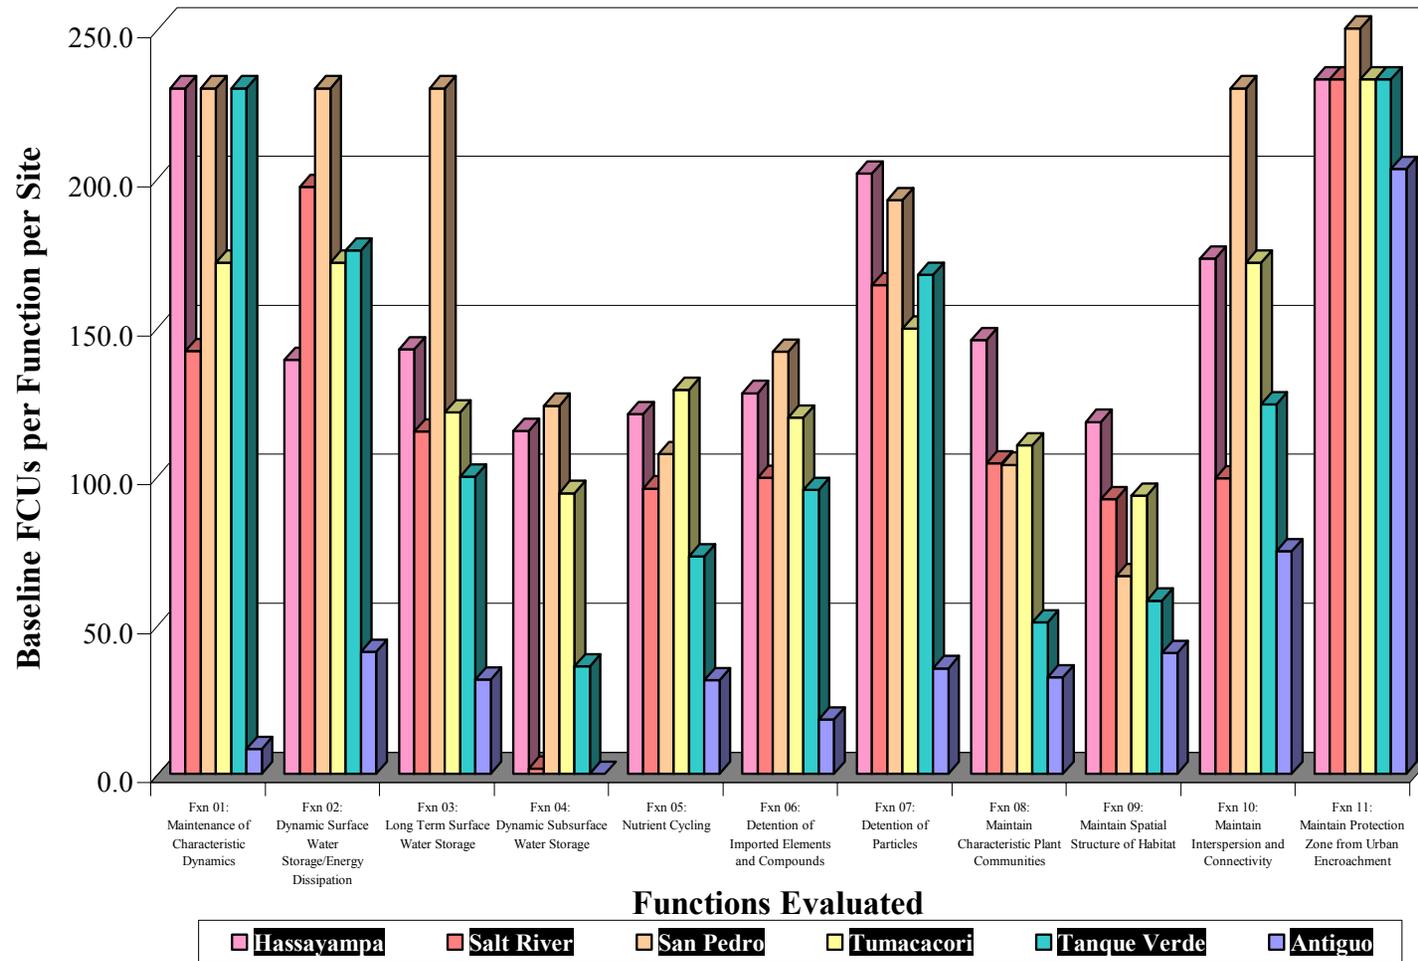
**Figure 4.20 Functional Capacity Units**

FCU for El Rio Antiguo are in blue and Tanque Verde units are in aqua.

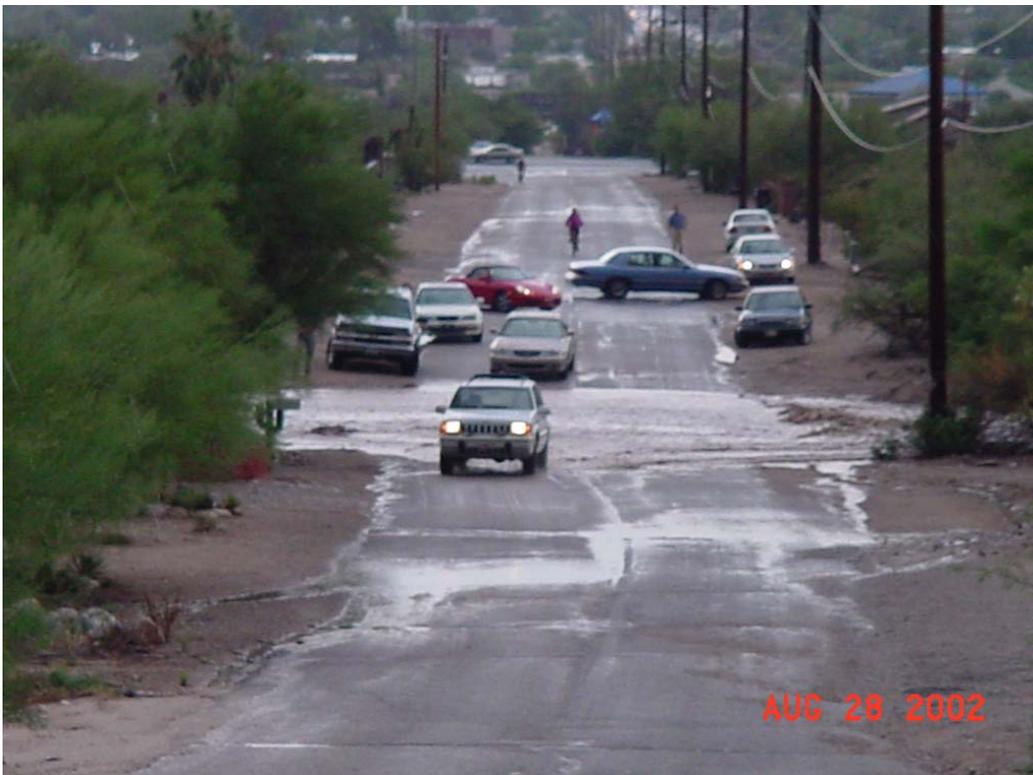
*Figure 4.22 Frequent flows cause obstruction to traffic and home access.*

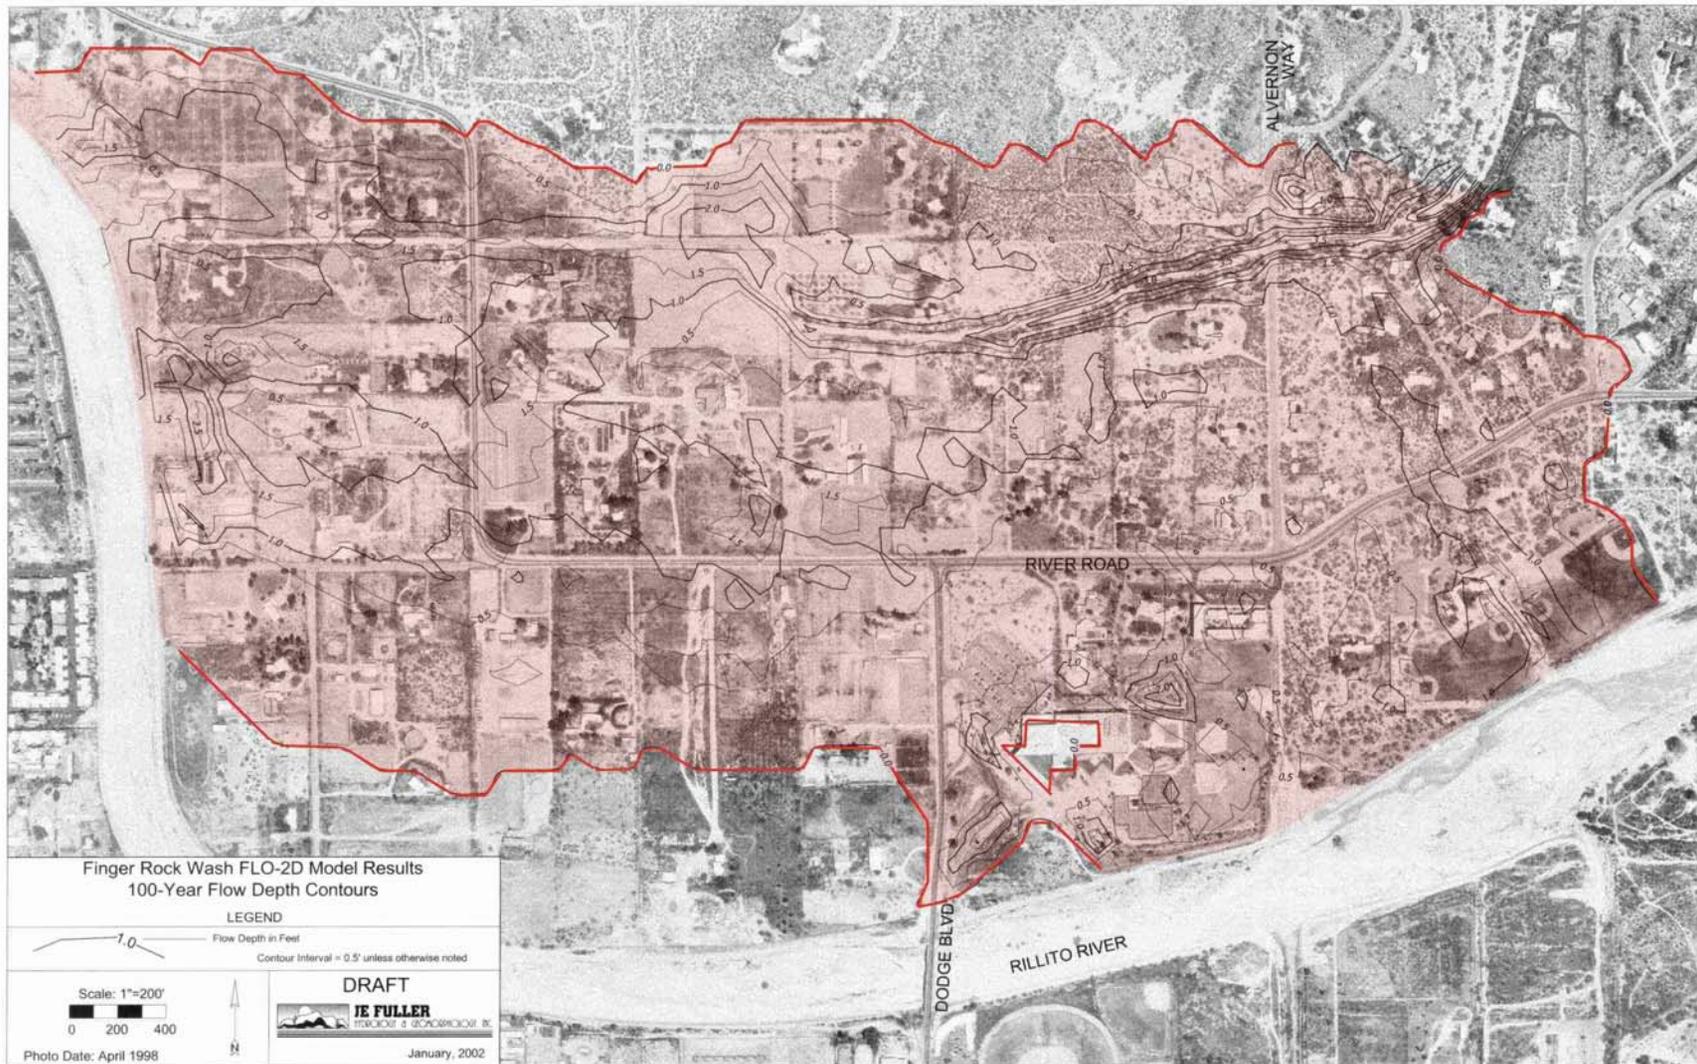
*Figure 4.23 100 year Floodplain in the Bend Area*

Average annual flood damages from all categories total \$270,494. Prevention of all of these damages would provide economic justification for a flood control project with an implementation cost slightly greater than \$4,000,000. The implementation cost that could be supported would be reduced by the annual costs to operate and maintain the project.

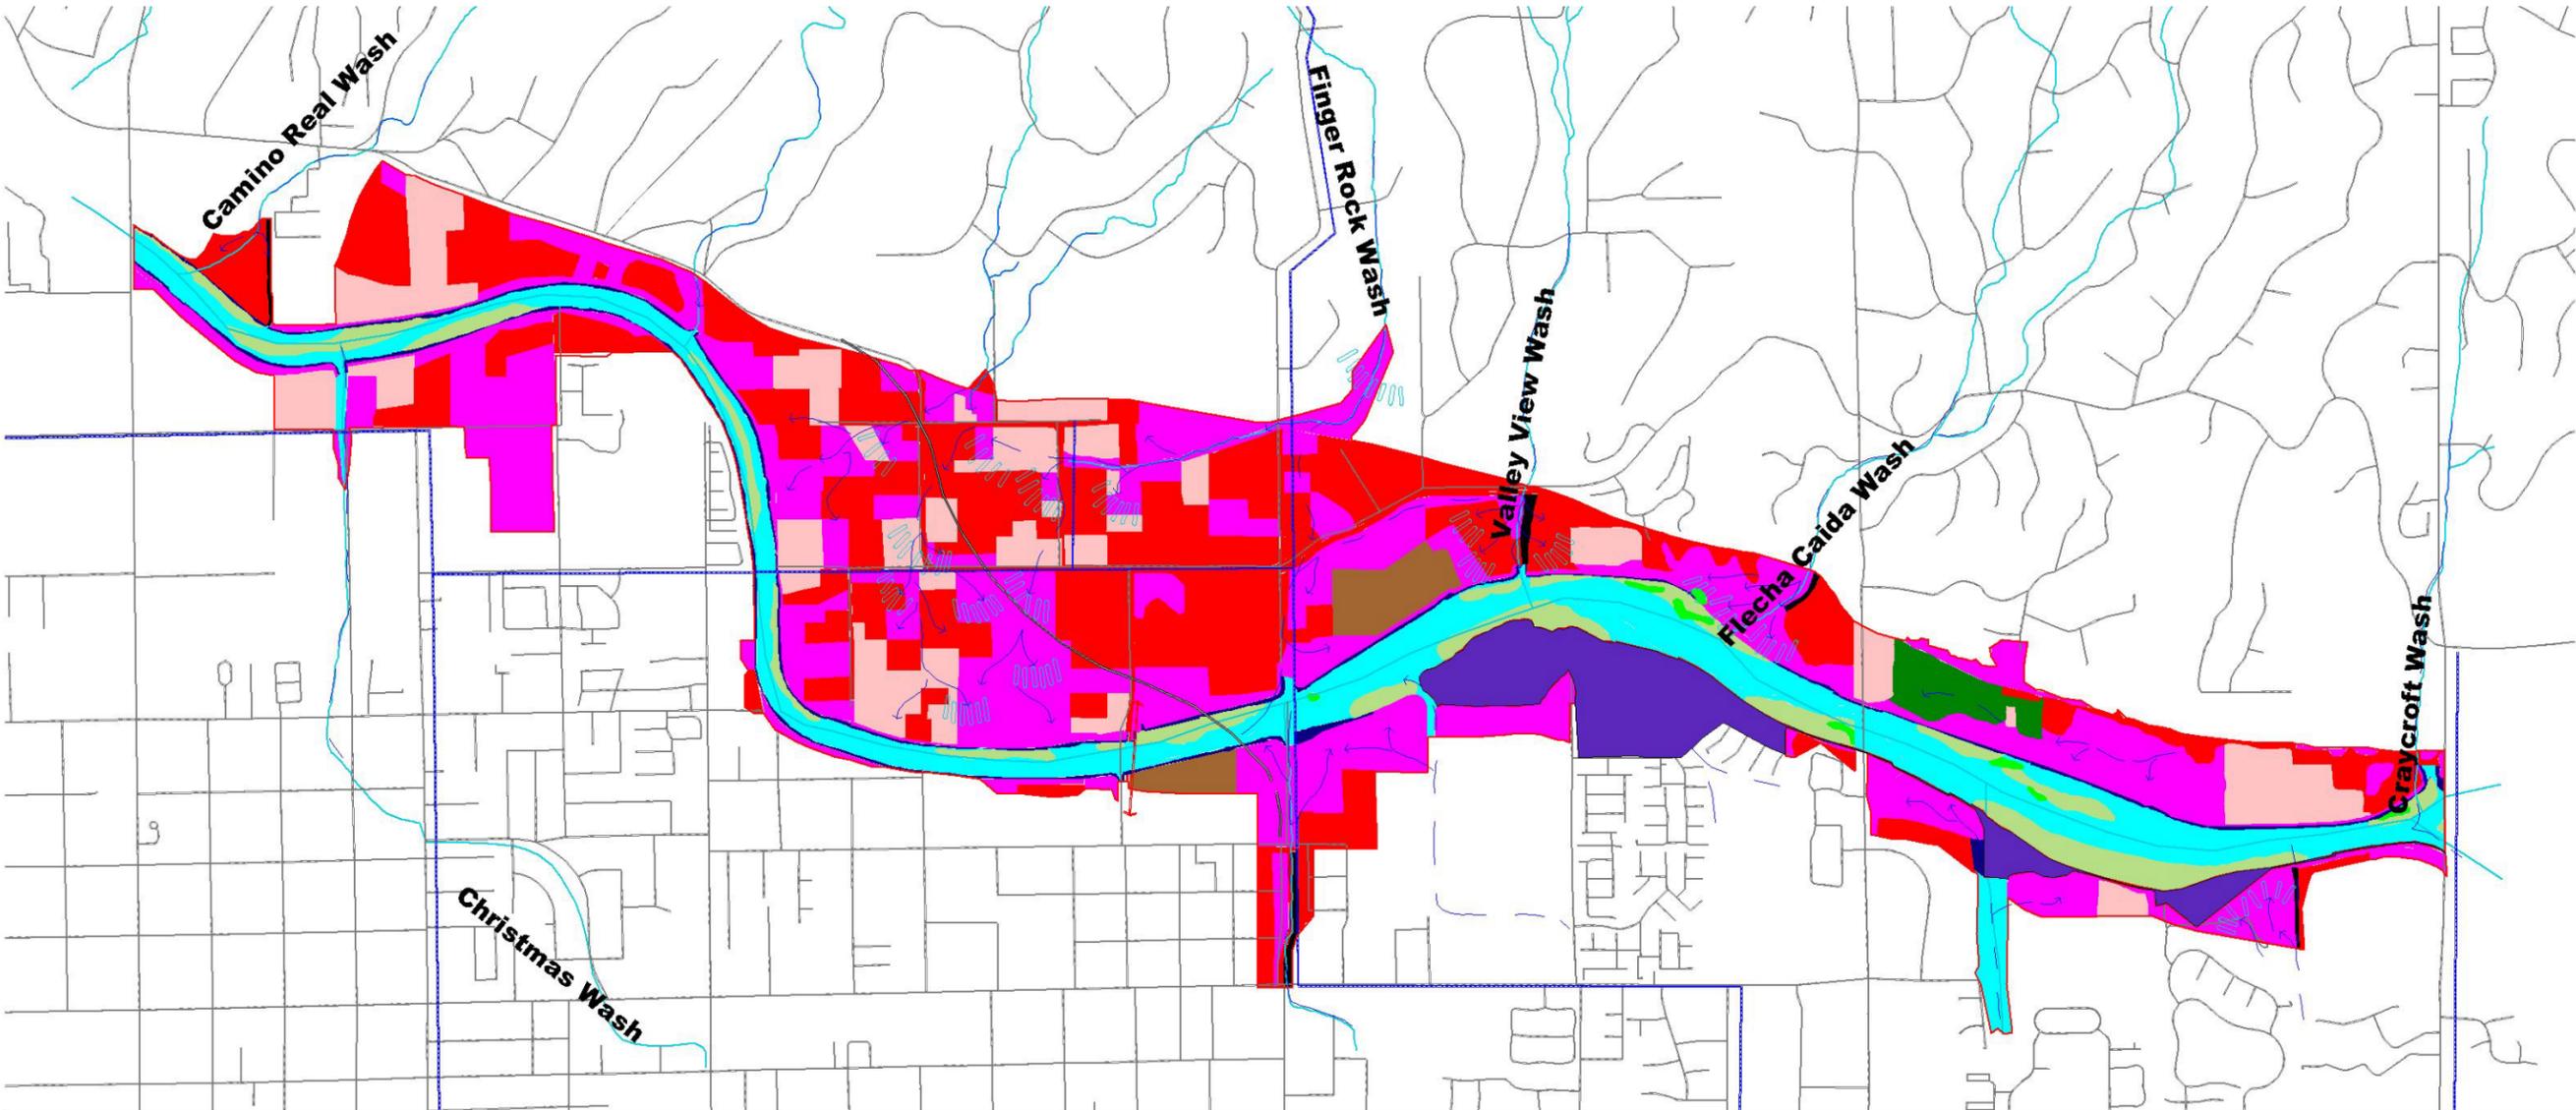
*Figure 4.15 Distribution of Vegetation Cover Types (PWAAs) in the study area*

- Swanwetlands.shp
- Study Boundary
- Dodge Bridge
- Rec\_pipe
- Water Distribution
- Catchments
- River Road Realignment
- Stnetall.shp
- Washes
- Existoond2.shp
- AGCROP
- CWFOREST
- DESERT
- DITCHES
- LOWFLOW
- MESQUITE
- PARK
- RIVERBOTTOM
- SCRUBSHRUB
- SOILCEMENT
- UPLANDBUFF
- URBAN

types include cotton-willow forest, mesquite, and scrub-shrub lands (Figure 4.15). Natural cienegas or seasonal emergent wetlands have disappeared from the study reach.

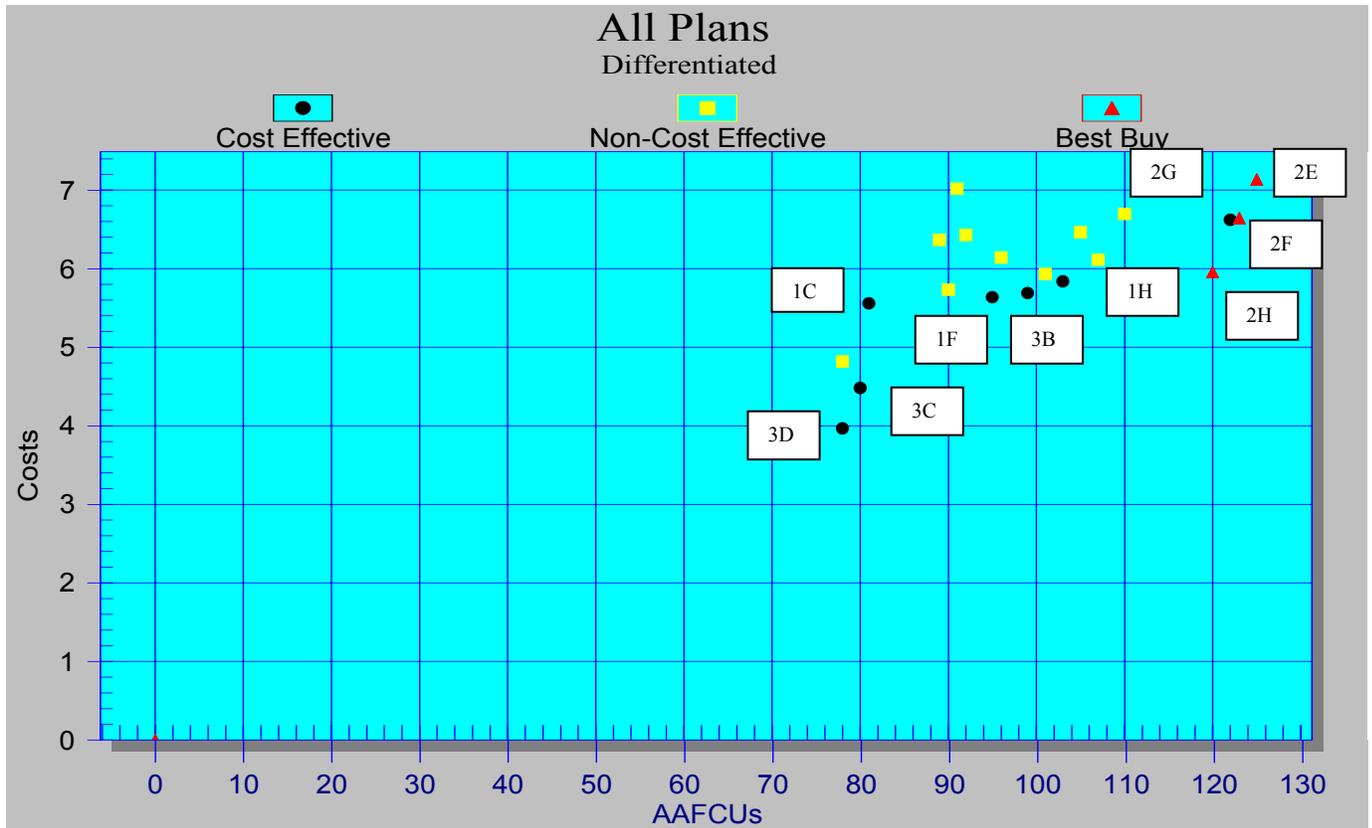
*Figure 5.24 All Plans Differentiated*

A scatter plot of plans is shown in Figure 5.24 below. Cost effective, non cost effective, and best buy plans differentiated. Alternatives are labeled for only the cost effective and best buy plans.

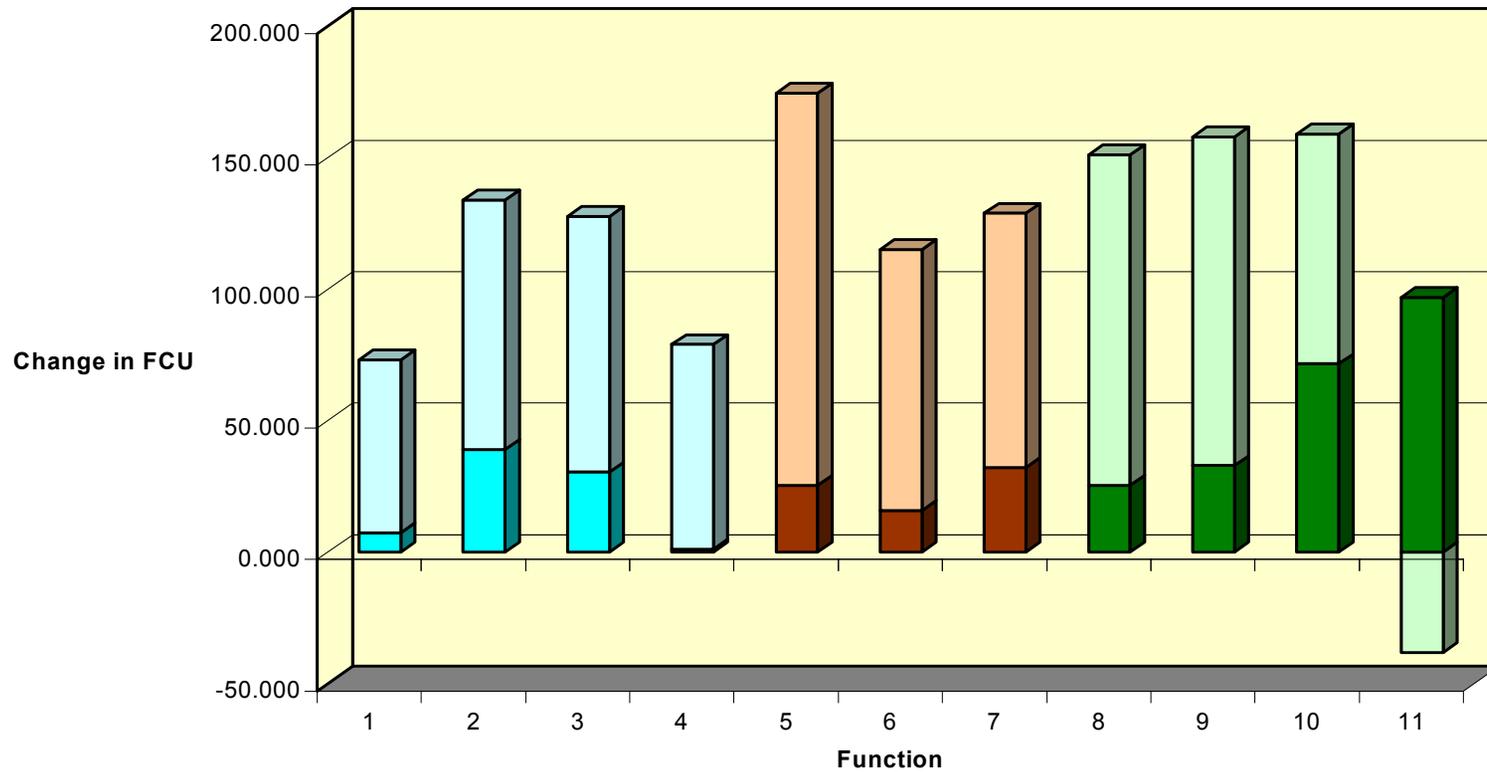
***Figure 6.2 Recommended Plan Compared to Future WOP***

Hydrologic functions are shown in blues. Biogeochemical Functions are shown in browns and Habitat Functions are shown in Greens.
