**RILLITO RIVER, PIMA COUNTY, ARIZONA**  
**EL RIO ANTIGUO**  
Draft Feasibility Study

SUBJECT: Final Feasibility Report for Rillito River, Pima County, Arizona (El Rio Antiguo)  
(PWI #013544)

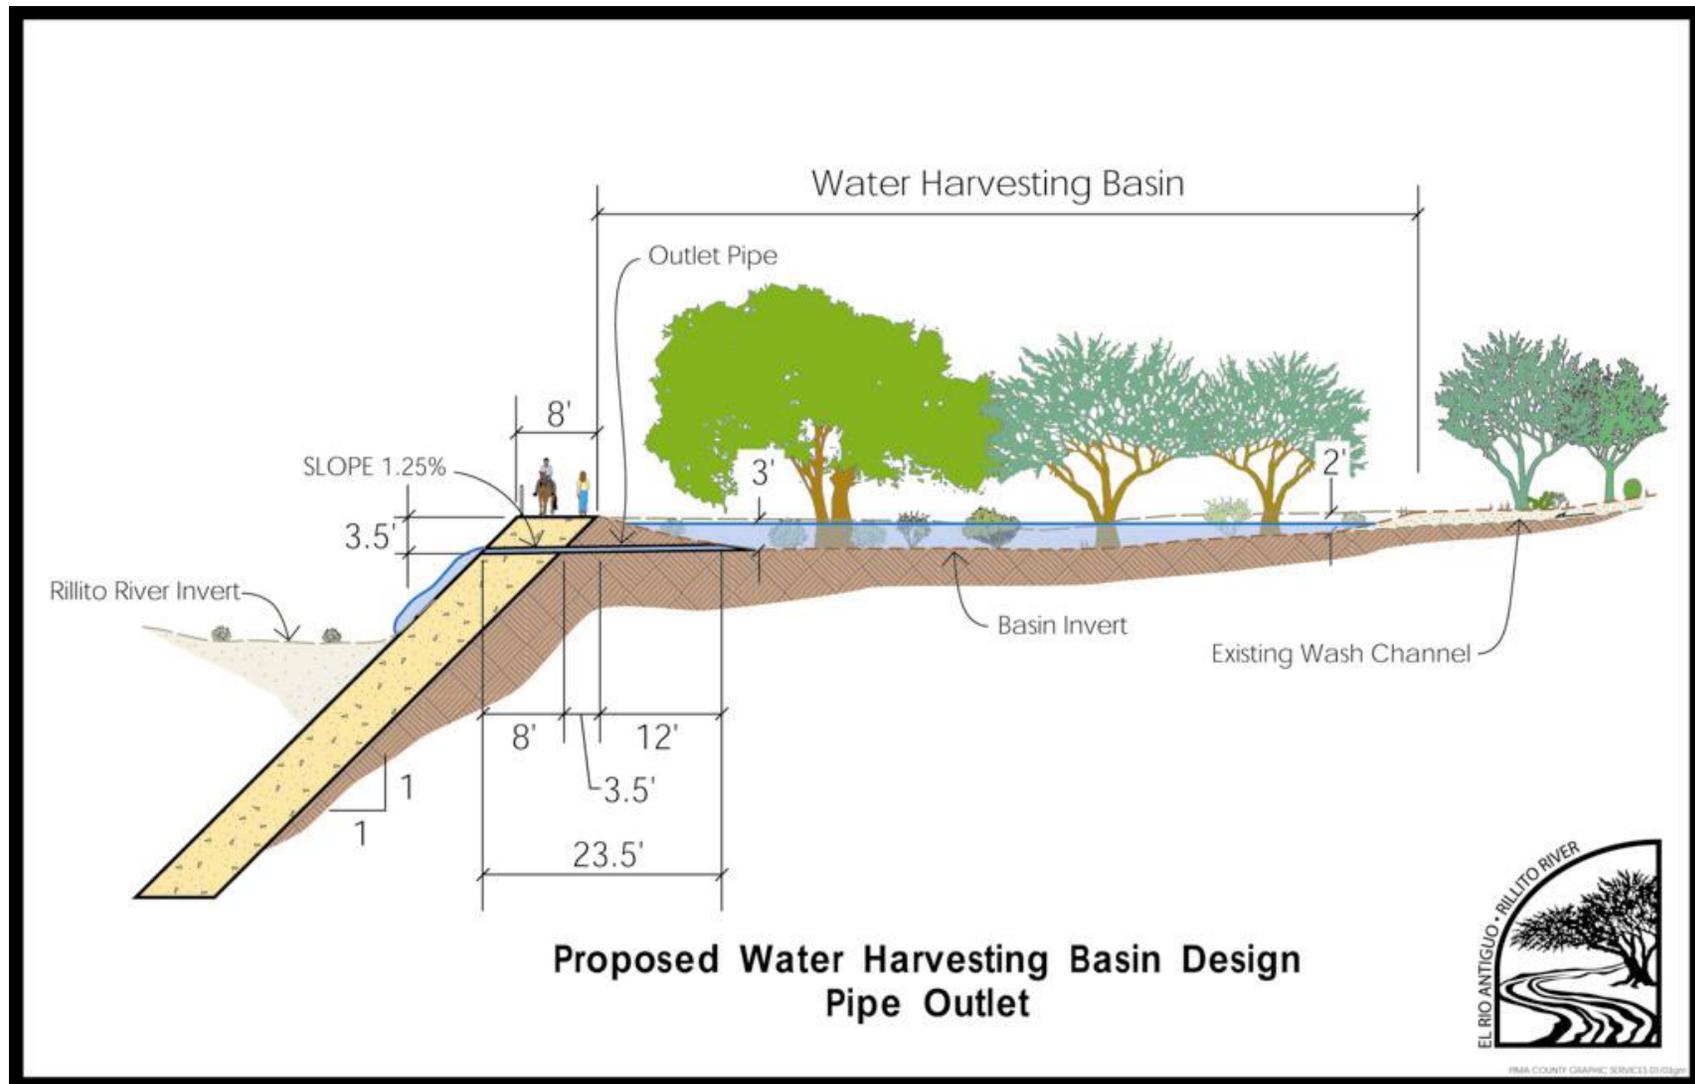
**Figure 6.4 Typical Basin Cross-Section**

1. This basin follows the design of Bosque Creek Basin.
2. The basin floor tapers from wash entry to 3 ft depth toward River with 4/1 slopes.
2. It cover approximately 5 acres as shown on Figure 6.1 and will support a Mesquite Bosque plant community.

Typical water harvesting basin cross-section using weep hole or pipe outlets. See Design Appendix for plan view of a typical basin and weir design.

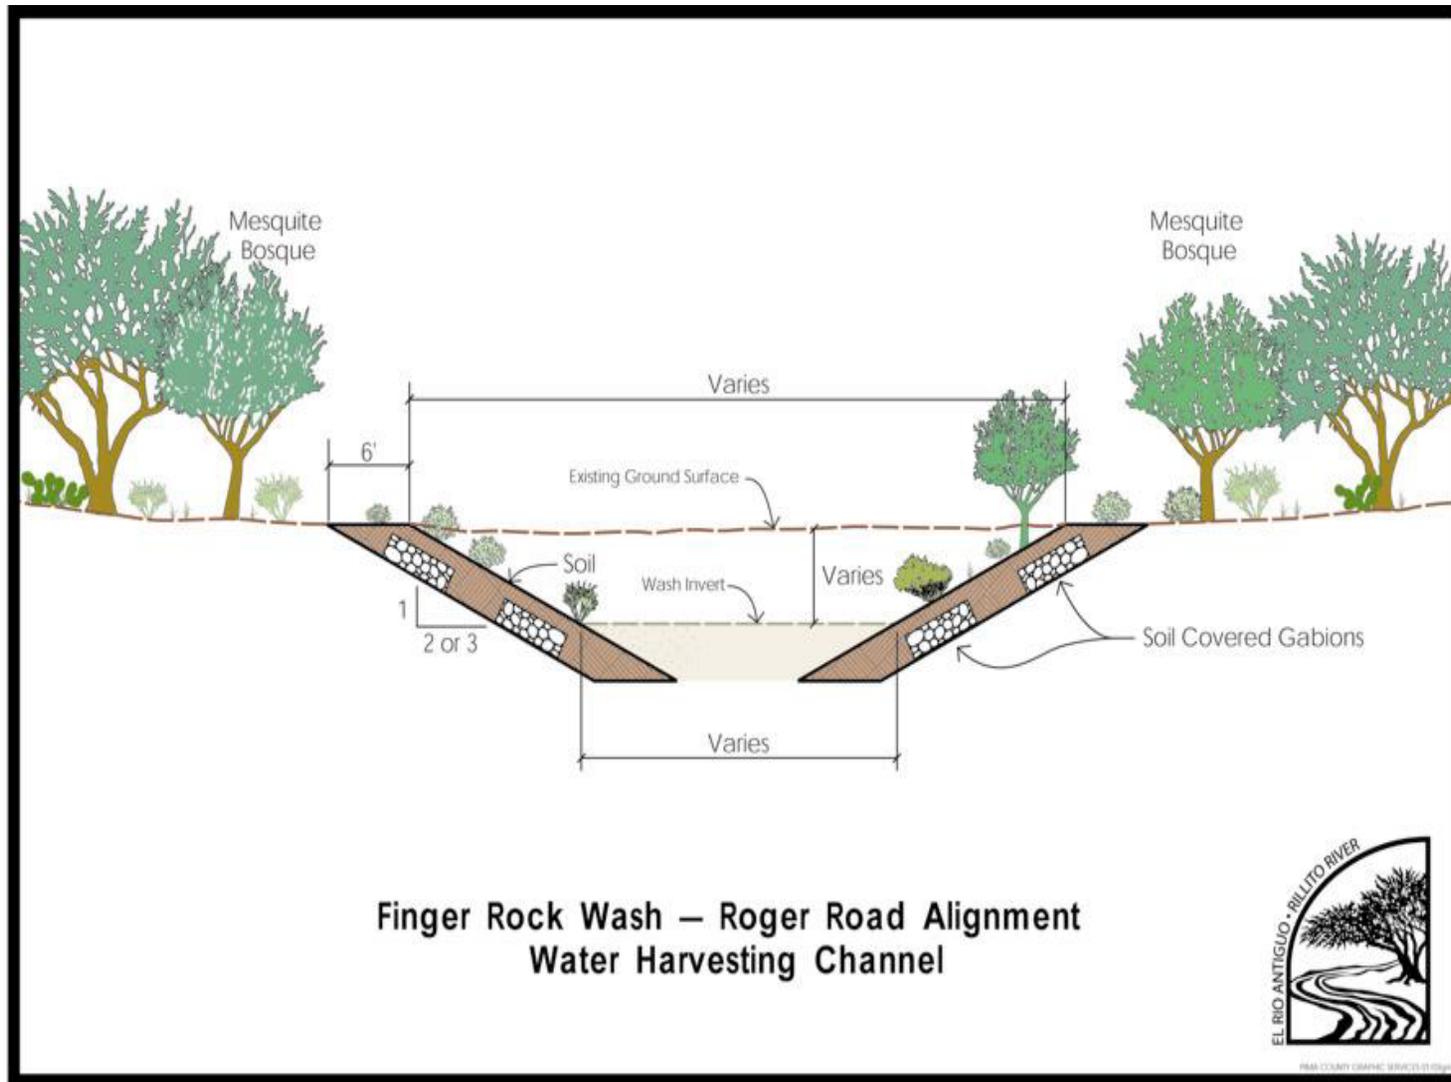
***Figure 6.5 Finger Rock Wash Low Flow Channel***

This feature will improve ecosystem function by providing flood flows to additional portions of the floodplain that were cut from the Rillito by construction of soil cement bank stabilization. It will also decrease depth to saturated sediment in the area, increase the flood prone area, detain nutrients, increase micro topographic relief, allow the area to support additional plant communities and increase habitat areas for wildlife.

Cross sectional view of Finger Rock Wash low flow channel supporting a Mesquite Bosque and reconnection of this tributary with the channel of the Rillito for wildlife and flood flows. The high flow channel will be similarly constructed.

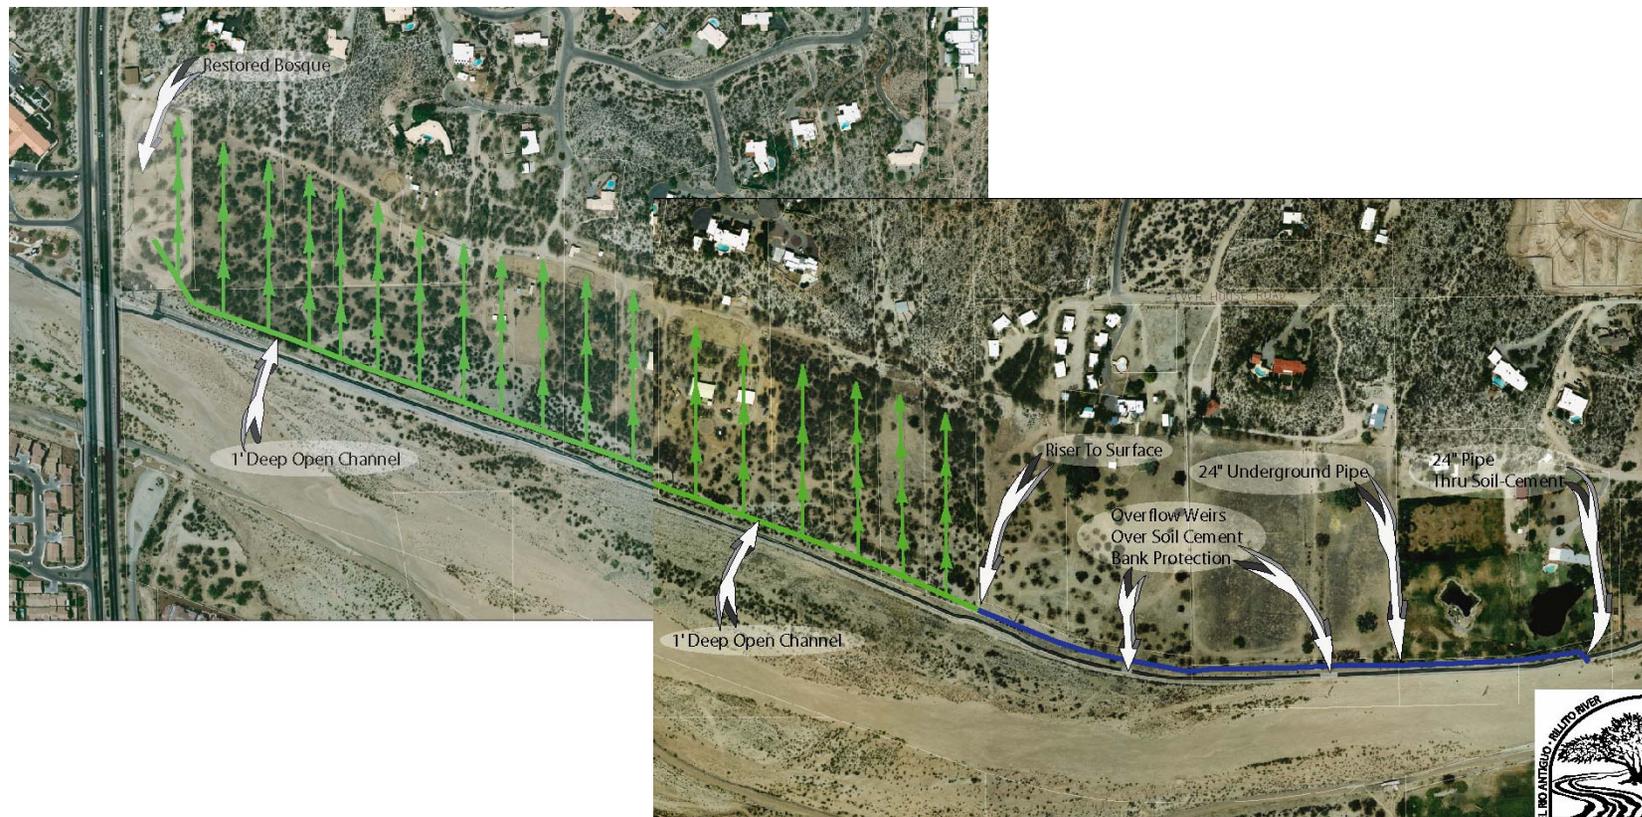
***Figure 6.6 Craycroft to Swan Water System***

Detail view of Craycroft to Swan pipe and ditch watering system. Flood flows from irrigation or natural floods will flow across the restored areas through a system of berms and swales. Excessive flood flows will drain through an existing culvert under Swan Road and existing weirs between Craycroft and Swan.
